## WHITWORTH SQUARE CONSERVATION AREA

### CHARACTER APPRAISAL AND MANAGEMENT PROPOSALS PLAN

ADOPTED FOR DEVELOPMENT CONTROL PURPOSES FROM 1<sup>ST</sup> SEPTEMBER 2011

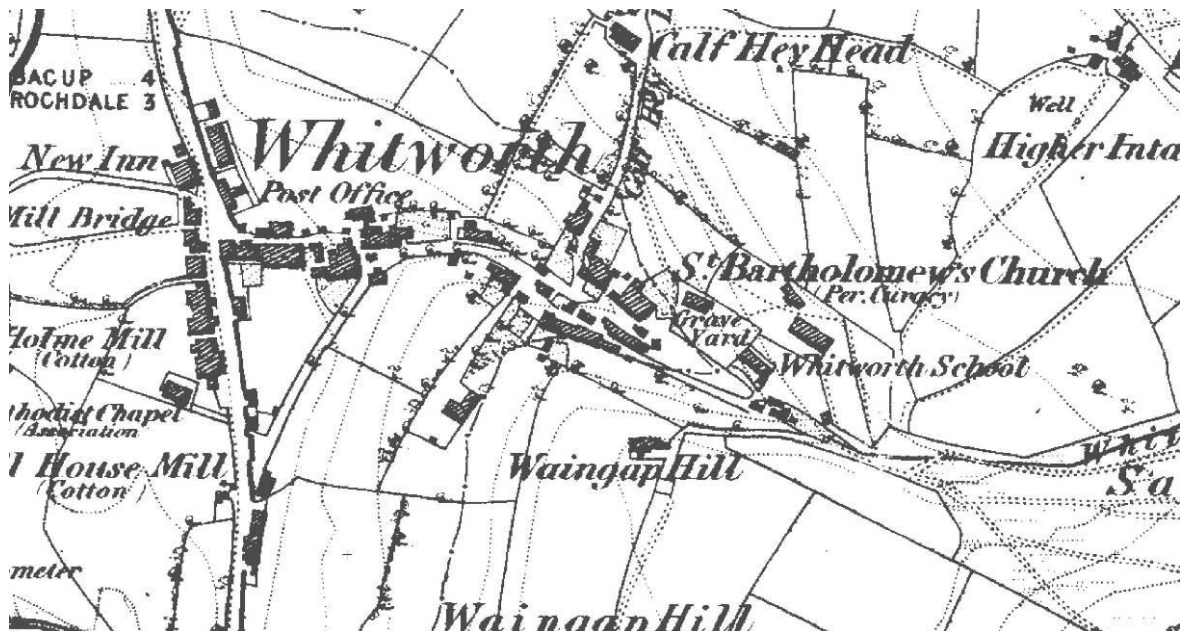
Historic map of 1851

By the time of the 1851 map, a small hamlet had formed around the junction of Church Street and Market Street, and Union Road had been created, presumably to bypass the narrow constriction of buildings which then lay on either side of Church Street. Whitworth village then contained a Post Office, the New Inn, two cotton mills, a Methodist Chapel, and a scattering of houses mainly along the west side of market Street. To the north of Calf Hey Head was a large sandstone quarry (High Field Quarry) with a further quarry on the moorland to the north-east of the village. Calf Hey Lane appears to have been a much more important route than now, with the land continuing past the house towards Long Acres Farm. Of note is the convergence of several pathways from the moorland down Whitworth Rake into the valley below.

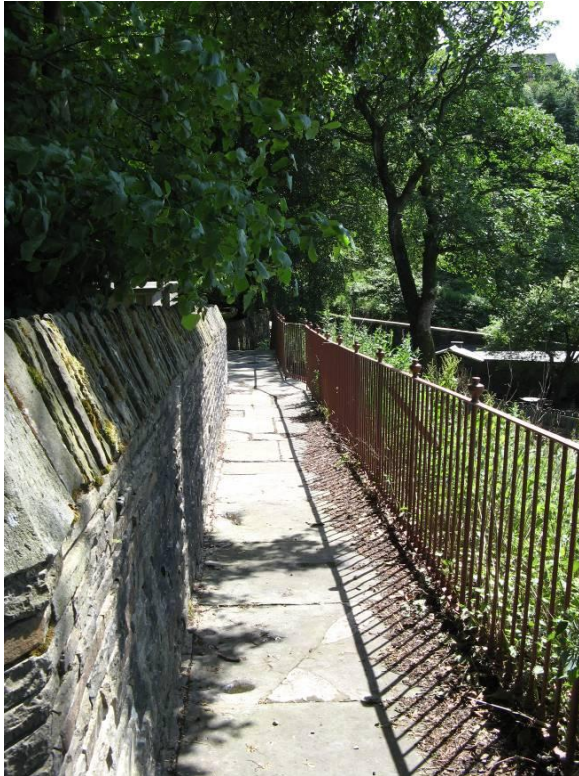
There are also examples of cast iron railings in many locations, most notably around the churchyard, where some have been replaced under the recent grant scheme. These are simple cast iron uprights, with arrow spikes. Some of these are in very poor condition and some have an undercoat but no top coat of paint (presumably the grant aid did not cover all of the necessary work). In places, modern timber fencing has been inserted to provide some level of protection. The removal of this fencing and its replacement with matching cast iron railings (as well as the repair and repainting of the existing cast iron railings), is urgently required. Traditional cast iron railings, again simple uprights with a spear head, can also be seen next to The Briars, and again in rather poor condition. Spiked cast iron railings, similar to those around the churchyard, can also be seen around the front garden to Whitworth House.

*Unpainted railings on edge of churchyard*

- Many of the monuments in St Bartholomew's Churchyard are in poor condition and in need of repair or restoration, including the listed village stocks
- Some of the railings around the pathways and the churchyard are in need of redecorating and modern timber fencing needs to be replaced with traditional iron railings

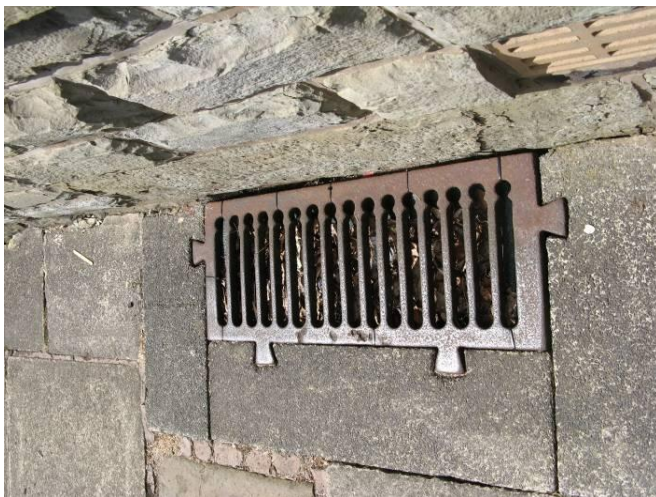
*Cast iron grille in pavement in Church Street*

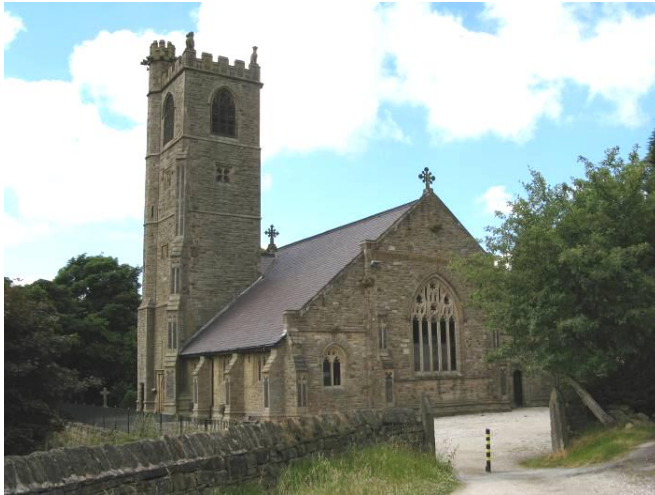
*St Bartholomew's Church*

The 1840s church was designed by Joseph Clarke in the Perpendicular style but was substantially rebuilt to a reduced footprint in the 1980s following a fire. The remaining historic sections are the tower and parts of the nave. The walls are of sandstone rubble and the roof is slated.

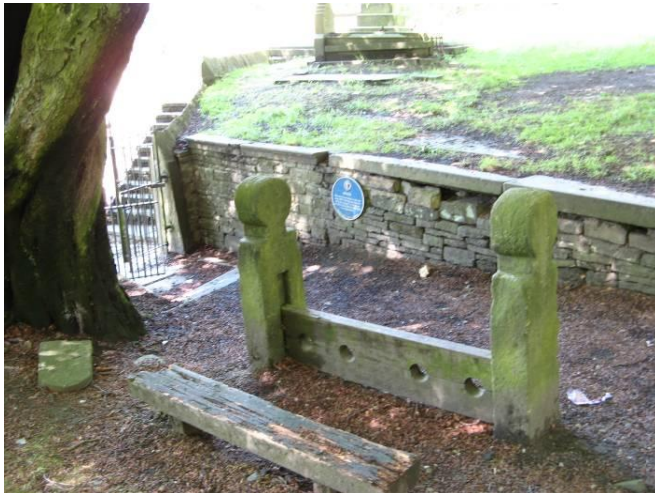
The stocks are made from wood and probably date to the 18<sup>th</sup> century.

*Stocks in St Bartholomew's Churchyard*

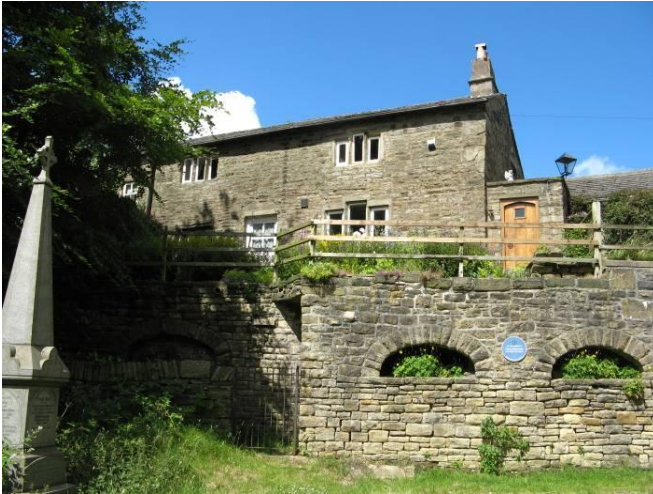
*The Old Parsonage, Whitworth Rake*

The Old Parsonage is a complex building which appears to date to the early 18<sup>th</sup> century but which the owners consider may retain late 17<sup>th</sup> century fabric. It has also been somewhat extended and altered over the years. The walls are coursed sandstone rubble with corner quoins, and there is a concrete tiled roof.

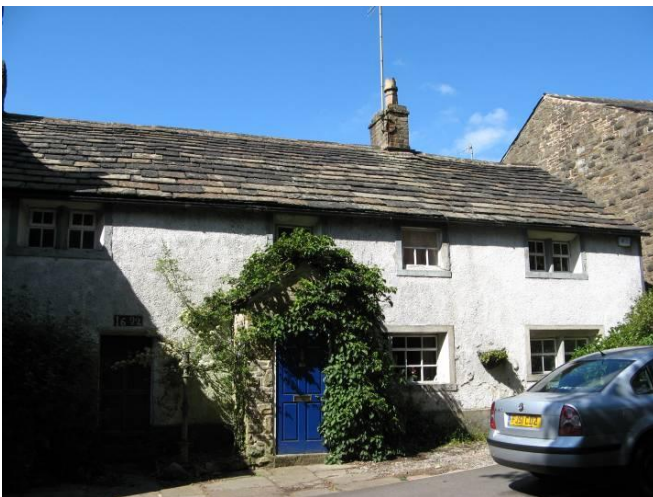
*Orchard Cottage, No. 11 Taylor Street*

This three-bay building is dated 1692 (datestone) and is faced in painted roughcast, probably over sandstone rubble. Some of the windows retain chamfered mullions although the actual opening lights are 19<sup>th</sup> century or later. The roof is covered in stone slates.

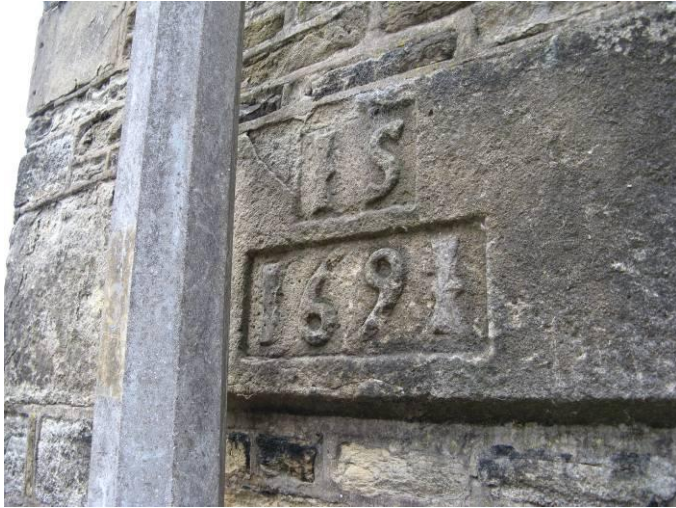
*Datestone 'IS 1691' on the listed barn in Taylor Street*

This is a relatively unaltered barn with a wide gable facing Taylor Street, on which a datestone 'IS 1691' is cut out of a large stone lintel. The building is constructed using roughly coursed sandstone rubble, with large corner quoins, and the gable end facing Taylor Street contains five ventilation slits and one owl hole. The roof is corrugated sheet. It is listed because of its association with No. 11 Taylor Street, also grade II.

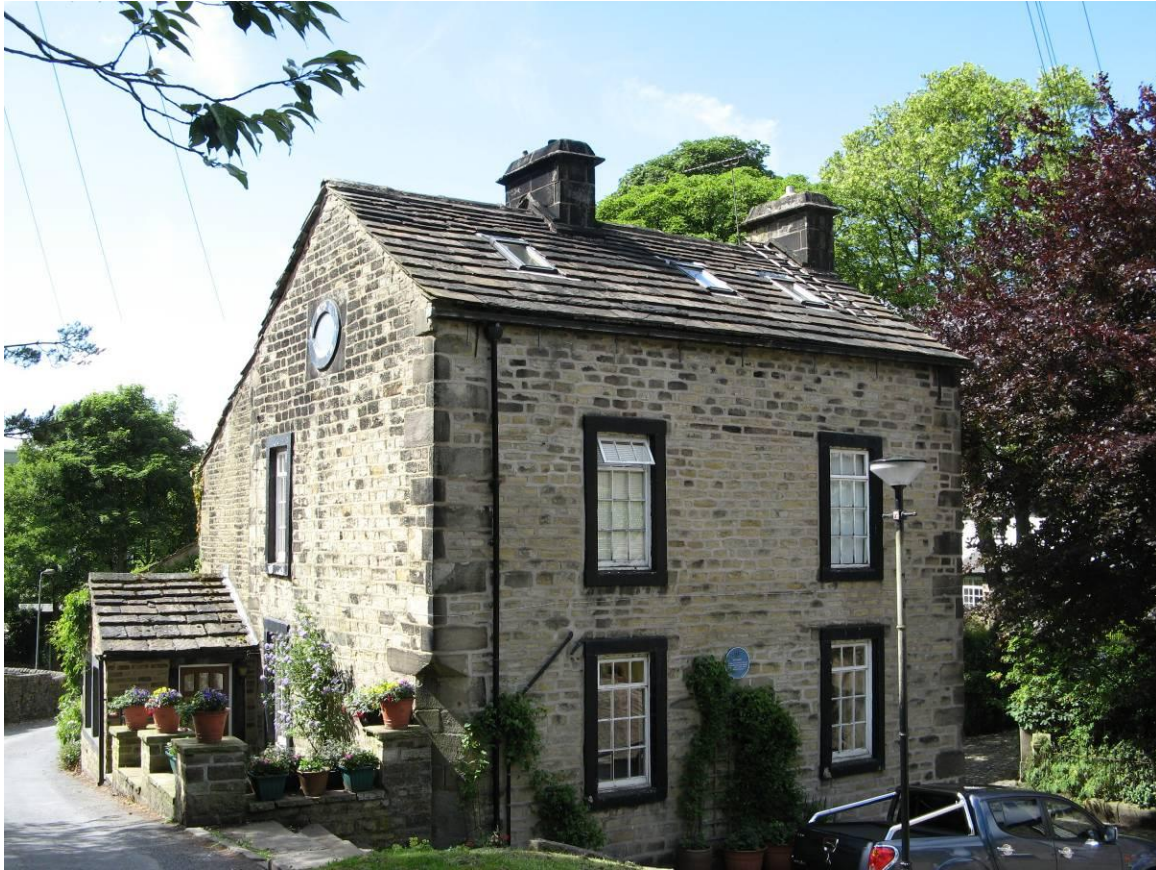
*The Briars*

The historic buildings of the Whitworth Square Conservation Area are built almost exclusively from the local sandstone, which was quarried off Whitworth Rake and also around the settlement. The stone is usually cut into regularly sized rectangular blocks with a roughly tooled outer face, usually referred to as 'rock-faced' stonework. The joints, even on the more modest cottages, are relatively fine and traditionally were filled with small quantities of lime mortar. The Briars in Whitworth Square is the only example of 'watershot' stonework; where the smooth sandstone blocks are set at an angle, with angled mortar, both details designed to shed water more easily. However, the very poor quality modern repointing has virtually obliterated the evidence of this feature.

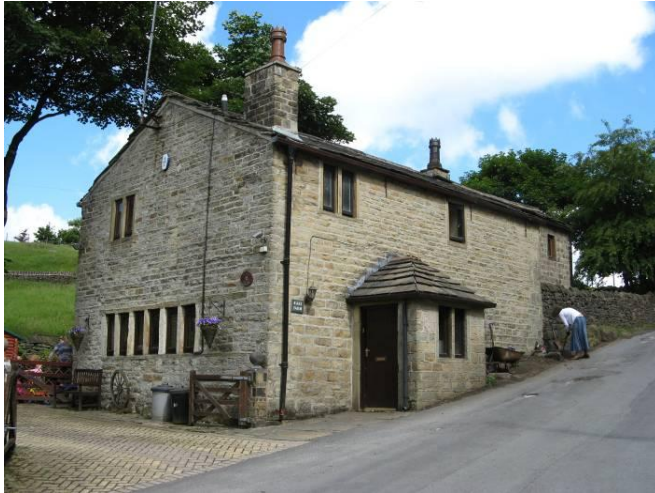
*Rake Farm*

Rake Farm in Whitworth Rake is another stone building which the owner dates to 1649, although it has been somewhat altered. It retains a row of stone mullioned windows to the ground floor end elevation facing down the road which may indicate the use of the building for handloom weaving. Similar details can be seen on Calf Hey Head (currently outside the Conservation Area), which the owner has dated to 1802. Both have stone slate roofs.

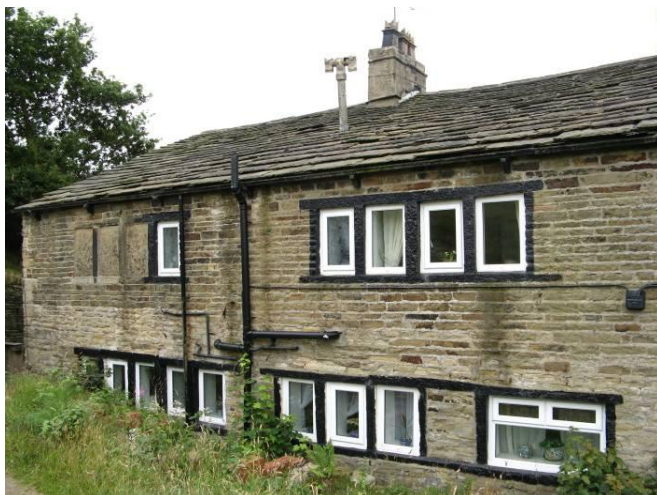
Calf Hey Head is a stone-built pair of unlisted houses, built originally as three units. Nos. 1 and 2 are now in single ownership. Their owner has reported that the building dates to 1802 and stylistically this would appear likely. The back (north) elevation retains rows of windows which would suggest that it was used for handloom weaving at some stage. The building was also used to house patients who were visiting Whitworth for treatment.

*Back elevation of Calf Hey Head*

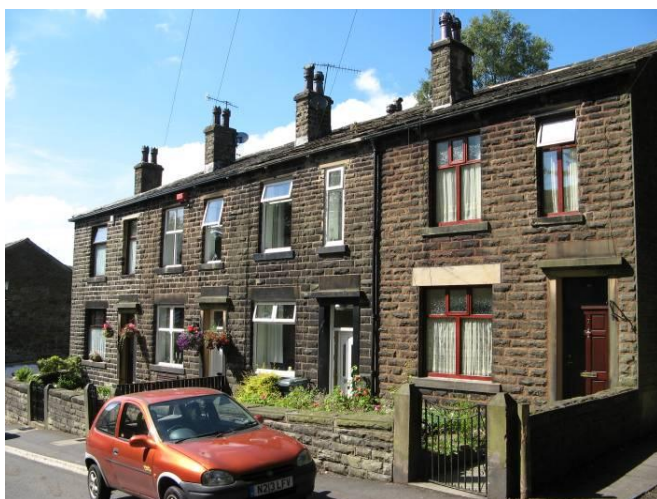
It has been noted that some of the unlisted 'positive' terraced or detached houses in the Conservation Area have been adversely affected by the alterations to the roofs, chimneys, windows and front doors. These changes are 'permitted development' which can be controlled by the Council through the imposition of an Article 4 Direction. Article 4 Directions are made under the *General Permitted Development Order 1995*, and can be served by a local planning authority to remove permitted development rights where there is a real threat to a particular residential building or area due to unsuitable alterations or additions. An Article 4 Direction is accompanied by a Schedule that specifies the various changes to family dwellings, which will now require planning permission. Usually, such Directions are used in conservation areas to protect unlisted houses in use as a family unit, rather than flats or bedsits where permitted development rights are already much fewer. It does not mean that development, such as changes to windows or doors, will necessarily be impossible. It does, however, mean that planning permission has to be sought and this allows for the merits of a proposal to be considered against the conservation interests.

*Protect the roofs and chimneys of these unlisted houses in Taylor Street by an Article 4 Direction*

Whilst an Article 4 Direction cannot be retrospective, the serving of one would incrementally improve the character and appearance of the conservation area. An Article 4 Direction can also be focused on groups of buildings, rather than the whole conservation area, such as unlisted buildings of particular local significance and all 'positive' buildings. Any Direction will require an up to date photographic survey to record the present condition of the buildings concerned, and written guidance will need to be provided to householders. Where resources allow, the provision of grants to help with the additional costs associated with traditional materials or the reinstatement of lost architectural features (such as the replacement of uPVC windows with windows to a traditional design) can be helpful.

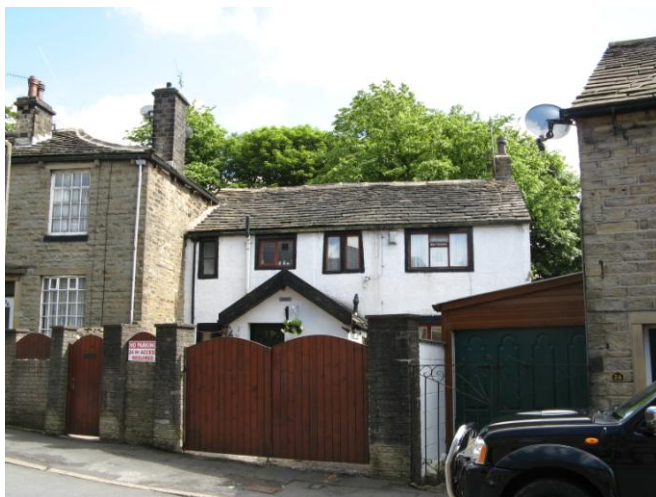
*Stone slate roofs in Church Street*

An Article 4 Direction can be 'fine tuned' to suit the particular circumstances of a conservation area. In Whitworth Square, the greatest threat appears to be to the slate roofs and chimneys, given that most of the windows and front doors in the conservation area have already been altered. The painting of existing buildings, the addition of porches, and the conversion of front gardens to car parking are not considered to be particularly relevant. It is therefore suggested that the Council serves an Article 4 Direction to bring under planning control all alterations to the existing roofs including:

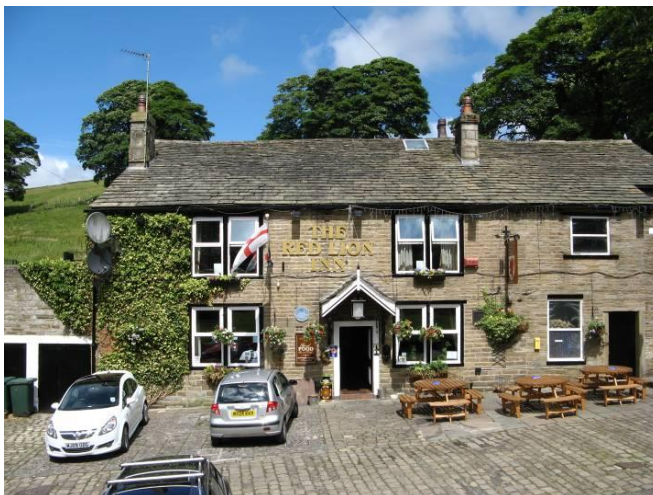
During the survey work for the Whitworth Square Character Appraisal, it was noted that a number of satellite dishes were visible which presumably had not been granted planning permission. Some properties have two satellite dishes, both of which would normally require planning permission. The rules governing satellite dishes in conservation areas are significantly tighter than outside such areas and were recently changed by a revision to the *General Permitted Development Order 1995*. This states that for all unlisted buildings in a conservation area, in whatever use and of whatever size, planning permission is required for all 'antennas' (which includes satellite dishes and any other equipment used to deliver electronic communications) which are located on a chimney, wall or roof slope which face onto, and are visible, from a road. In such cases, planning permission will usually be refused. The rules governing other locations on the building are extremely complex so it is always best to ask the local planning authority if planning permission is required before carrying out the work.

*Satellite dishes in Whitworth Square*

- The Borough Council will consider taking Enforcement Action against the owners of properties where satellite dishes have been erected without planning permission and negotiation has failed to achieve a satisfactory outcome.

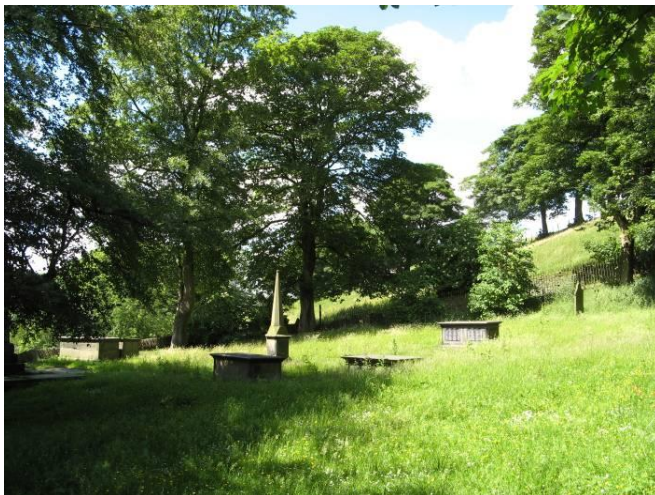
*Trees in St Bartholomew's Churchyard*

There are many mature trees of townscape importance in the Whitworth Square Conservation Area and the most significant of these are marked on the Townscape Appraisal Map. Some of these are specifically protected by Tree Preservation Orders, and some, such as the trees in the churchyard, are the responsibility of the Borough Council, but the majority are in private ownership. Individual owners need to be encouraged to look after their trees, to remove any which are dangerous or diseased, and to plant replacement trees where the removal of an existing significant tree has become necessary. One such tree lies on the west side of Whitworth Rake, where its roots have been undermined by soil erosion – urgent action is required to safeguard this tree before it finally falls down.

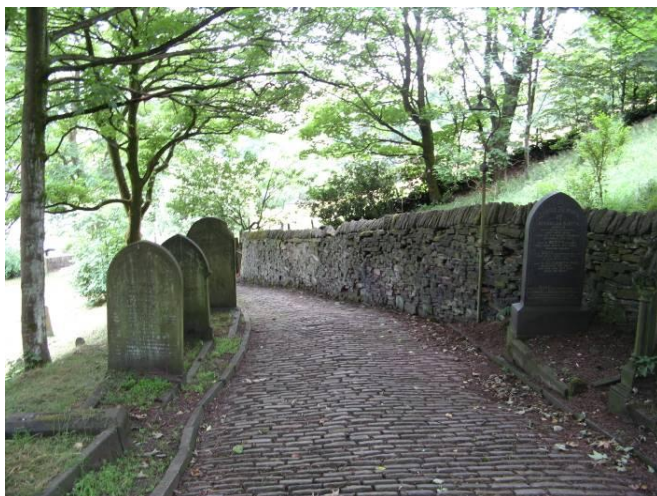
It has been noted that areas of sandstone flags and setts remain in the Conservation Area and these will have to be carefully maintained and protected from damage. This will generally be the responsibility of the County Council.

*Traditional paving in the churchyard*

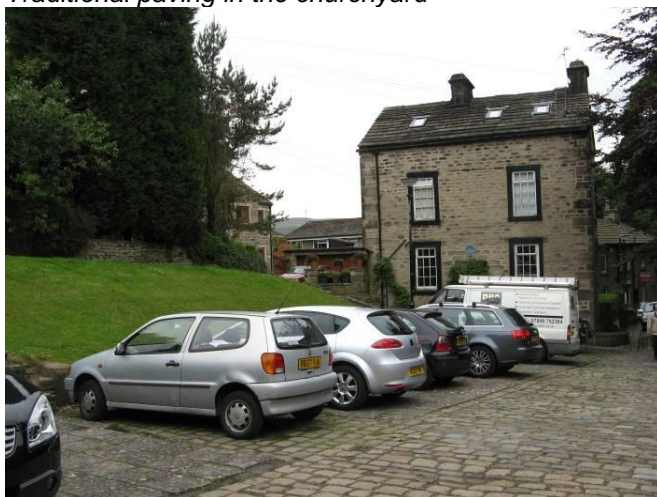
*Concrete and traditional stone paving in Whitworth Square*

traditional paving would be advantageous, including the replacement of the fake stone concrete paving in Whitworth Square. Funding permitting, the addition of further areas of traditional paving (stone setts and stone flags) would be advantageous.

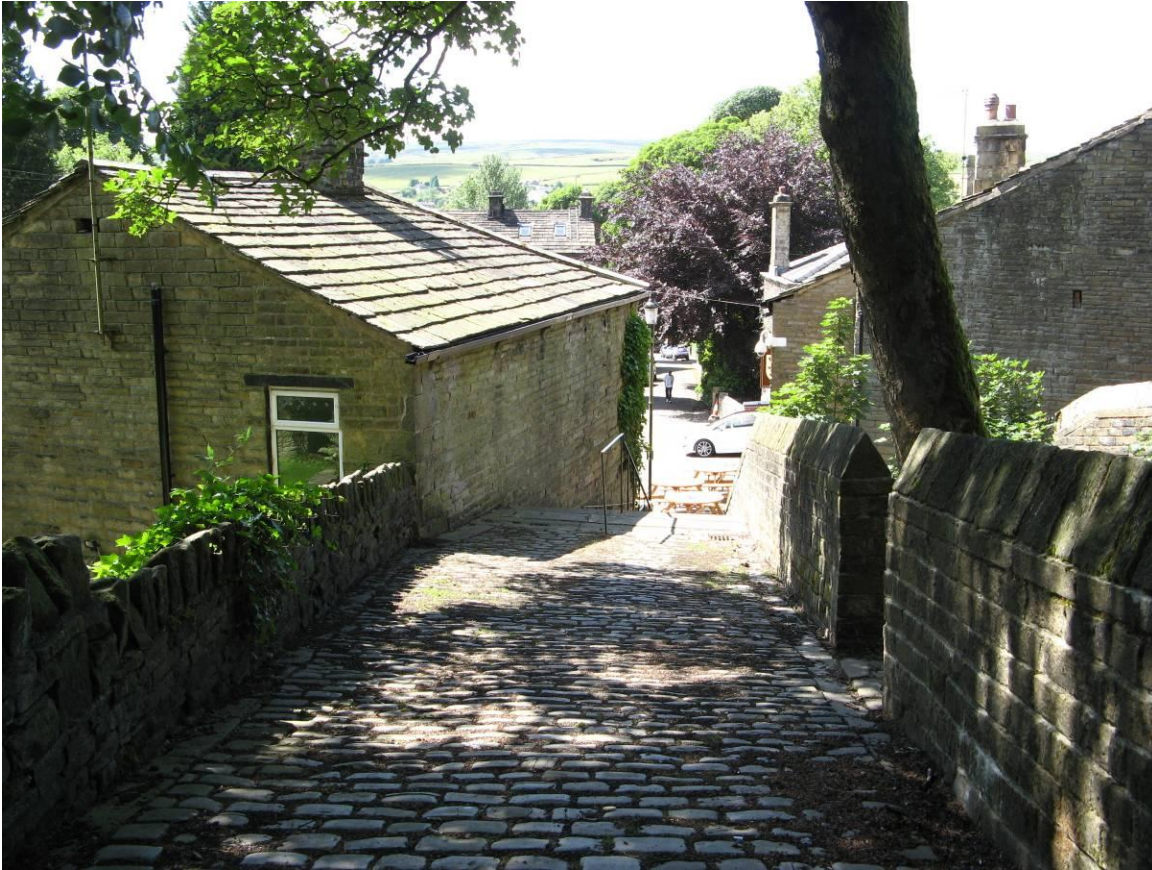
*High quality traditional paving links Whitworth Square to the churchyard*

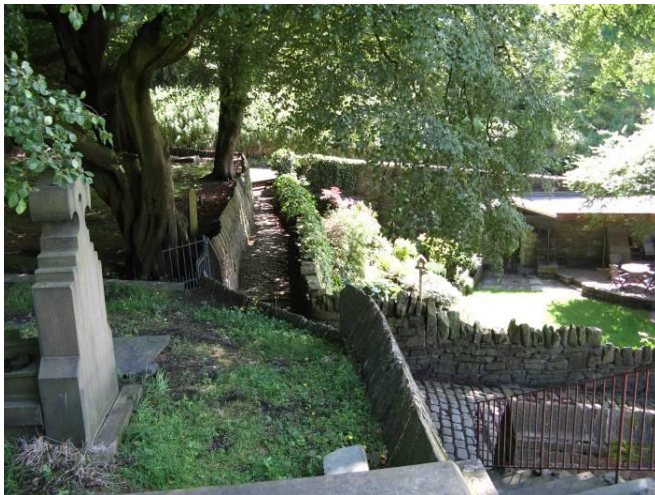
The churchyard is now in the care of Rossendale Borough Council and a certain amount of work was undertaken under the previous grant scheme. However, railings remain unpainted or are in need of renewal, some gravestones have been vandalised, the village stocks require additional repair, and some of the trees need further work. Some of this could be undertaken by local people on a voluntary basis.

*Further improvements to the churchyard would be welcome*

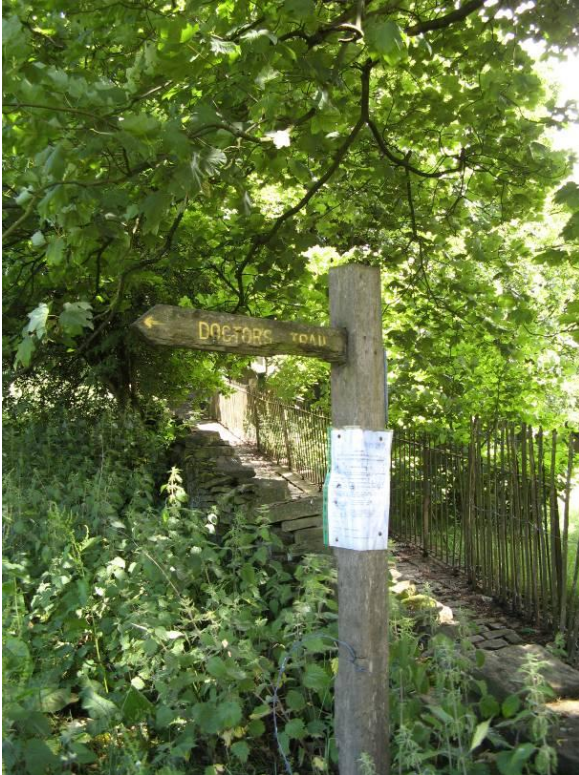
These were provided some time ago by Whitworth Town Council. Further plaques could be added to explain the significance of the Whitworth Square in greater detail. Signage for the 'Whitworth Doctors' Trail' also needs to be upgraded or replaced.

*Signage to the Doctors' Trail is in need of replacement*
