WHITWORTH SQUARE CONSERVATION AREA

CHARACTER APPRAISAL AND MANAGEMENT PROPOSALS PLAN

ADOPTED FOR DEVELOPMENT CONTROL PURPOSES FROM 1ST SEPTEMBER 2011

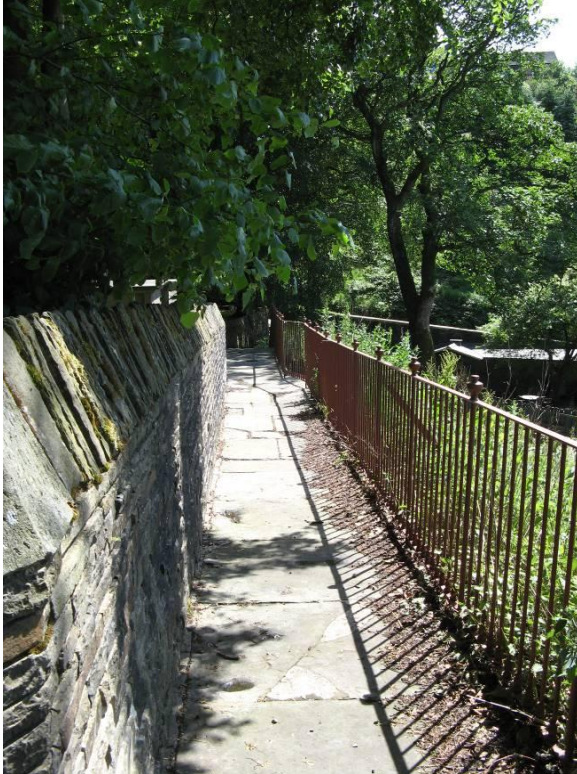
There are also examples of cast iron railings in many locations, most notably around the churchyard, where some have been replaced under the recent grant scheme. These are simple cast iron uprights, with arrow spikes. Some of these are in very poor condition and some have an undercoat but no top coat of paint (presumably the grant aid did not cover all of the necessary work). In places, modern timber fencing has been inserted to provide some level of protection. The removal of this fencing and its replacement with matching cast iron railings (as well as the repair and repainting of the existing cast iron railings), is urgently required. Traditional cast iron railings, again simple uprights with a spear head, can also be seen next to The Briars, and again in rather poor condition. Spiked cast iron railings, similar to those around the churchyard, can also be seen around the front garden to Whitworth House.

Unpainted railings on edge of churchyard

- Many of the monuments in St Bartholomew's Churchyard are in poor condition and in need of repair or restoration, including the listed village stocks
- Some of the railings around the pathways and the churchyard are in need of redecorating and modern timber fencing needs to be replaced with traditional iron railings

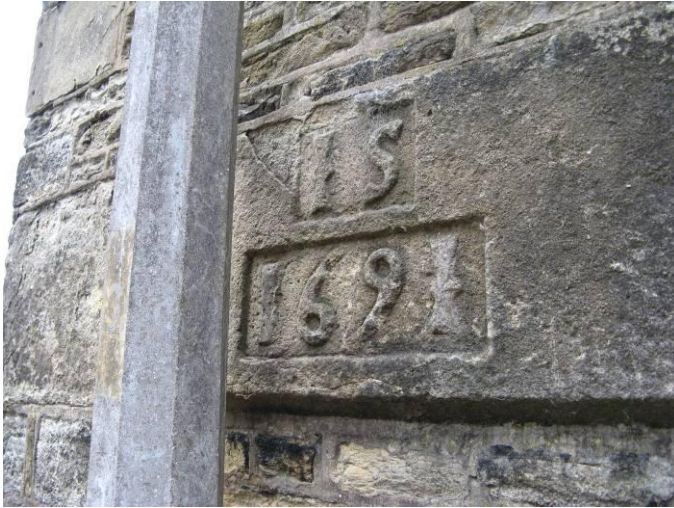
This is a relatively unaltered barn with a wide gable facing Taylor Street, on which a datestone 'IS 1691' is cut out of a large stone lintel. The building is constructed using roughly coursed sandstone rubble, with large corner quoins, and the gable end facing Taylor Street contains five ventilation slits and one owl hole. The roof is corrugated sheet. It is listed because of its association with No. 11 Taylor Street, also grade II.

Datestone 'IS 1691' on the listed barn in Taylor Street

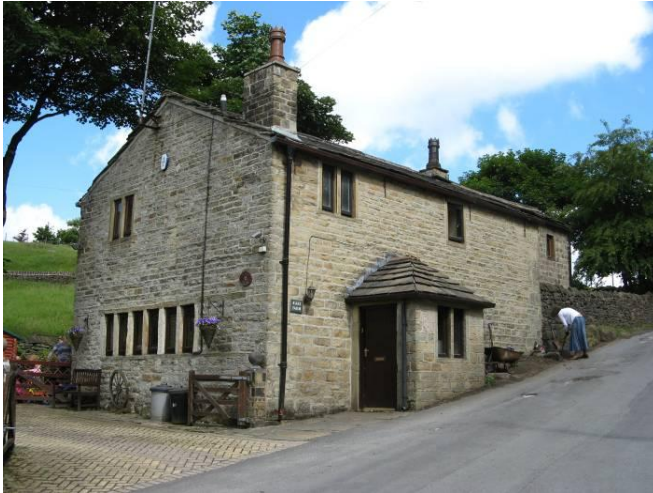
Rake Farm

Rake Farm in Whitworth Rake is another stone building which the owner dates to 1649, although it has been somewhat altered. It retains a row of stone mullioned windows to the ground floor end elevation facing down the road which may indicate the use of the building for handloom weaving. Similar details can be seen on Calf Hey Head (currently outside the Conservation Area), which the owner has dated to 1802. Both have stone slate roofs.

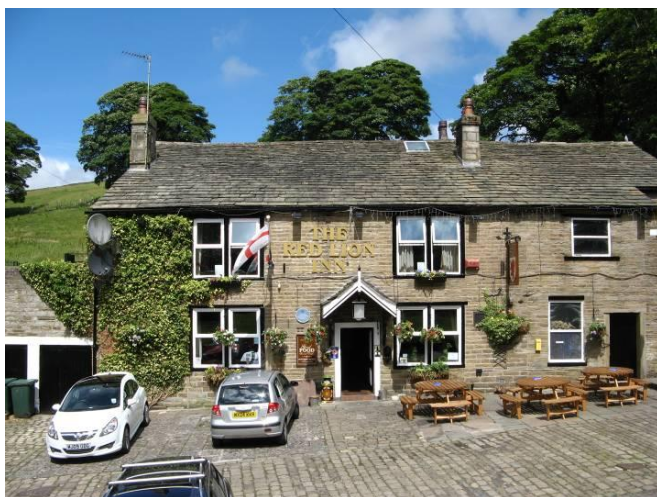
During the survey work for the Whitworth Square Character Appraisal, it was noted that a number of satellite dishes were visible which presumably had not been granted planning permission. Some properties have two satellite dishes, both of which would normally require planning permission. The rules governing satellite dishes in conservation areas are significantly tighter than outside such areas and were recently changed by a revision to the *General Permitted Development Order 1995*. This states that for all unlisted buildings in a conservation area, in whatever use and of whatever size, planning permission is required for all 'antennas' (which includes satellite dishes and any other equipment used to deliver electronic communications) which are located on a chimney, wall or roof slope which face onto, and are visible, from a road. In such cases, planning permission will usually be refused. The rules governing other locations on the building are extremely complex so it is always best to ask the local planning authority if planning permission is required before carrying out the work.

Satellite dishes in Whitworth Square

- Where satellite dishes have been erected without planning permission and negotiation has failed to achieve a satisfactory outcome the Borough Council will consider taking Enforcement Action against the owners of properties.

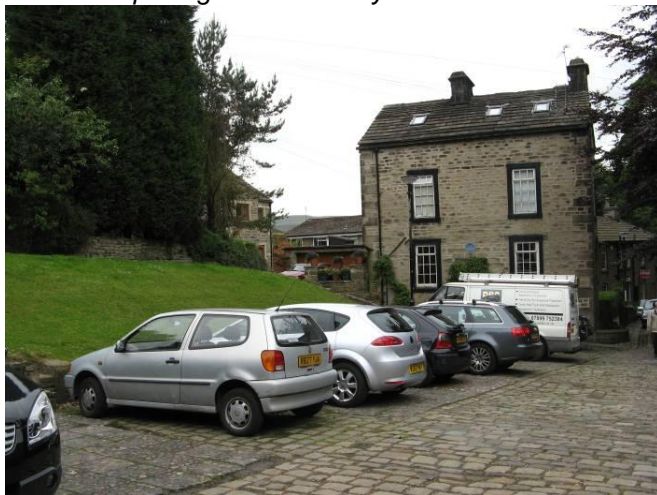
Concrete and traditional stone paving in Whitworth Square

traditional paving would be advantageous, including the replacement of the fake stone concrete paving in Whitworth Square. Funding permitting, the addition of further areas of traditional paving (stone setts and stone flags) would be advantageous.
