BACUP TOWN CENTRE CONSERVATION AREA

CHARACTER APPRAISAL AND MANAGEMENT PROPOSALS PLAN

ADOPTED FOR DEVELOPMENT CONTROL PURPOSES FROM 2nd DECEMBER 2011

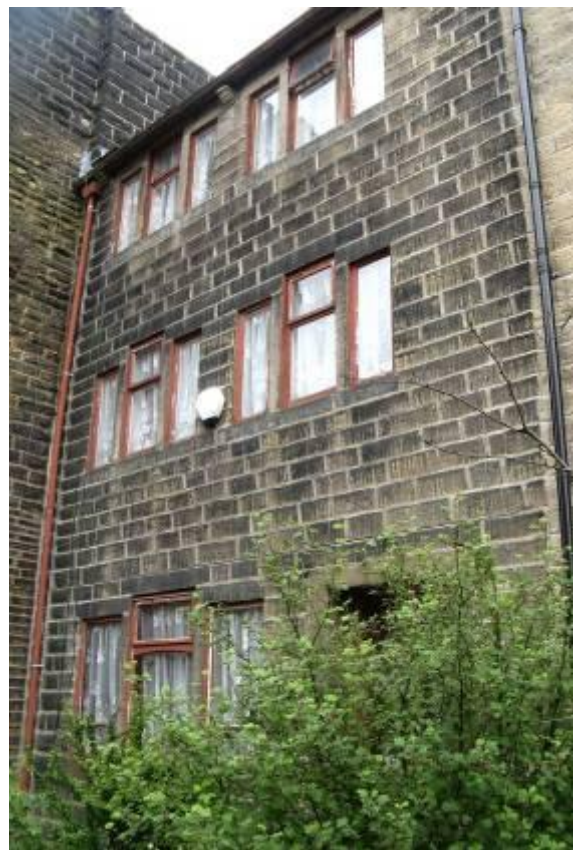
No.16 Rochdale Road c.1800 (grade II)

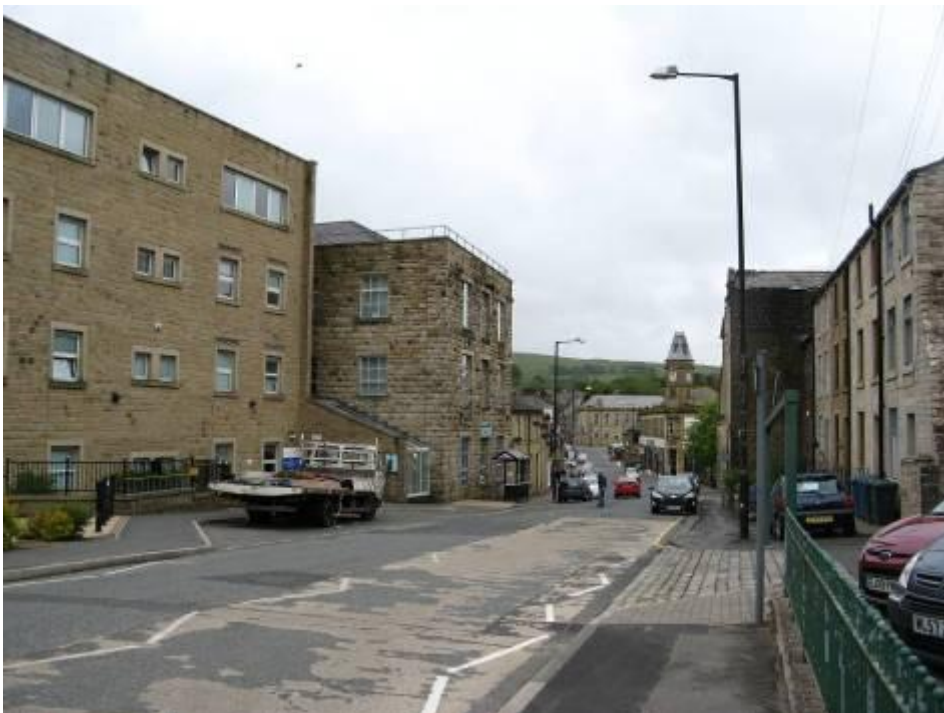
View down Rochdale Road – Irwell Mill on left

To the east of the industrial area and along Rochdale Road, the rising topography has heavily influenced both the spatial quality and also the physical aspects. Rochdale Road is at a significantly higher level than the valley floor below, leading to a number of flights of steps forming linkages between the two areas. A landscaped buffer zone exists along much of this change in level, which does little to enhance spatial quality, in some places even detracting from it by blocking significant views. The further away from the town centre, the wider the views across the town become, with some of the best views along the valley in both directions from close to the present George and Dragon Public House.

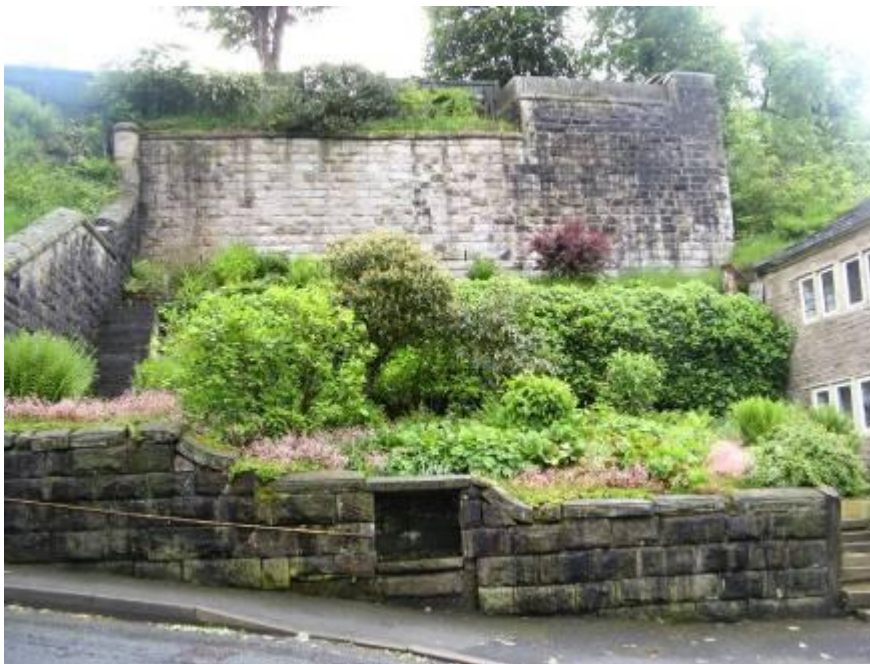
Boundary wall in Bankside Lane

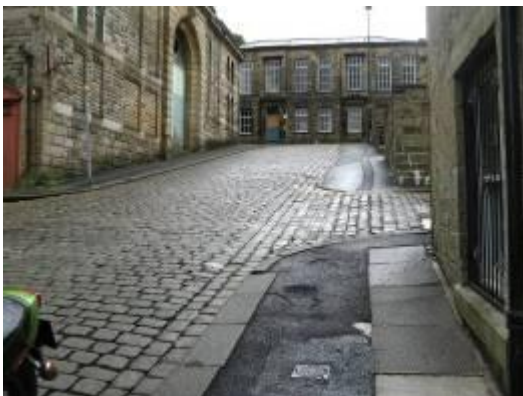
Traditional paving in Bank Street although the stone pavements have been replaced

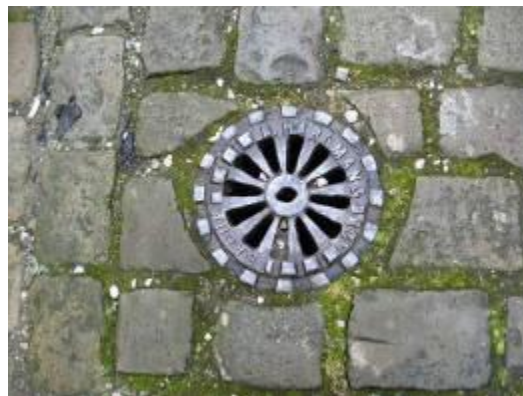
Whilst modern tarmacadam is used for many of the pavements and street surfaces in the Conservation Area, Bacup is fortunate in retaining some substantial remains of the original (probably 19th century) sandstone setted or flagged paving which must once have been ubiquitous. These stone flags came from the Haslingden Flag beds. Examples can be mainly seen in the middle west of the Conservation Area, between Market Street and Fern Street, although a few narrow setted streets remain off Union Street. The setted streets next to the old Market Building and former Police Station are of special significance in that they provide an appropriate setting for these important historic buildings. A path next to Bankside Cottage retains some particularly fine examples of sandstone flags and huge pieces of sandstone which have been used to create steps. All of the traditional paving or street surfacing is marked on the Townscape Appraisal Map, although smaller sections also remain which have not been specifically recorded. Some cast iron coal or drain covers remain, such as the one in Bank Street entitled *R Hardman & Bro. Bacup*. Examples remain, though in a limited number, of a gully sometimes referred to as a 'Bacup gully'. This is a glazed purple-brown claypipe in the shape of a narrow trough about one meter long with a knockout in the sides at the upper end to accept sink wastes, and a spitter to the trap at the other. These carry a full length cast iron grate of diagonal trellis work.

Drain cover in Bank Street

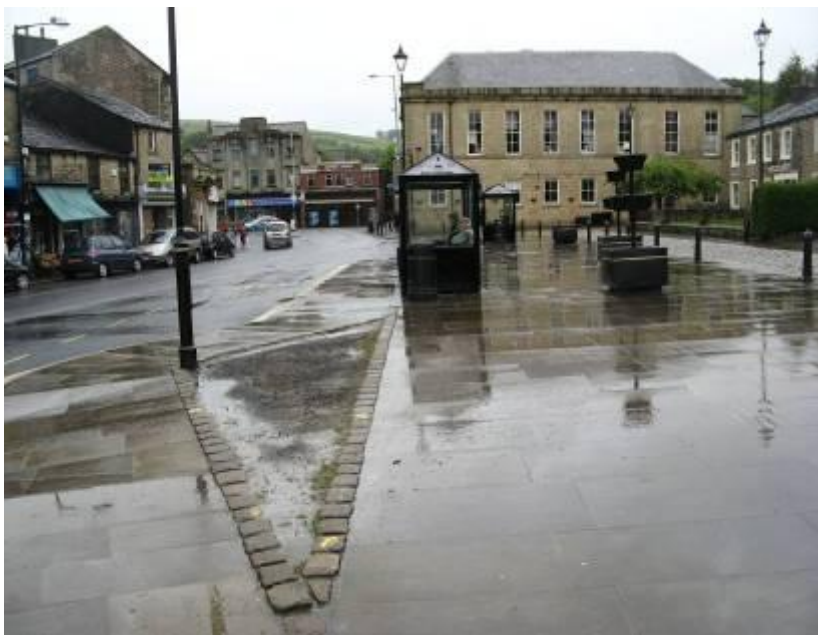
East side of St James Street, showing repaved area

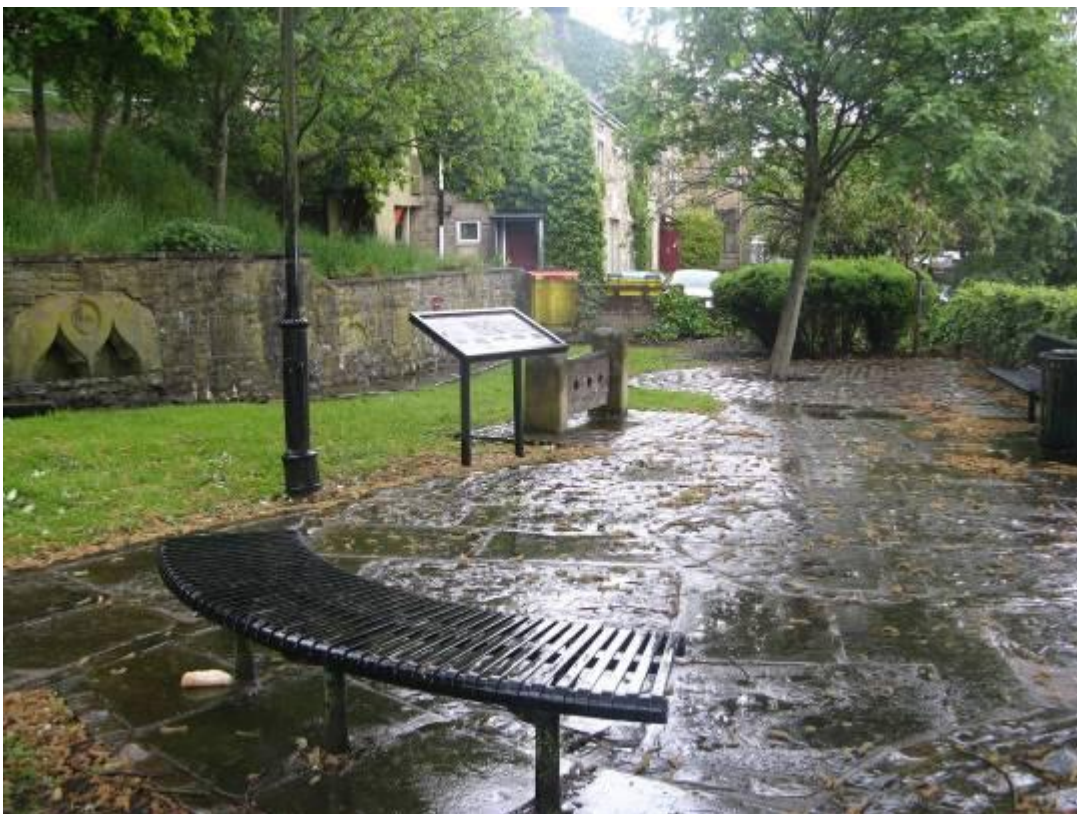
Wall of History, Todmorden Road

An unusual feature in the Conservation Area is the Wall of History off Todmorden Road, a small landscaped area which includes an information panel about the history of Bacup, and a number of old tombstones, the listed stocks, and several plaques of local interest. These include a plaque to the Bacup Co-Operative Store, dating to 1862, and a plaque for the Bacup Bowling Club, dated 1921.

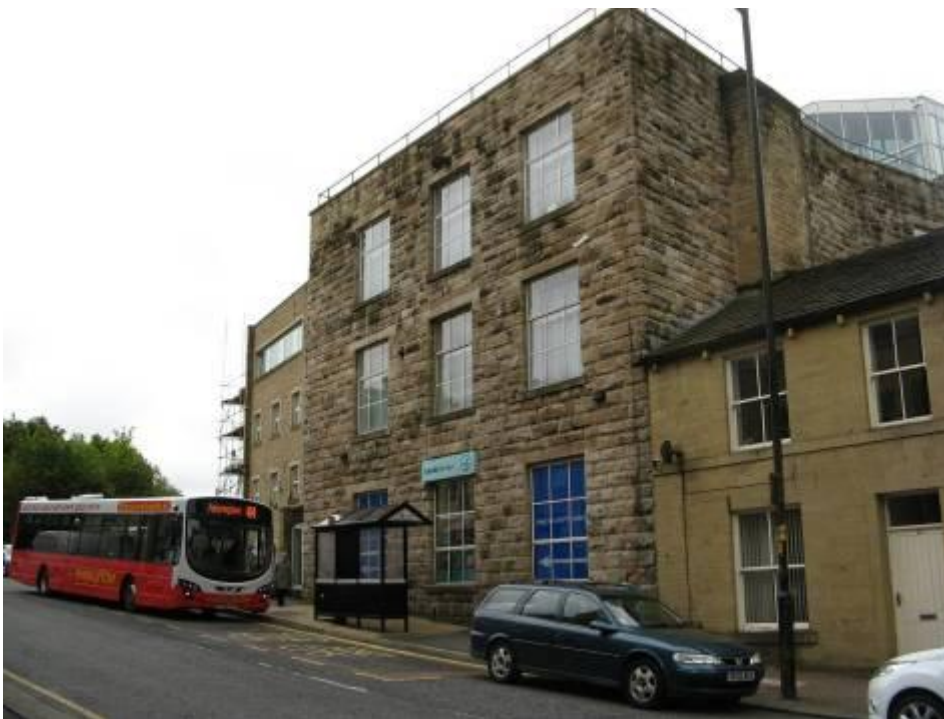
Irwell Mill, from Rochdale Road

The Conservation Area retains a valuable collection of buildings from the late 18th or the 19th century which relate mainly to its function as a mill town. Most of these are listed grade II although one, The Laurels, is listed grade II*. There is only one mill complex left (Irwell Mill, dating to 1824-5) within the present boundary, of which some of the buildings are presently derelict and threatened with demolition, although a large portion of the building has been imaginatively converted into office accommodation. Just outside the current Conservation Area in Burnley Road, Underbank Mill was built in 1837 (only part of the original building remains) and Waterside Mill was built in 1839. This building is derelict and at risk.

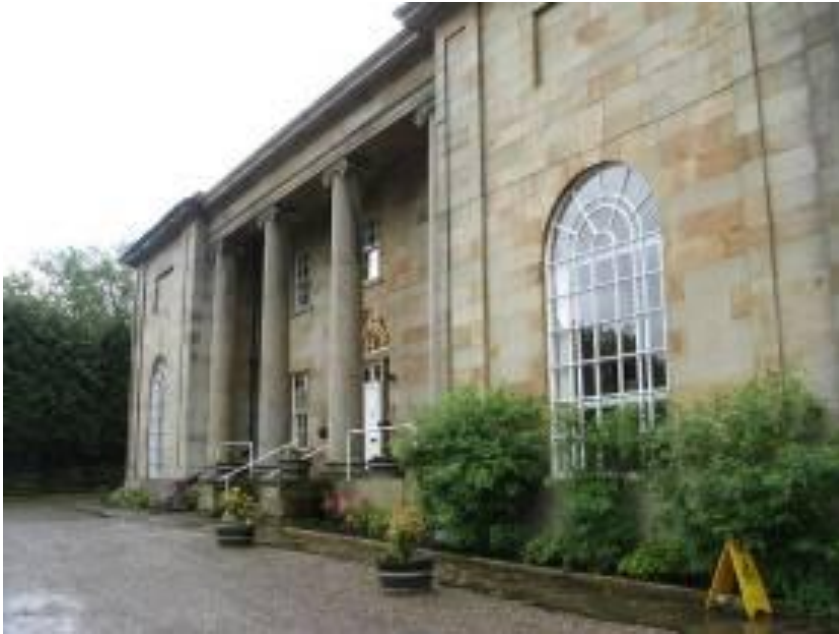
Forest House, now The Laurels, Bankside Lane

This large house was probably designed by John Foster of Liverpool in around 1828. It is built in a neo-classical style using ashlar, with a hipped tiled roof which is largely hidden by moulded parapets. Its most notable feature is provided by the symmetrical front elevation which contains a row of four two storey Ionic columns which mark a recessed bay. On each side are two end bays which stand slightly forward and are decorated by a large round-headed window with multiple panes of glass. Once derelict, the house is now a home for the elderly.

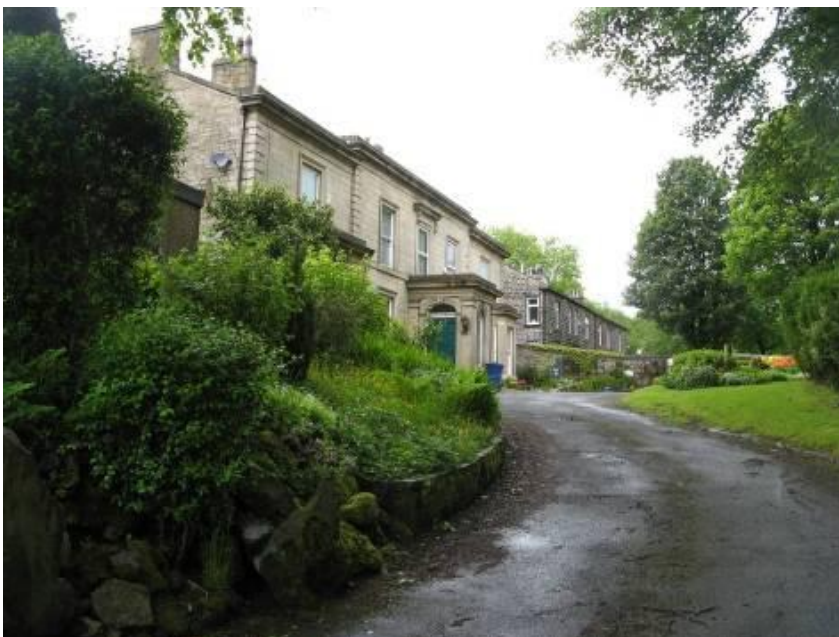
Bankside Hall (on left), Bankside Lane

Bankside Hall has now been divided into three properties – Bankside Hall, Bankside House and Bankside Cottage. It dates to the mid 19th century and is built in the Italianate style with coursed dressed sandstone walls with a hipped slate roof concealed by a moulded parapet. The one over one sash windows appear original.

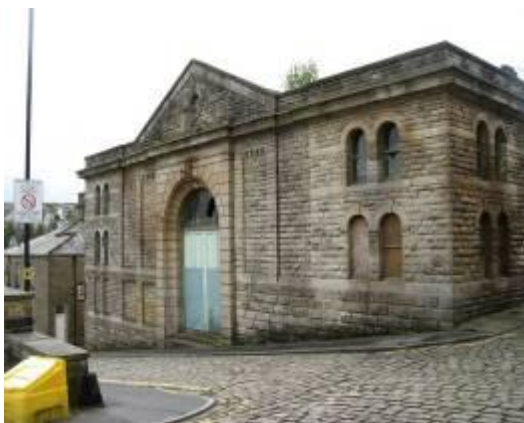
Old Market Hall, Bank Street

The Old Market Hall dates to 1867 with a later addition to the west side. It is built on a slope with three bays one side and eight bays the other in a simple rectangular shape. The walls are rock-faced sandstone with sandstone ashlar bands and dressings, in a vaguely Italianate style. A large portico adds definition to the Bank Street elevation. On the lower ground floor there are eight shops, with some original shopfronts, now in a very poor state of repair. The building has been empty for some time and is at risk.

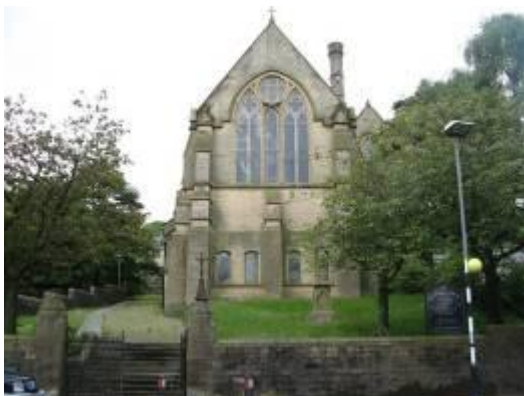
St John's Church, Burnley Road

The church was built on the site of the late 18th century church in 1882 to the designs of Medland Taylor. It is constructed using coursed sandstone with a blue slate roof with patterned bands of green slate. The style is simplified Gothic with traceried windows.

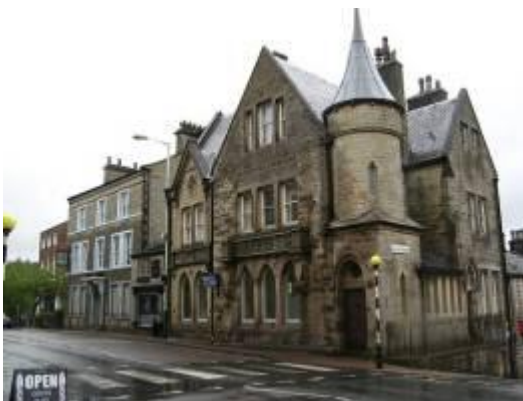
Nos. 18 and 20 Market Street

This is one of the most unusual buildings in Bacup and occupies a prominent corner site. It was built in the Scottish Baronial style in 1862, as the Lancashire and Yorkshire Bank, using smooth faced sandstone blocks with a slate roof with a notable circular corner turret, topped by a lead-covered roof.

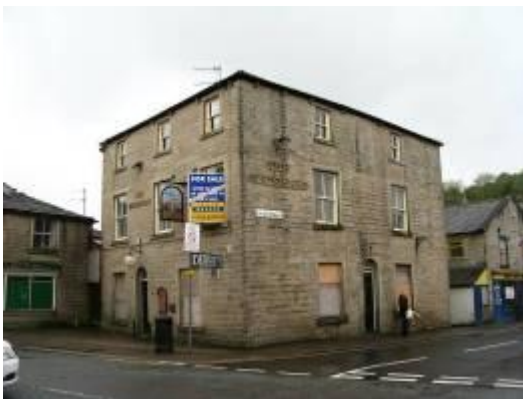
The Waterloo Hotel, No.1 Rochdale Road

This dates to c1840 and is three storeys high with a pyramid-shaped slate roof. Built from coursed sandstone, it has symmetrical elevations to two sites and sits on a prominent corner site at the junction of Union Street and Rochdale Road. It is currently (2011) vacant.

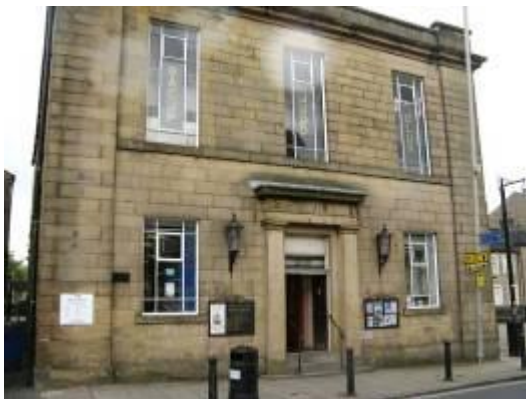
Bacup Library (former Mechanics Institute)

This building was built in 1846 using sandstone ashlar with a hipped slate roof. The simple rectangular plan is two storeys high with a central front door with a simple Tuscan doorcase. The mechanics Institute was founded in 1839 and this building was erected by some of the principal manufacturers of the town at a cost of £1,300 and was presented to the members in July 1846.

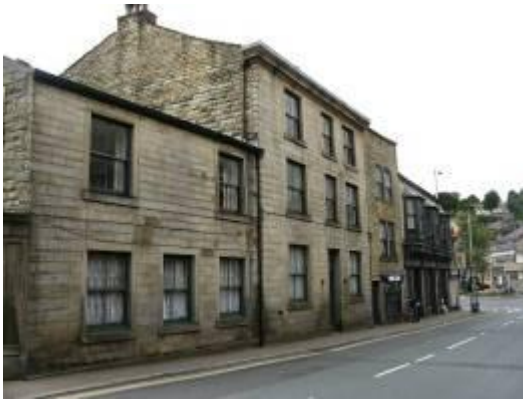
No.17 Yorkshire Street (in centre)

This three storey building retains an almost symmetrical but very plain front face, three windows wide with a central front door. The stone slate roof is partially hidden by the heavily moulded parapet. It dates to the early 19th century and is now used as offices.

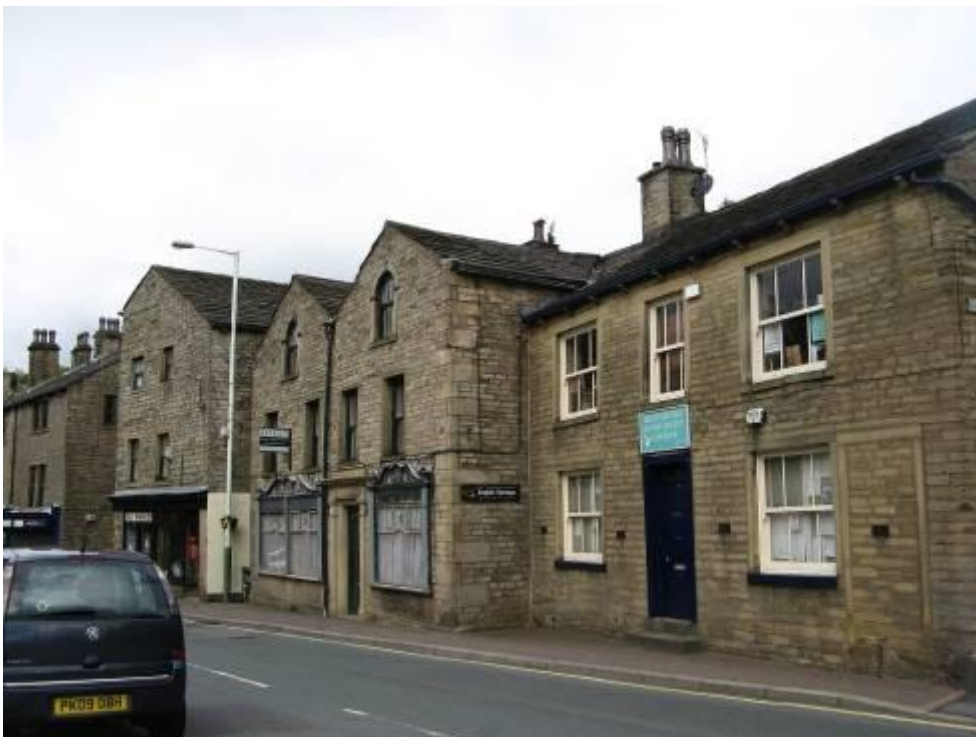
Nos. 20 and 22 Yorkshire Street

These gabled three storey houses are dated 1770 and may have been built as a taking-in warehouse for woollen cloth, later becoming a public house and then a shop with residential accommodation above. They are faced in watershot coursed sandstone with quoins, and retain their stone slate roofs and shopfronts which may date to 1907 (date plaque).

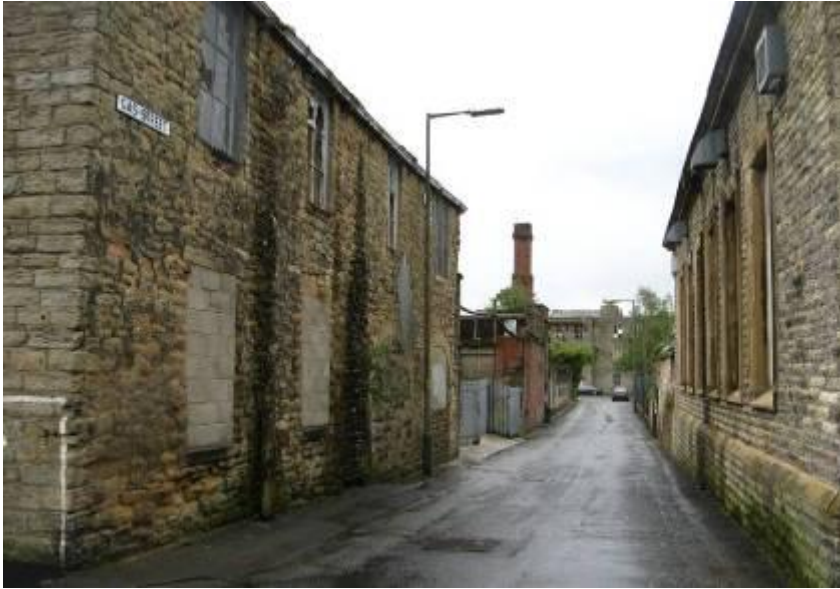
View from Lee Street to the derelict mills beyond the conservation area boundary

It is noticeable that only one listed former mill remains in Bacup, the Waterside Mill in Burnley Road. The two largest mills in the town, Tong Mill and Irwell Mill have either been demolished (Tong Mill) or heavily altered and extended (Irwell Mill). Some further mill buildings, associated with Irwell Mill, remain on the south side of Lee Road, but they are derelict. Two further mills lie to the south of Lee Street, outside the Conservation Area. Church Street mill, the earliest mill in the town, was probably demolished when St John's Church was rebuilt in 1882-3.

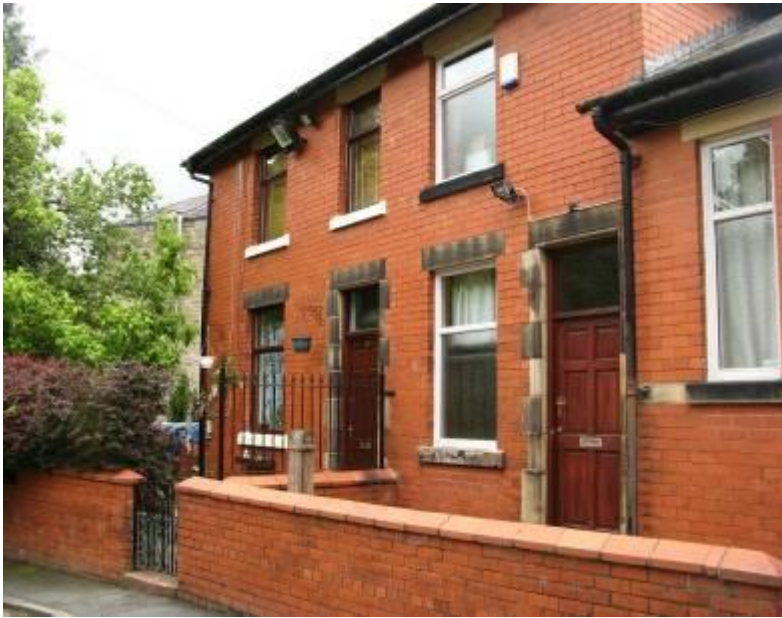
A hard, almost engineered red brick which came from nearby Accrington also features in the town including the Club Hall, Nos. 9 and 11 Princess Street, and the adjoining garden wall, all of which form a group. No. 10 James Street is also faced in this material, as well as the extended building which reaches up Lane Head Lane. Less attractive is the modern brickwork on Barclays Bank (No. 12 Market Street).

Brick building in Princess Street (No.11)

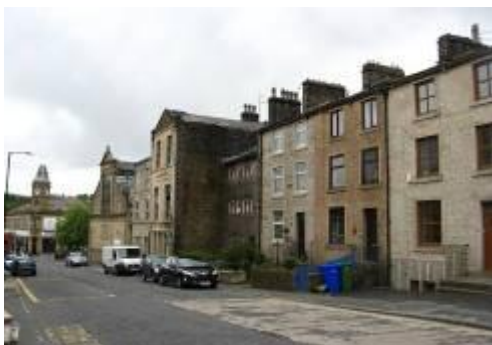
Sandstone is the predominant material in Bacup (Rochdale Road)

Bacup is therefore built almost exclusively from the local sandstone, quarried from the hills around the town. The sandstone is used as a rough rubblestone (mainly for boundary walls) or as coursed blocks, usually rock-faced or watershot. 'Watershot' sandstone is a typical feature of the area, the smooth sandstone blocks set at an angle, with angled mortar, both designed to shed water more easily. Good examples include Nos. 12, 14 and 16 King Street and Ivy Cottage, Bankside Lane. The mills were generally constructed using coursed square rock-faced sandstone. Smooth blocks of stone called ashlar are used for the more prestigious buildings such as Bacup Library, where it provides a more quality finish. Ashlar blocks are also used in many Bacup buildings to define window or door openings, and for corners. Mortars were traditionally lime based and pointed flush to the face of the stone. The proliferation of 'strap' pointing is a regrettable feature, having come about through the use of hard cementitious mortars which accelerated the erosion of the stone to such an extent that the flush pointing soon protruded from the eroded face of the stone. This form of pointing not only detracts from the visual appearance of a building, but also causes damage to the stonework.

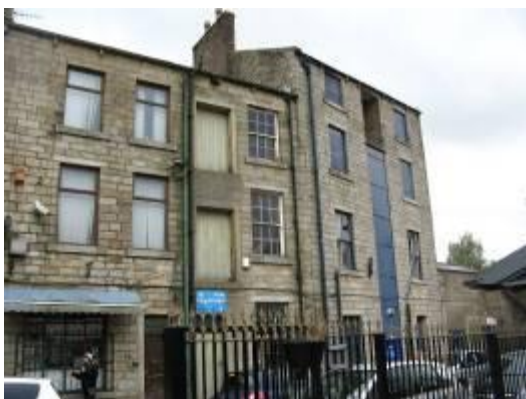
Varied window types at the back of St James Square facing Temple Court Place

Mullioned windows were traditional in vernacular construction from the earliest stone buildings up to about 1830 or 1840. It was usual for the lintel over the centre light to be bedded on top of those to either side, giving the typical stepped, mullioned window. These can be seen throughout the Conservation Area including Nos. 15-19 Union Street, where stepped windows survive to the rear elevations, the front windows being replaced by sashes in the Victorian period. Sash windows survive in very few places, with examples of early multi-paned Georgian windows being very rare although on the rear elevation of No. 5 Bankside Lane (which overlooks Elgin Street) can be seen a broken Georgian multi-paned window which is presumably original. Altered or replaced sash

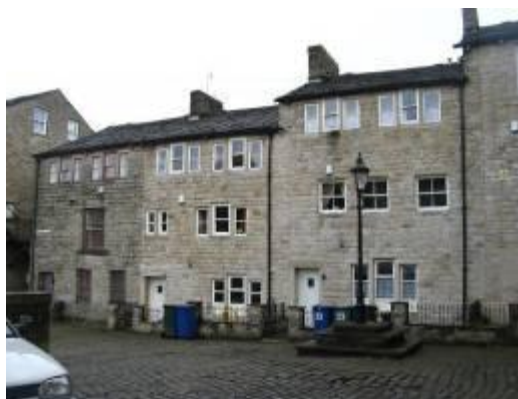
Sash windows in the restored listed buildings backing onto Industrial Place

windows can be seen in No. 13 St James Square (rear), No. 3 St James' Street (rear) and Nos. 17 and 19 Industrial Place (rear). There are very few original 18th or even 19th century doors in the Conservation Area, although some can be seen in Rochdale Road.
