Proposed Haslingden Conservation Area

Conservation Area Appraisal

MARCH 2017

Buttress

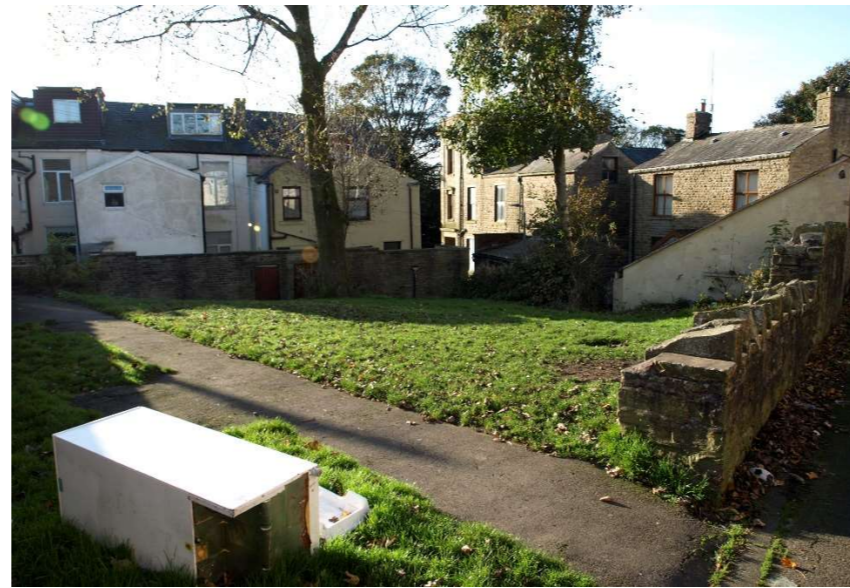
For example, the open space off Victoria Street, and the nearby Well Bank, could provide open green leisure space for local residents. Alternatively, open spaces such as the disused area on Bell Street (Figure 14) were caused by the demolition of existing properties. Therefore this space has the potential for future development, which would give this area a purpose, which it is currently lacking.

Figure 13 Open space on Victoria Street.

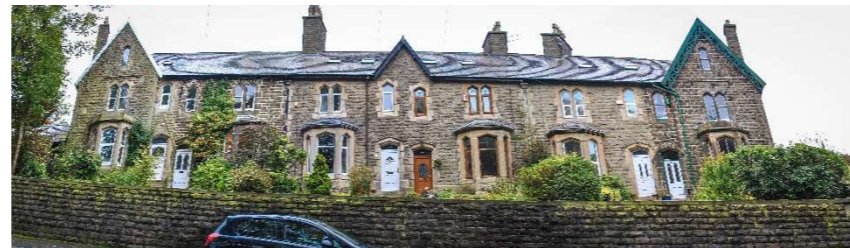
Figure 30 Group of houses on Grane Road

Some high quality residential boundary wall examples still exist, such as the group of 6 houses on Grane Road (Figure 30) and properties along Helmshore Road, where properties are of higher status; larger in size and with more attached land.

This terrace group on Grane Road is an attractive and self contained development, responding to the slope of the Road to the south west. The properties appear to be in good condition and retain their boundary wall and gate. One house looks to have retained its original decorative fascias.

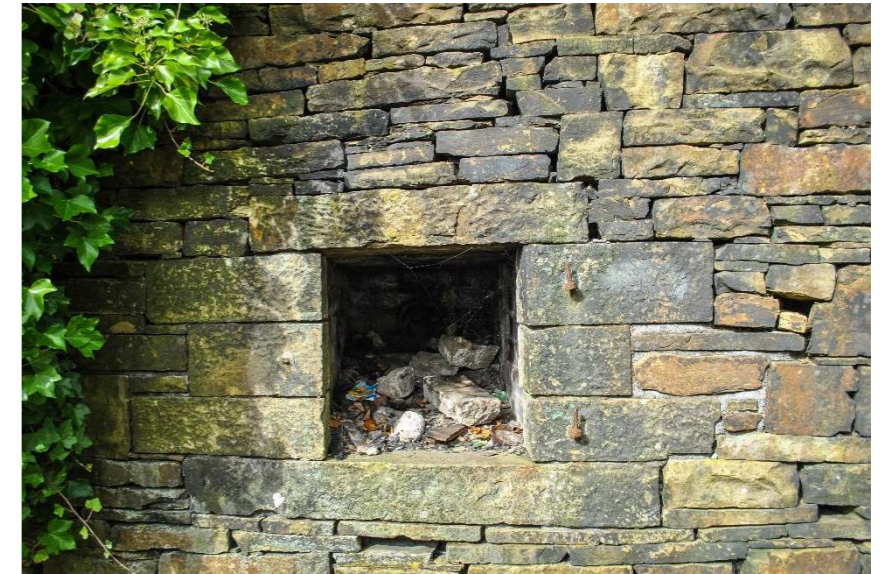
There is also an interesting example of a boundary wall associated with a former mill. The wall is of high quality, and appears to retain some features from its original use, including a potential waste disposal area.

Figure 32 Feature of historic wall on Bell Street

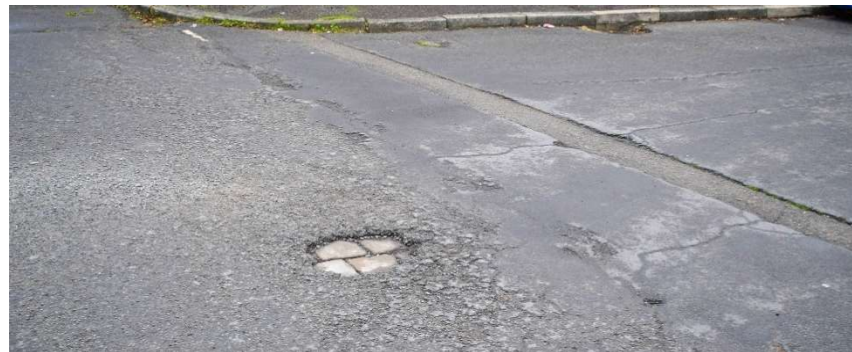
Figure 33 Evidence of earlier cobbles visible through a hole in modern tarmac.

The public realm of Haslingden is almost exclusively modern; very few historic finishes or active furniture and infrastructure remain. There is evidence of historic cobbles underneath modern tarmac, implying that these have either been extensively covered throughout the town, or removed. There are a handful of examples of retained cobbles, such as Back Regent Street (Figure 34), and Market Place at the top of Deardengate, which are positive features of the town.

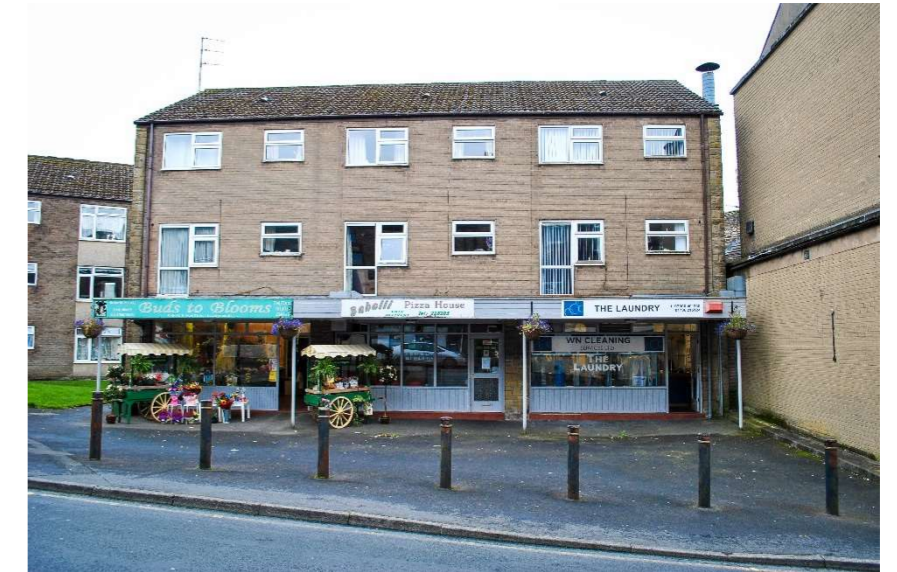
The public realm on the Pleasant Street Square is an example of open space that has the potential to provide a greater contribution to the surrounding streetscape and business as it is currently unused.

Figure 37 Pleasant Street Square

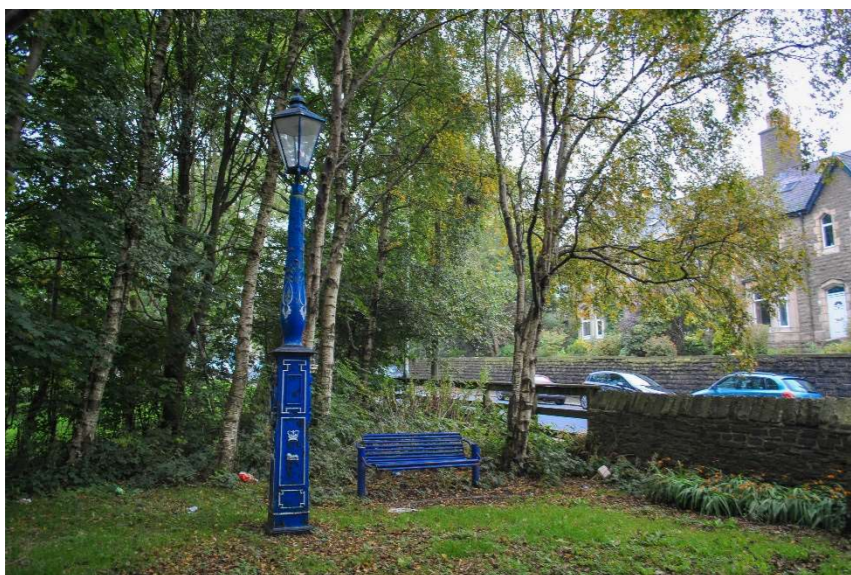
Figure 40 Disused public realm on Grane Road.

The public realm on Grane Road is an example of one of those spaces with potential for future use and enjoyment. The area has clearly been laid out as a place intended for leisure, with a footpath marked by stone setts hidden beneath overgrowth. There is a bench and a historic lamp post, which is hidden from view. It appears as though this area was used as a viewing platform, but the adjacent trees are overgrown and obstructing any view.

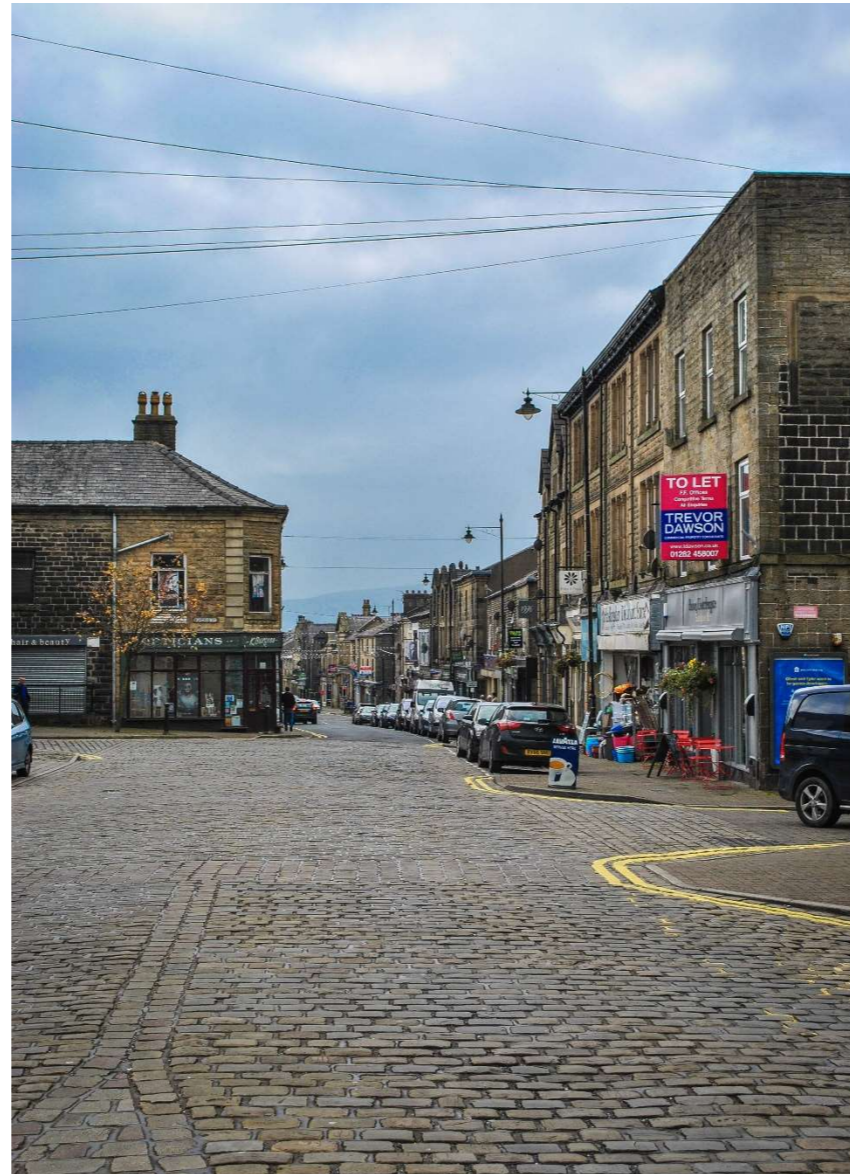
Figure 41 Stone setts at the north of Deardengate

The paving along Blackburn Road, Manchester Road and Deardengate is generally herringbone orientation, some with borders, and tactile paving at crossing points. Main roads are tarmac. There are limited stone setts within the town, but examples are principally focused around the commercial core, namely at the north of Deardengate, and in historic secondary spaces. The residential areas, and streets leading towards the main crossroads, are characterised by tarmac road and pavement surfaces.

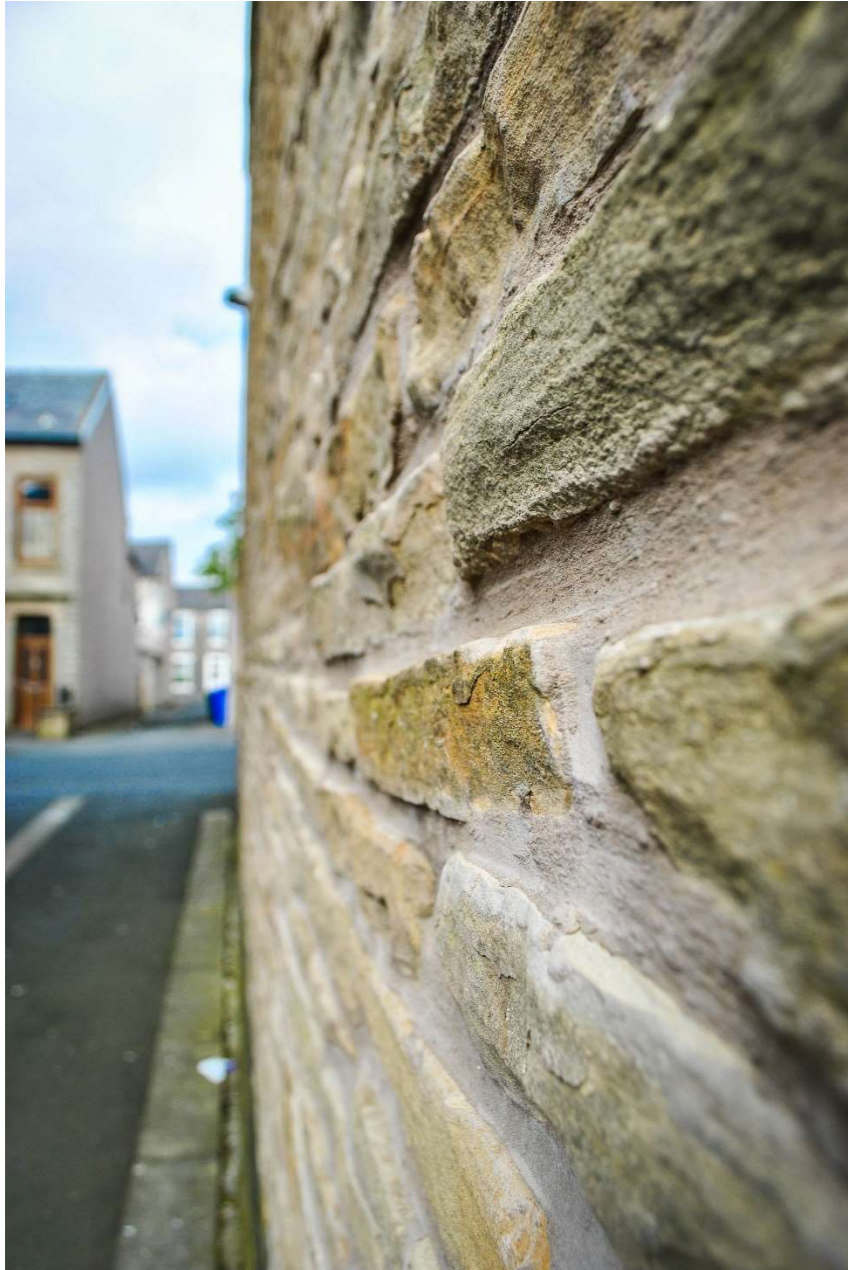
Figure 43 Example of watershot coursing

Haslingden is a principally stone-built town, using stone from local quarries, and many of its earlier vernacular buildings have watershot coursing (Figure 43). The civic buildings of Haslingden town centre have ashlar façades. There are some examples of brick buildings, though these are few in comparison. Local quarries also provided the materials for the

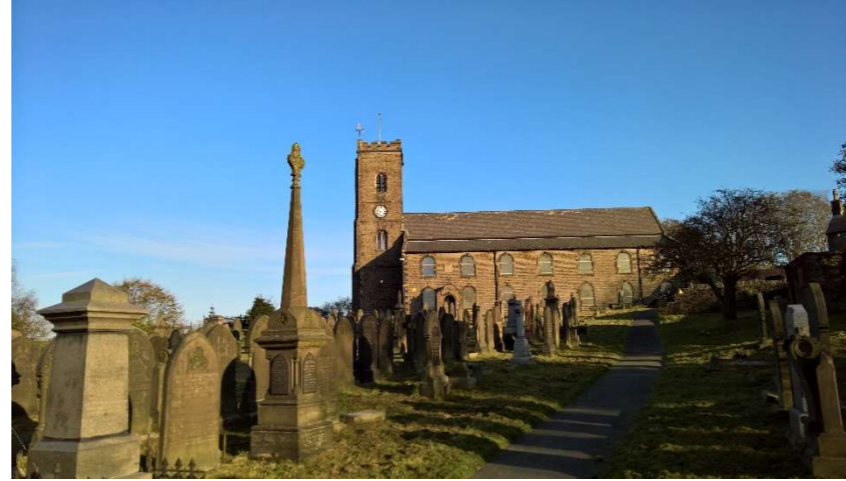
Figure 47 Church of St James

The Church of St James was built in 1780, enlarged and the tower added in 1827, and underwent further alterations in the 19th century. The building is watershot coursed, which is a characteristic of historic buildings in this area.

The church was originally built in 1780; it was later enlarged and the tower added in 1827, and further changed in the later 19th century. It is built of watershot coursed sandstone with rusticated quoins and a slate roof.

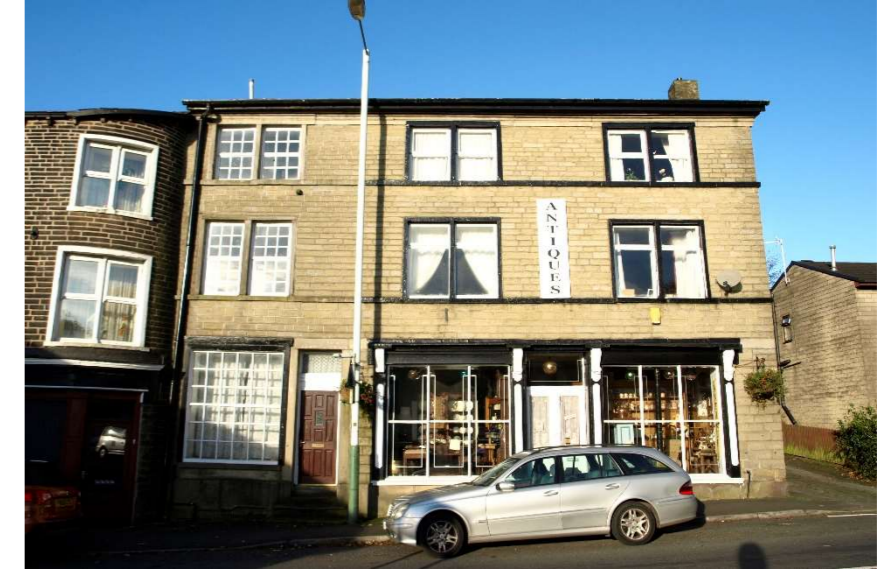
Figure 48 6 & 8 Church Street

Late 18th century house, probably for putting-out manufacturer. Altered in 19th century, now 2 shops. Watershot coursed sandstone, in the traditional method for this area.

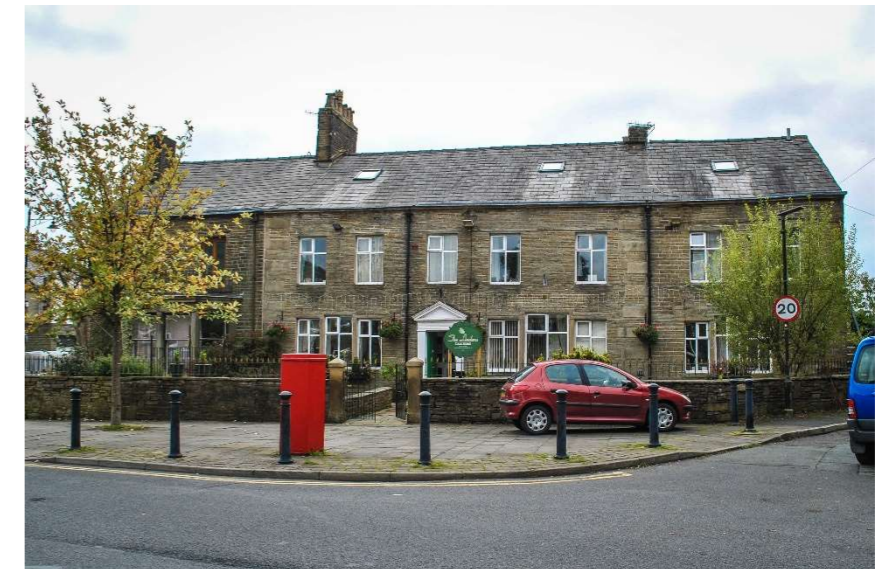
Figure 49 The Lindens

Late 18th century merchant's house. Watershot coursed sandstone in the traditional manner, slate roof, with end wall chimneys.

Individual trees outside The Lindens (Figure 49) also provide positive contribution to the public realm, whilst signalling the northern boundary of the commercial town centre and transition into residential spaces. Other existing trees within the Conservation Area are considered to have a positive impact on the townscape, and are marked on the Townscape Appraisal Map.

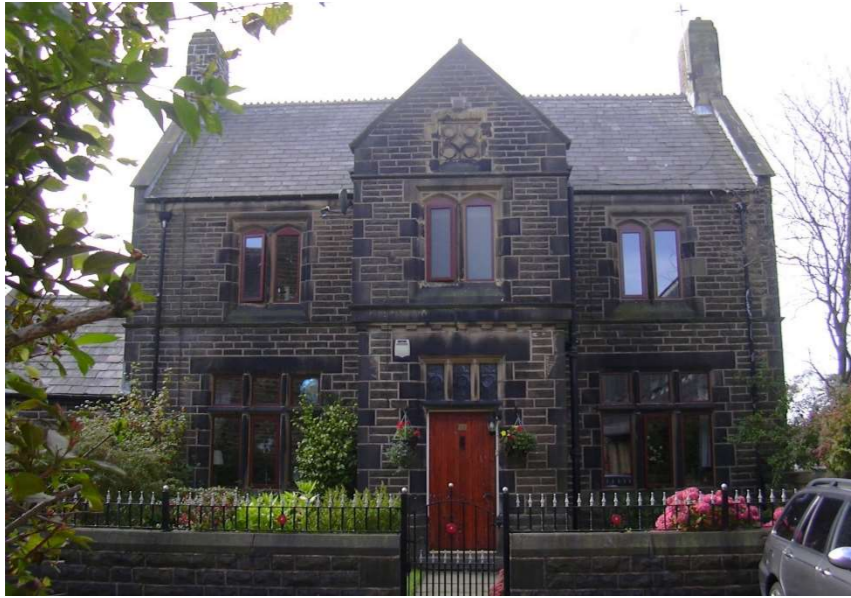
Figure 50 © Robert Wade 2009
<https://www.flickr.com/photos/rossendalewadey/3984008906/>

Mid-19th century caretaker’s house to Manchester Road Methodist Church. Rock-faced sandstone with quoins, steeply-pitched slate roof with gable chimneys and stone copings. Included for group value with the Methodist church and 31 Manchester Road.

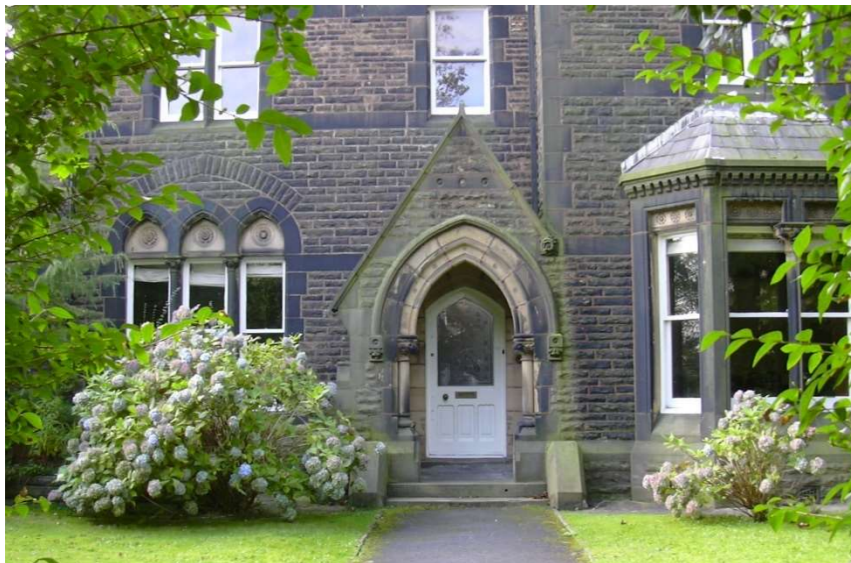
Figure 51 © Robert Wade 2009
<https://www.flickr.com/photos/rossendalewadey/3983249939/>

Late 19th century Methodist manse. Rock-faced sandstone with dressed bands and carved dressings. Included for group value with the Methodist church.

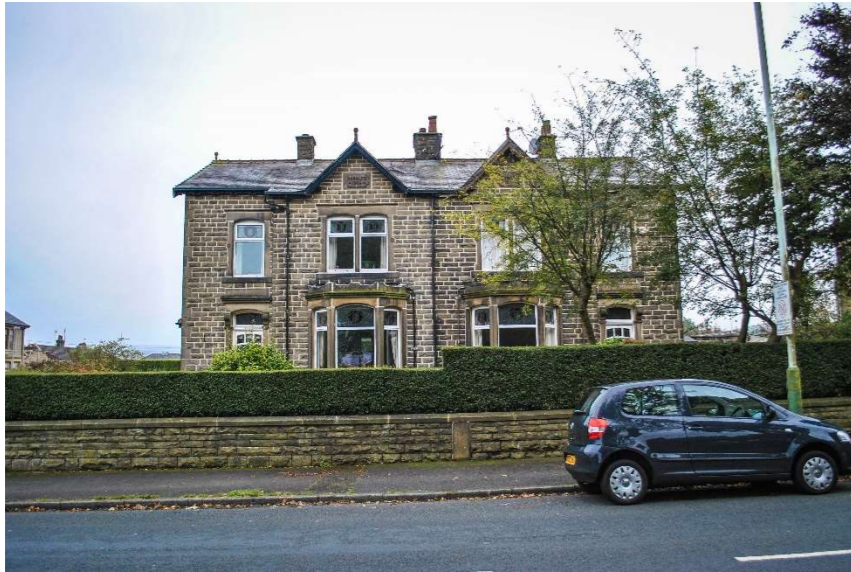
Figure 53 Rosslye House

Dated 1914, Rosslye House and its neighbours represent the wealthier residential area of Haslingden, situated primarily to the south west. The projecting bays with pitched gables and large glazed windows highlight the status of the buildings.

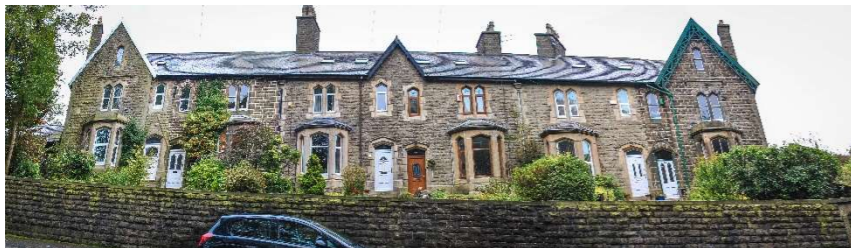
6.5.1.2 10-20(???) Group of 6 houses (Grane Road)

Figure 54 Grane Road

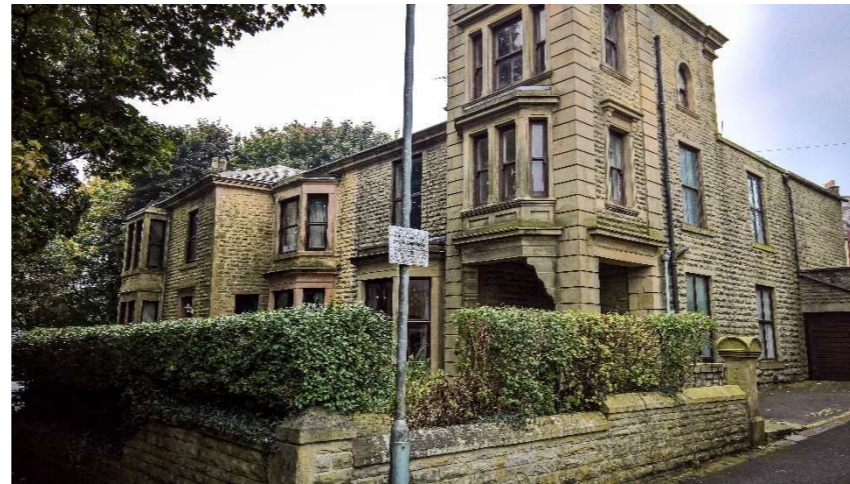
Figure 55 Unknown

This property sits to the westernmost boundary, as the terrace housing begins to break up towards Well Bank. Its size and design are unique in Haslingden, making it an interesting and important residential building. It is one of the properties dating from the 1870s, laid out around a formal square.

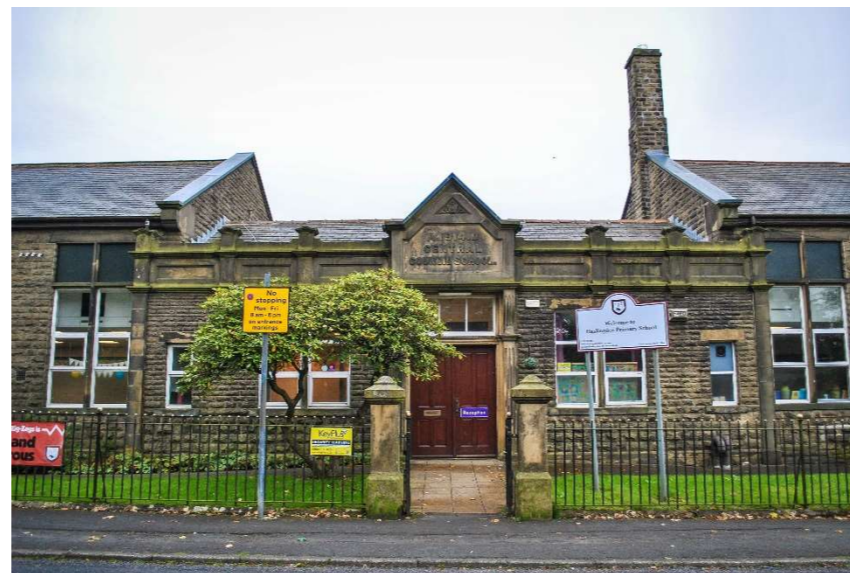
Figure 56 Haslingden Primary School

The Central Council School was built in 1914 and opened by Mayor Tom Baxter on the 21st August 1915. It forms a distinct and characterful southern boundary to the Conservation Area

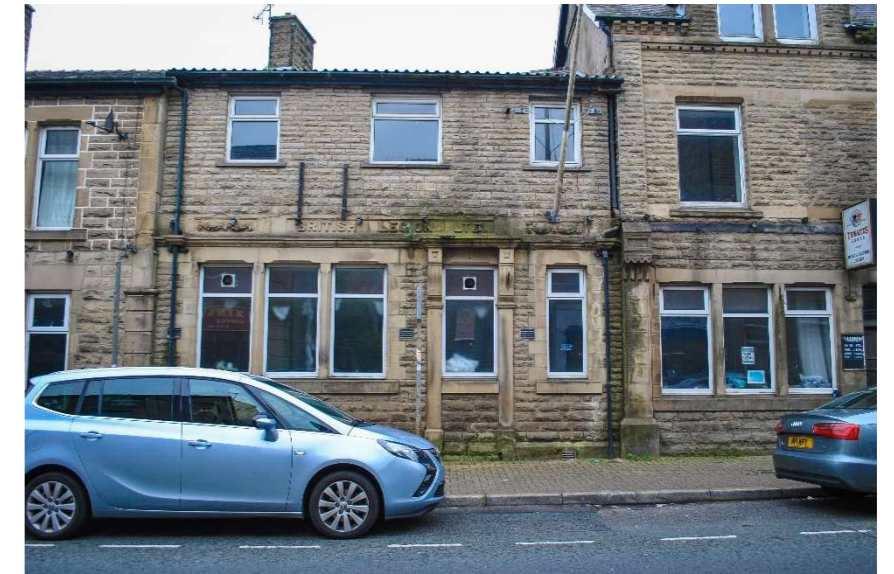
6.5.2.2 75 Deardengate, The British Legion

Figure 57 The British Legion, Deardengate

In comparison to some of the more central or significant public buildings, the British Legion building is relatively plainly detailed. However, it retains some interesting features, despite inappropriate modern alterations, and evidence of some condition and damp issues. This building has great potential for enhancing the Deardengate approach.

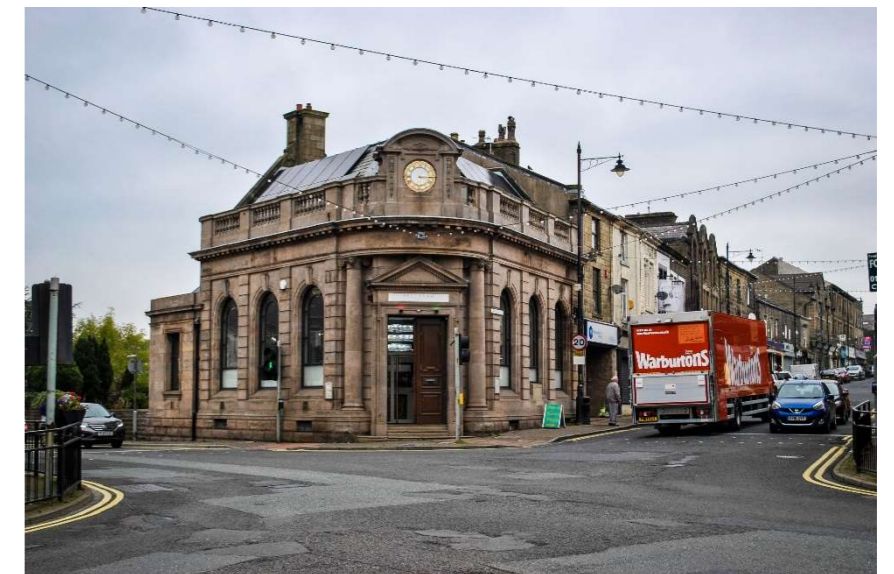
Figure 58 55 Deardengate

55 Deardengate is one of the four corners forming the central Conservation Area crossroads. It is one of the most richly decorated buildings in the whole town, and has a distinctive shape dictated by the corner plot.

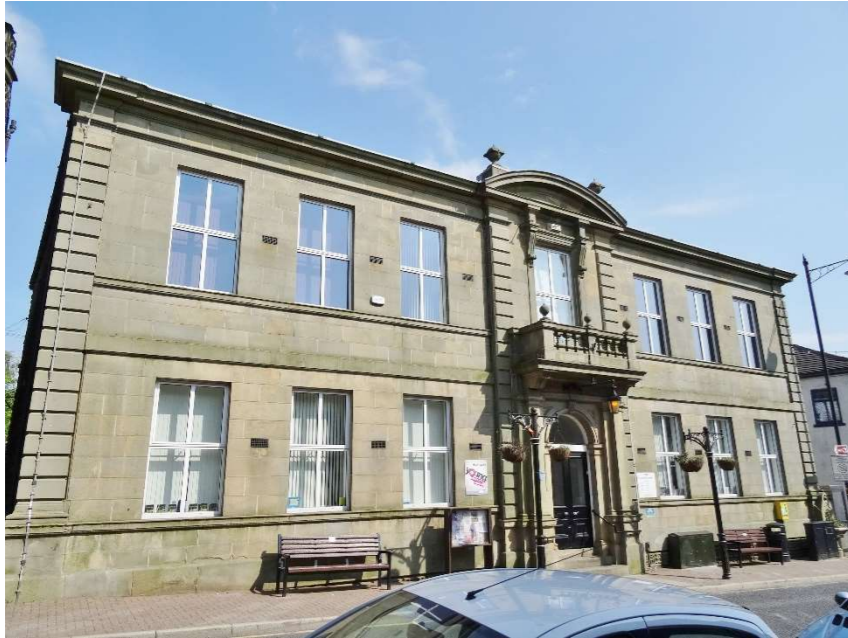
6.5.2.4 Haslingden Library, Deardengate

Figure 59 Haslingden Library © Brian Evans 2016
<https://www.flickr.com/photos/stagedoorjohnnie/27468371136/>

The public library was originally built as the Mechanic’s Institute in 1859. Its ashlar facing and grand central porch marks it out as a significant building within the Deardengate streetscape. Though the windows have been replaced with plastic frames, the size of the mullions and transoms remains appropriate for the façade. The attached water fountain has been repurposed into an attractive street planting.

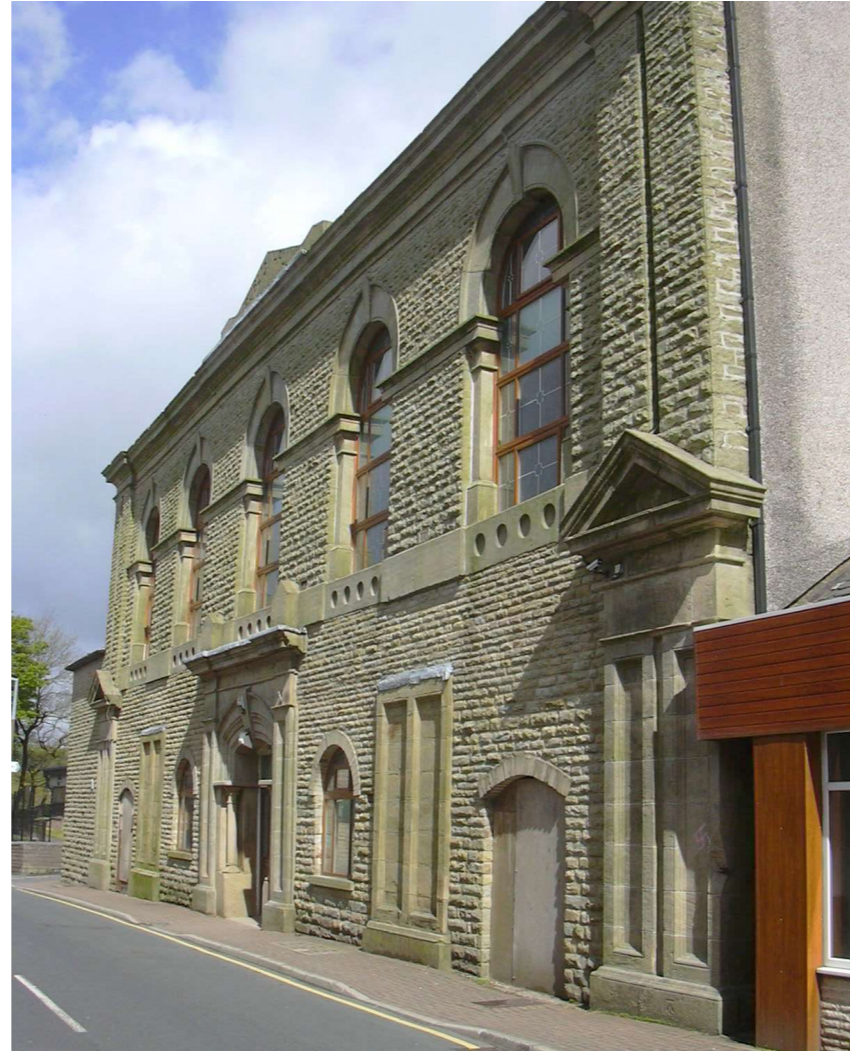
6.5.2.5 Public Hall, Regent Street

Figure 60 Public Hall © Robert Wade 2012
<https://www.flickr.com/photos/rossendalewadey/7195381822/>

Built by a private company in 1868, purchased by the council in 1898. It does not appear to presently be in use, and it has undergone some inappropriate alterations, such as window replacements. However, detail of the principal façade on Regent Street is interesting and stands out as an important building in juxtaposition to the surrounding area.

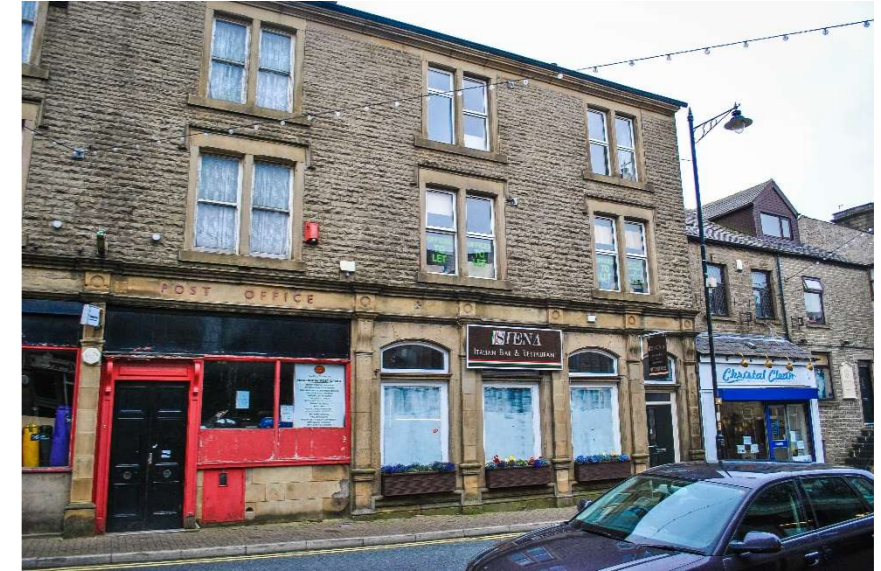
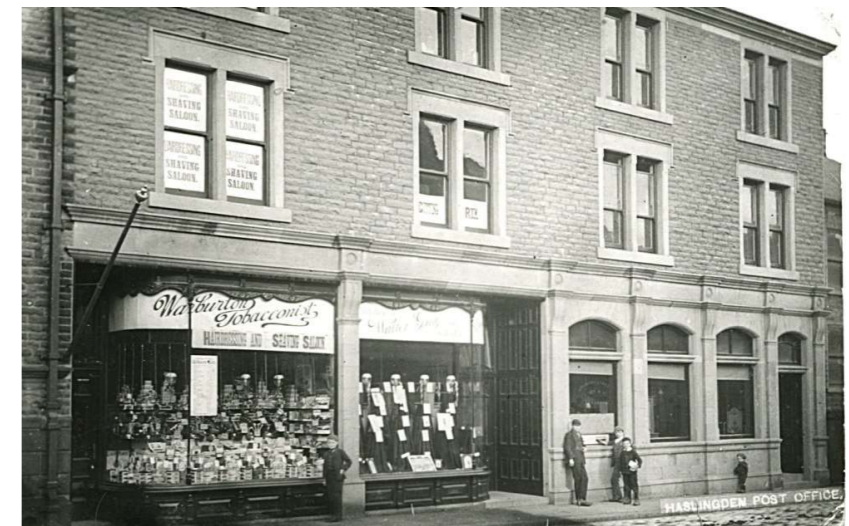
Figure 61 Post Office

The Post Office was originally situated in the right hand side of the building (photo above), with a tobacconists occupying a large curved glazed shopfront, which is now lost.

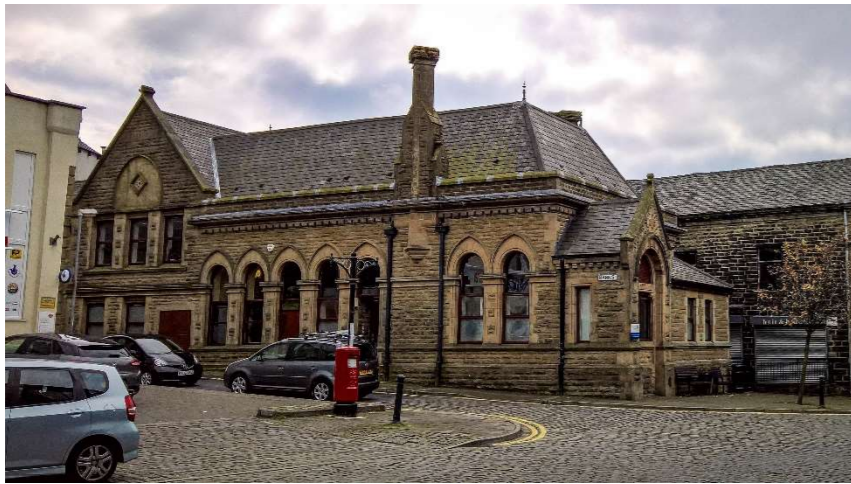
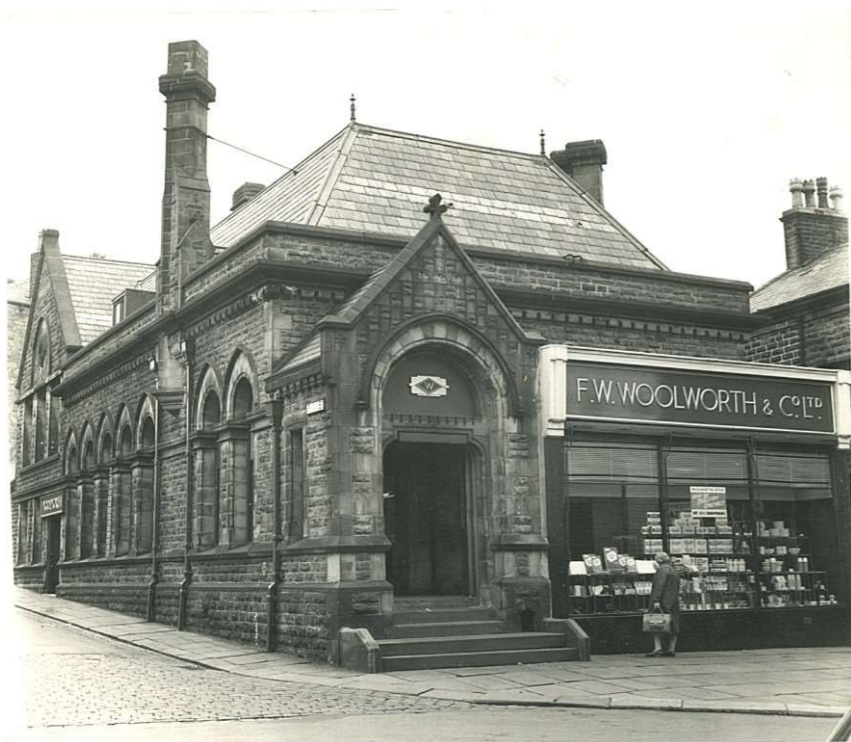
Figure 63 Dearden House

Dearden House is a focal building at the top of Deardengate, facing onto Market Place. It is stylistically noticeable different from the more restrained properties around it. Upon first viewing, it appears that the building has only had minimal external alterations.

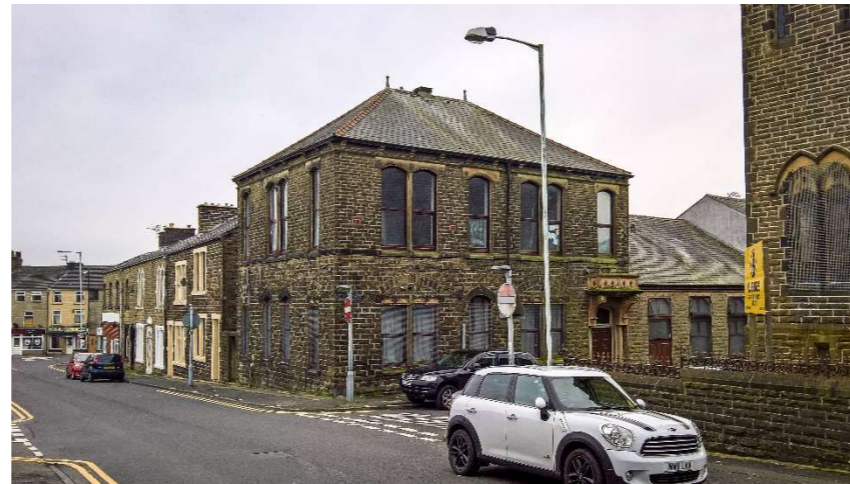
Figure 65 The Registry Office

This building on the corner of Union Street and John Street was built in the 1890s by the Haslingden Blue Ribbon club, and used as a gym. In 1901 it was opened at the Haslingden Picturedrome, and by 1912 it was the Haslingden Weavers' Institute. It operated as the registry office during the 20th century. Most recently, it operated as the Bait-ul-Mukarram Mosque and Islamic Centre, however the property was considered too small to meet the needs of the community. Presently, the building appears to be unoccupied.

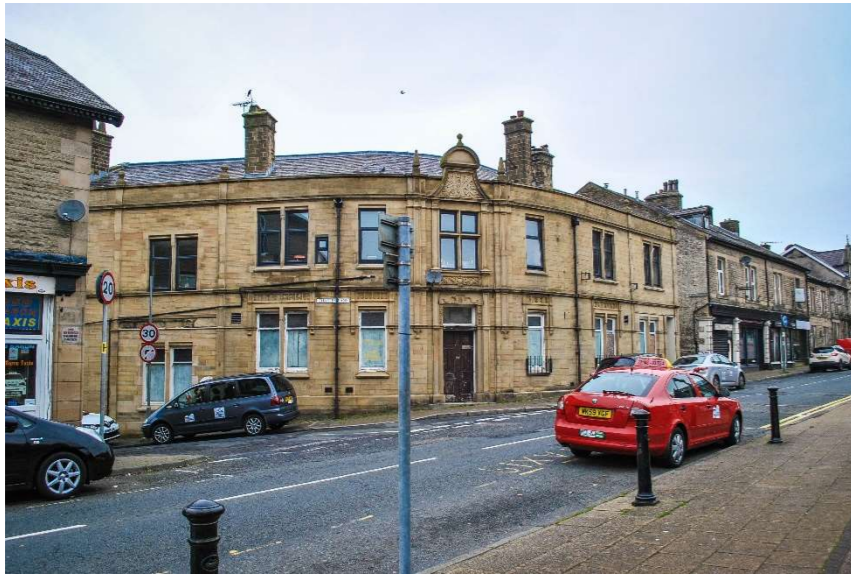
Figure 66 The Roebuck.

The Roebuck survived 20th century clearance schemes, when many other inns were taken down. With the New Inn on Bury Road, it is one of the oldest surviving inns in Haslingden. It was built in the 18th century, but has been extensively altered since, including a rebuilding scheme in 1896.

The curvature of The Roebuck on the corner of Charles Lane and Deardengate highlights the sweeping topography of Haslingden. It is a low building, and less richly detailed than buildings closer to the town centre, but the retained details are fine and interesting. It has some inappropriate window replacements, drainage facilities and a poorly located satellite dish. The building currently appears to be under or unused, and would benefit from repurposing in order to contribute to the sustainability of the building in the future.

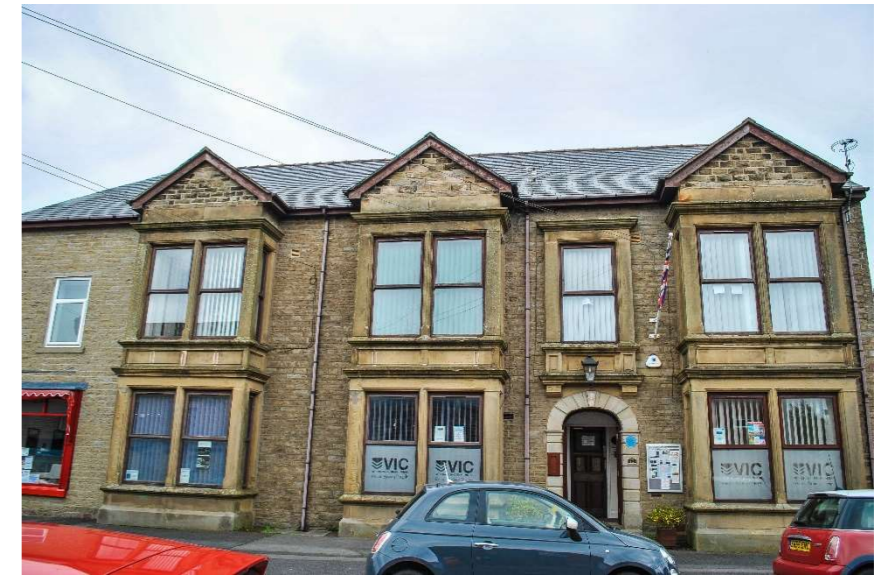
Figure 68 The New Inn/Veterans in Communities

The New Inn was built in 1790 and survived, along with The Roebuck, the clearance schemes of the 20th century, though it was refaced in the 19th century, which is when the first-floor bays and associated gables were constructed. It was later renamed the Thorn Inn, and also operated as The Mary Hindle Resource Centre until the Veterans in Communities group took over in 2013-14. During the power loom riots of 1826, the building is said to have housed prisoners. The building has a distinctive triple pitched gable on projecting bays, making it a grand addition to the north of Haslingden.

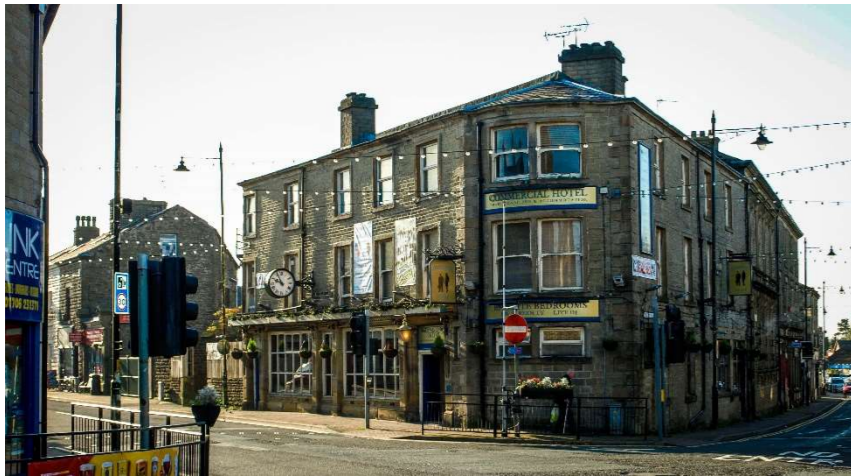
Figure 70 Commercial Hotel

Built around 1830, the Commercial Hotel responds to the curving lines of the Haslingden town centre and contributes to the creation of the Deardengate Crossing. The pub is relatively simple in comparison to other prominent buildings, but moulding and dentilling and ground floor level adds visual interest.

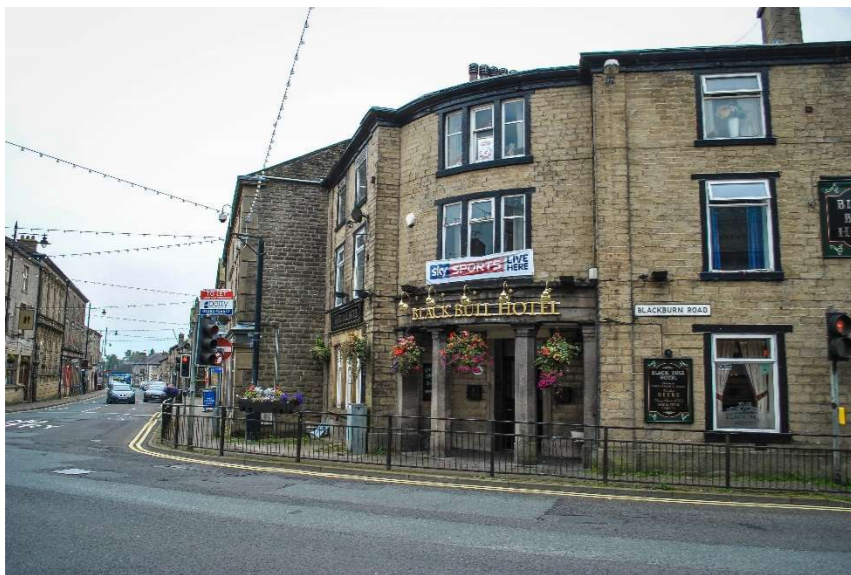
Figure 71 The Black Bull Hotel

Much like the Roebuck, the Black Bull Hotel responds to the curving lines of Haslingden town centre, meaning that it has a unique and interesting shape. It also forms one of the four corners of the central crossroads, around which the whole Conservation Area is focussed. Built around 1830.

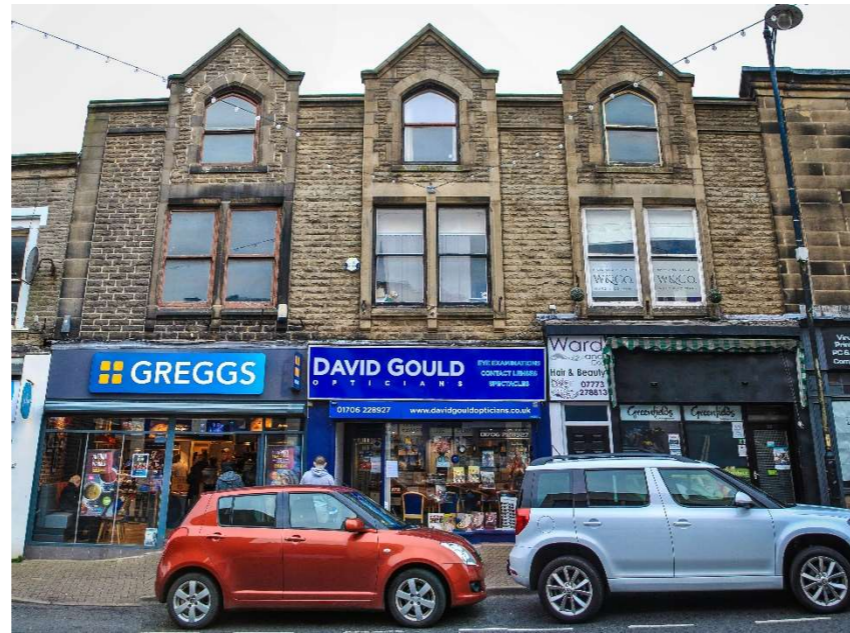
6.6.1.6 39-43 Deardengate

Figure 72 39-43 Deardengate

This property's distinctive triple pitched gables make it stand out on a street predominantly made of smaller 2 storey and larger 3 storey commercial premises. At a high level, it adds visual interest to the view up Deardengate. Unfortunately, bulky modern shopfronts at the ground floor level have either removed, damaged or obscured the original frontage of this building. Sensitive shopfront treatment and associated fabric repairs would help to elevate this building.

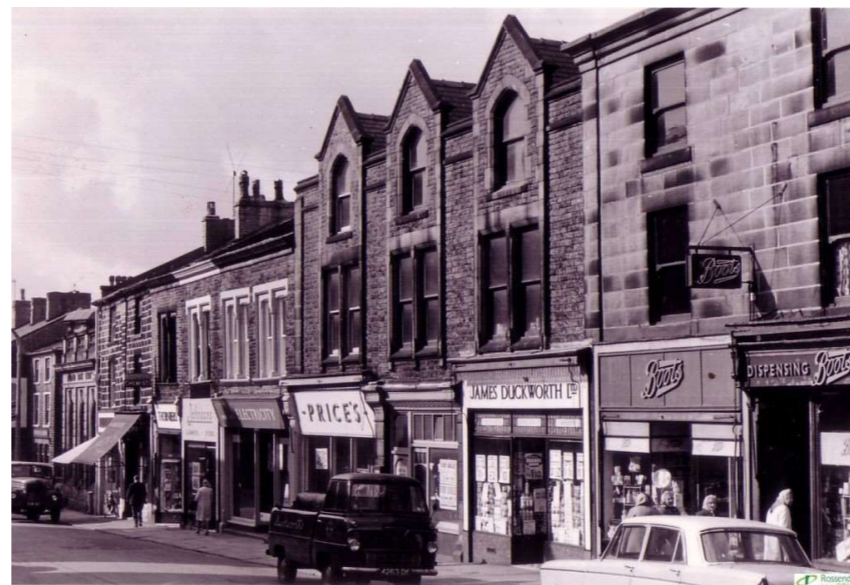
Figure 73 39-43 Deardengate (1965)
<http://haslingdens.blogspot.co.uk/2009/02/deardengate-shops-in-1950s-to-1970s-etc.html>

Number 39 has been in known use as a green grocer since c1965. Around this time, the middle unit of 41 was a chip shop, and the current Gregg's at 43 was a bread shop

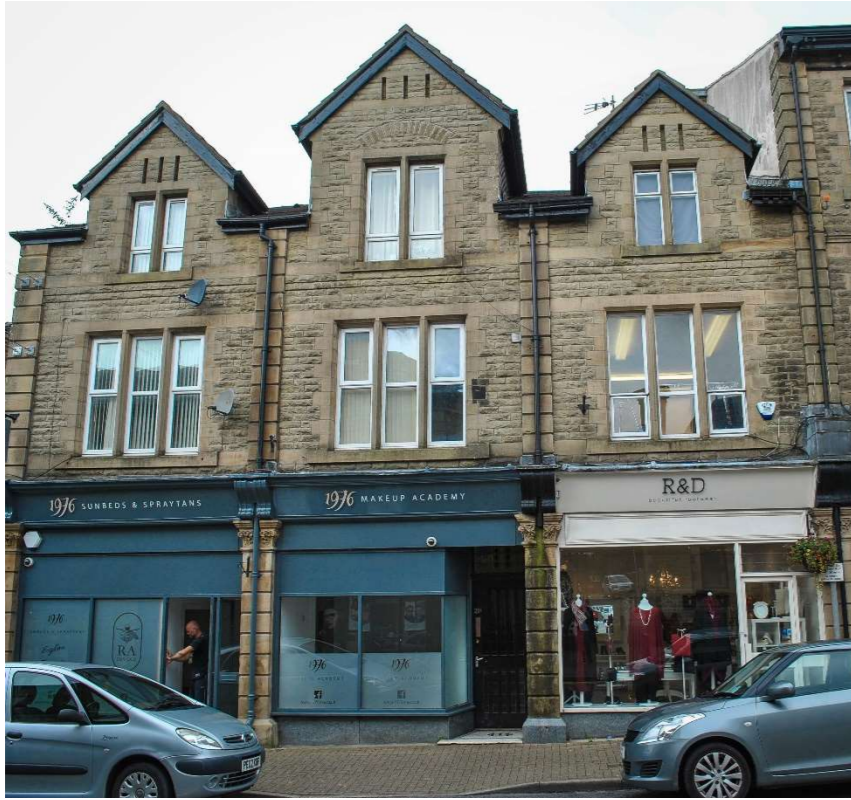
Figure 74 17-21 Deardengate

17-21 Deardengate have the distinctive triple pitched gables that are more prominent in the north of the Haslingden Conservation Area. At ground floor level, the shopfront pilasters are stone ashlar, which have bene retained and well used in the context of modern premises.

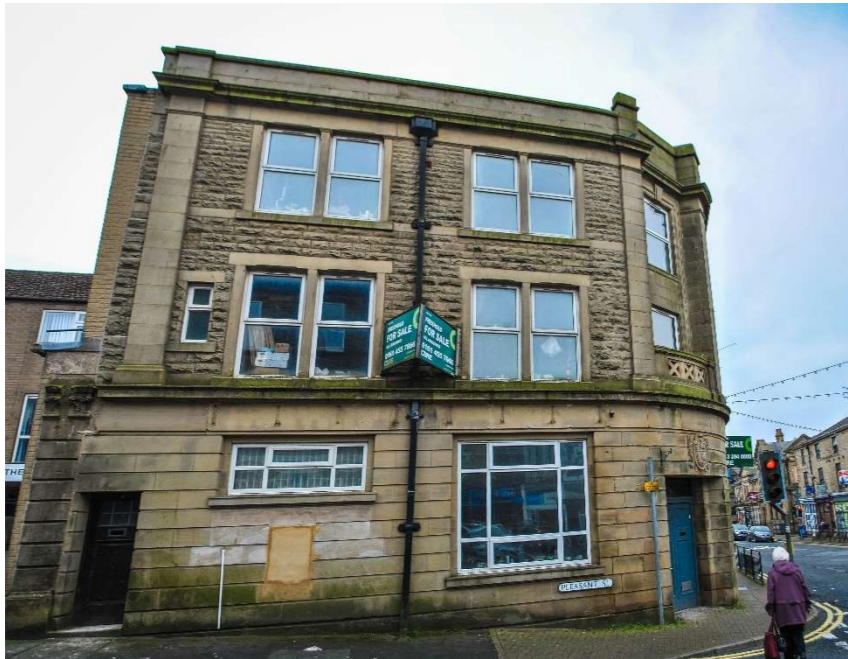
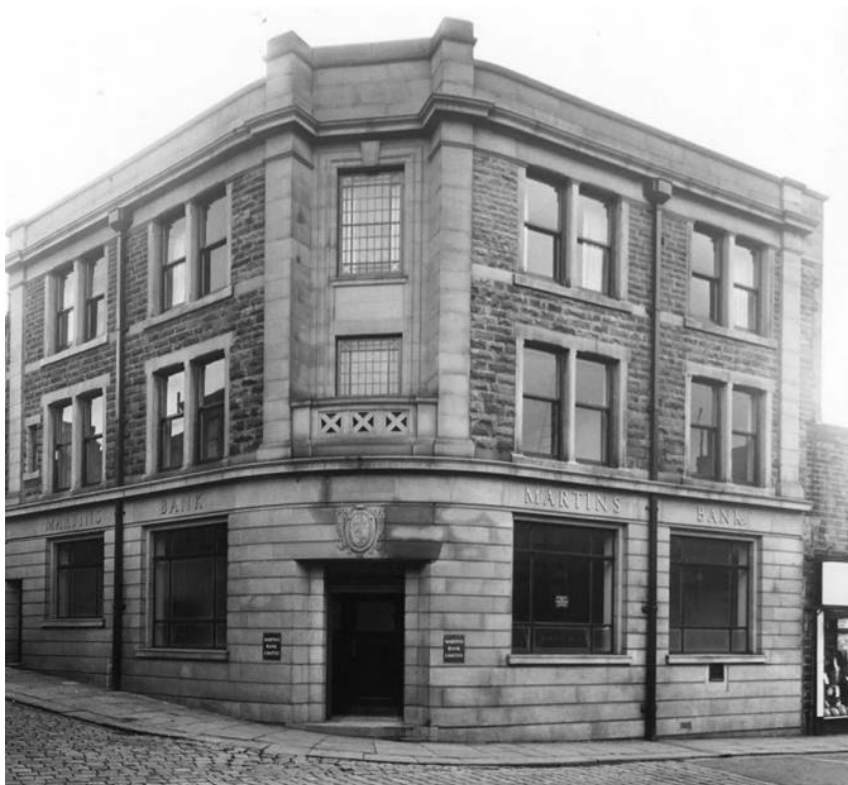
6.6.1.10 34 Deardengate

Figure 78 34 Deardengate

Figure 79 34 Deardengate

34 Deardengate is not currently in use. It retains many of its interesting decorative features. External investigation suggests that the building has undergone some alterations, but they have not irretrievably damaged the character of the building.

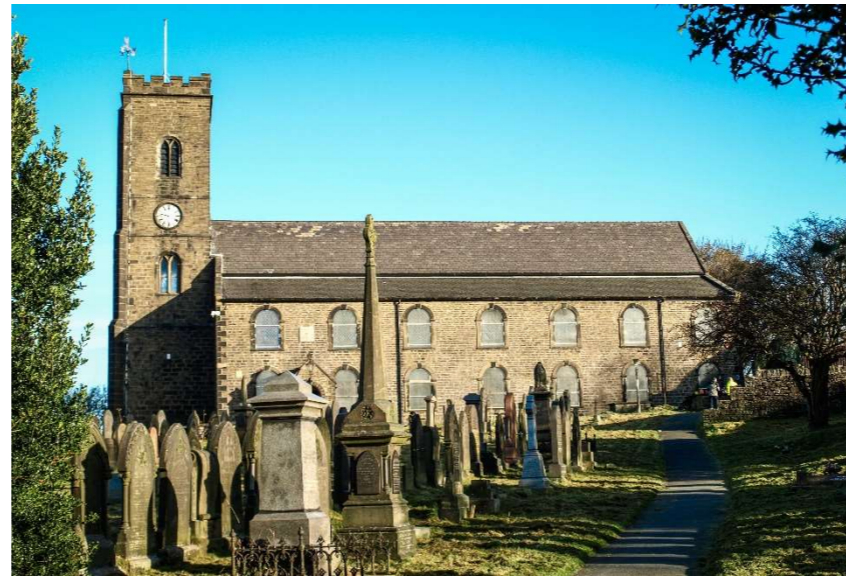
Figure 80 Church of St James

One of the few listed buildings within the Haslingden Conservation Area. The church is situated in an elevated position, looking over the rest of the town to the south.

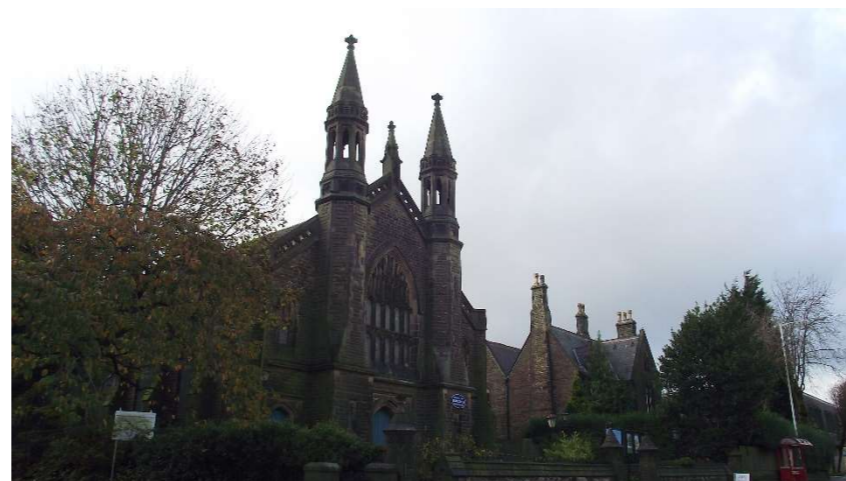
Figure 81 Manchester Road Methodist Church, © Robert Wade 2015 (<https://www.flickr.com/photos/rossendalewadey/22644618737> <https://www.flickr.com/photos/rossendalewadey/8737376351/>)

The Manchester Methodist Church has a prominent position on the Manchester Road entrance to the town centre. It is situated within a principally residential area, with modern buildings in its near vicinity, therefore it stands out as a landmark building.
