Proposed Haslingden Conservation Area

Conservation Area Appraisal

MARCH 2017

Buttress

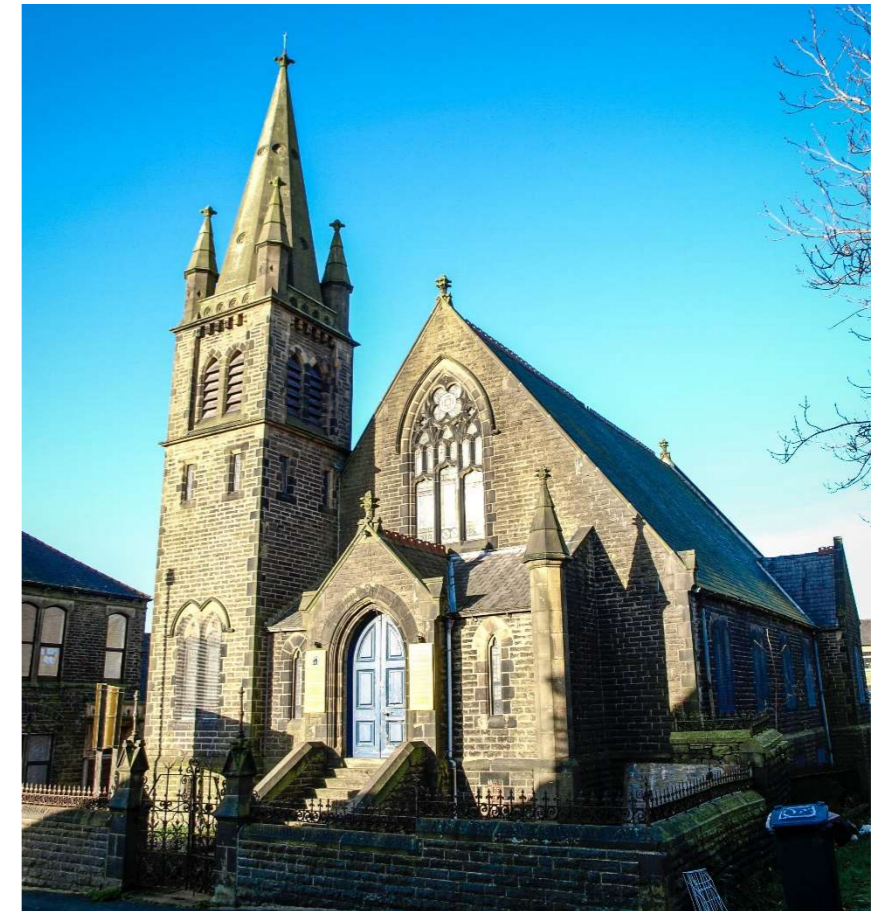
Figure 82 New Jerusalem Church

This Swedenborgian church of 1891, closed in the 90s, and is now used as a gym. It is slightly isolated, situated towards the north-west boundary of the Conservation Area. However, it sits adjacent to the 20th Century clearance Character Area and has a positive influence.

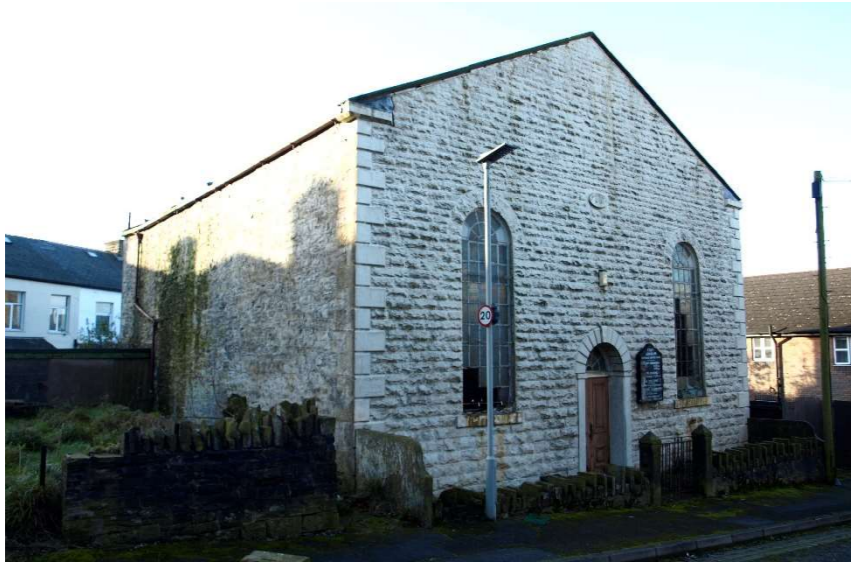
Figure 83 Cave Adullam Chapel

The chapel is not within the Conservation Area boundary, but it is considered to contribute to the variety and interest of the area, especially in the context of other ecclesiastical buildings in the town. It was built in 1859 and opened in 1860.

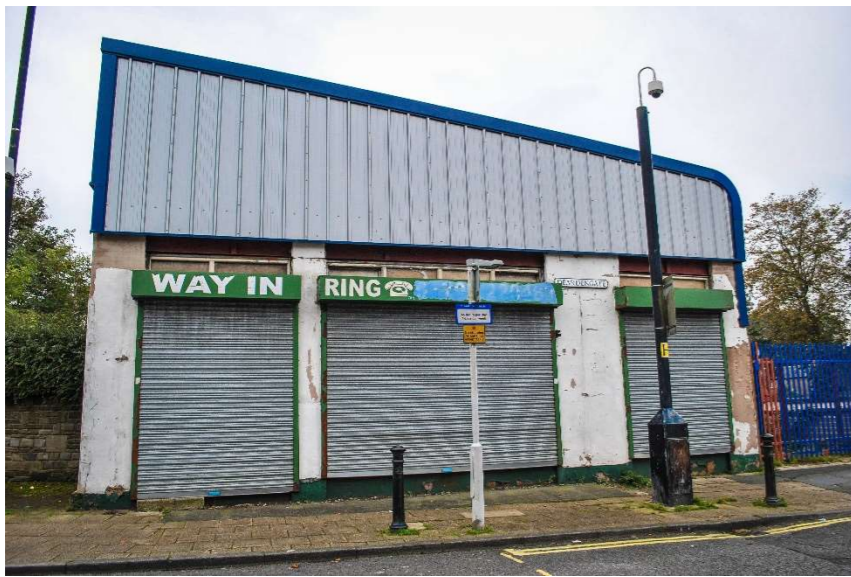
Figure 84 (Disused?) Garage on the corner of Helmshore Road and Warner Street.

The Helmshore Road garage is one of the corner properties visible when approaching the town from the south. Its scale, materials, design, signage are not compatible with the historic buildings in its immediate vicinity. The building is also having a negative impact due to its neglect and closed off street level frontage.

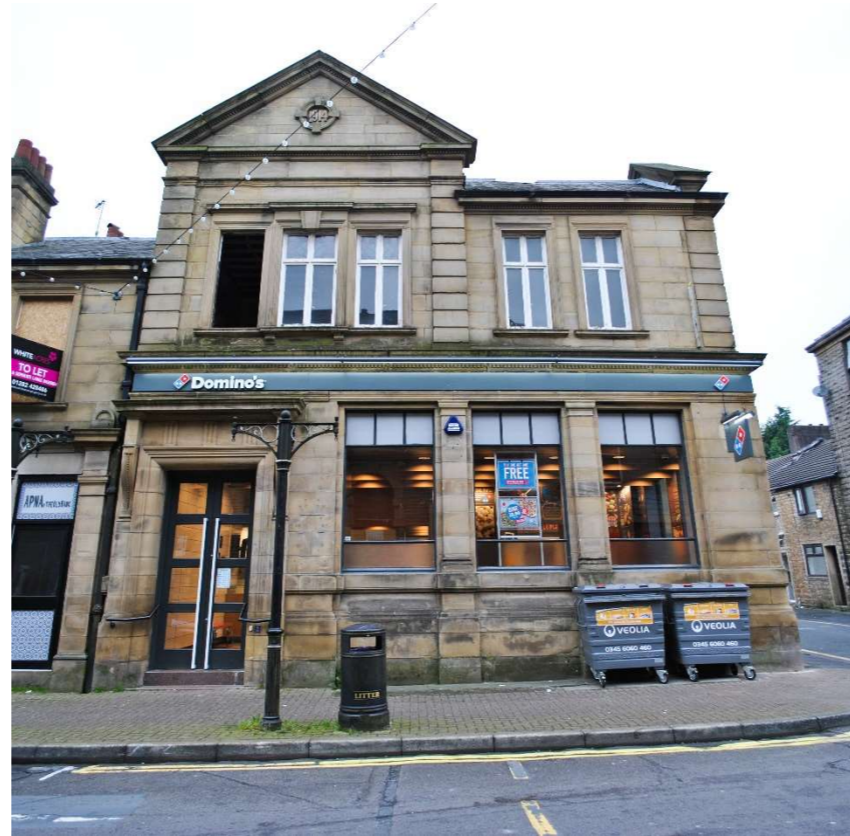
At first floor level, the building appears vacant. The left window underneath the pediment is completely missing, leaving the interior open to the elements.

Figure 85 67 Deardengate

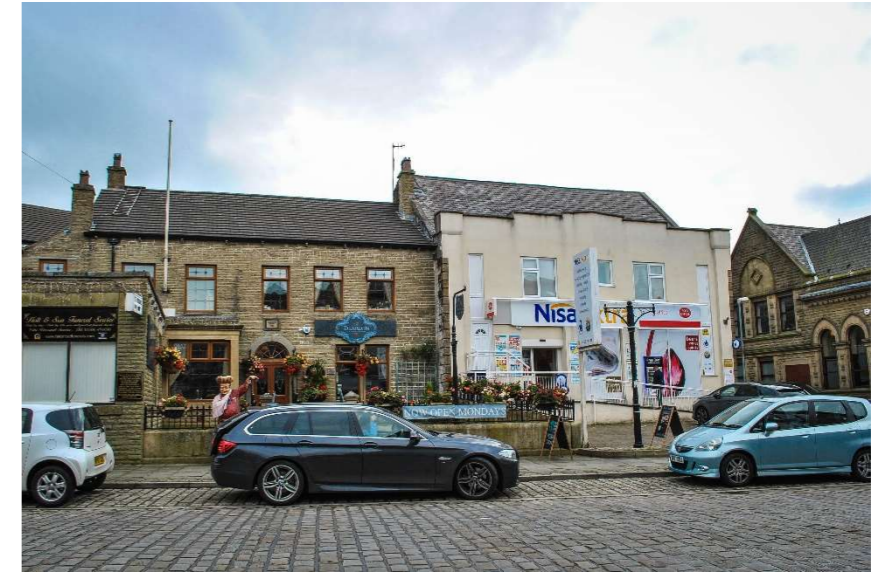
6.8.3 14 Deardengate

Figure 87 14 Deardengate

The former Empire Cinema on Deardengate, looking onto the Market Place, has been extensively altered and refaced, drastically changing its character and having a negative impact on the surrounding buildings. This is generally an area of better quality buildings with appropriate shopfront treatments, therefore it stands out in comparison.

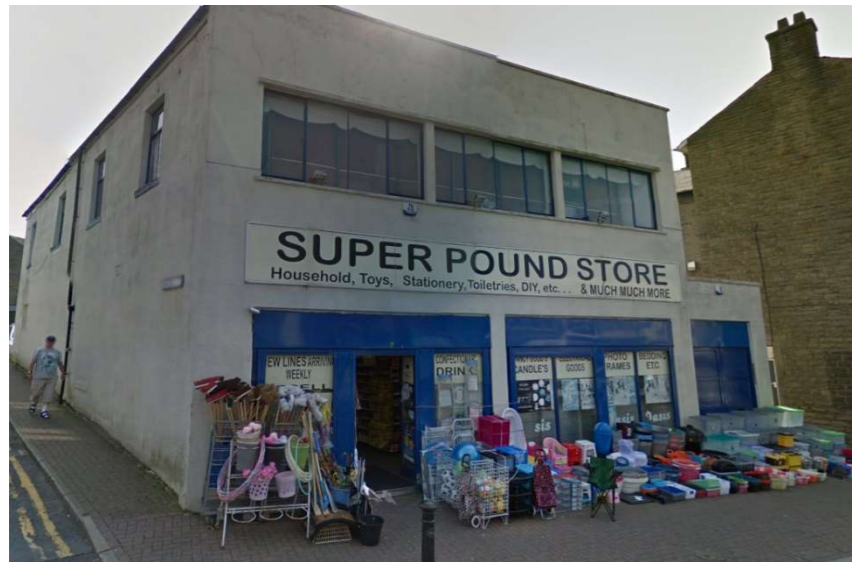
Figure 89 26 Deardengate

26 Deardengate stands out in contrast to its historic neighbours. Its architectural style and materials are entirely at odds with the prevailing character of the historic high street. Due to the significance of Deardengate in the history and development of Haslingden, the building is a momentous detractor. This is heightened by the use of public pavement as unorganised retail space.

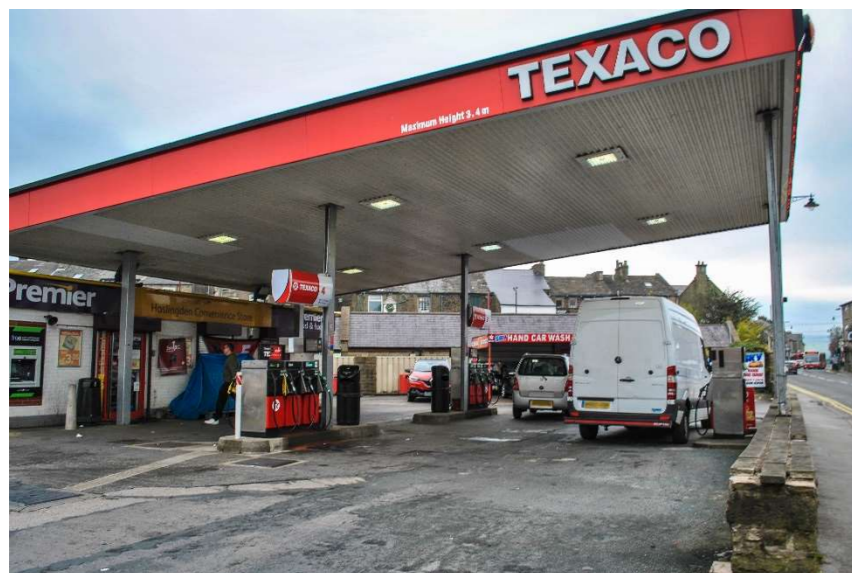
6.8.5 Petrol Station on Blackburn Road

Figure 90 Petrol Station Forecourt

It is recognised that the petrol station is a functional space. However, the forecourt creates a space leak on Blackburn road, breaking up the

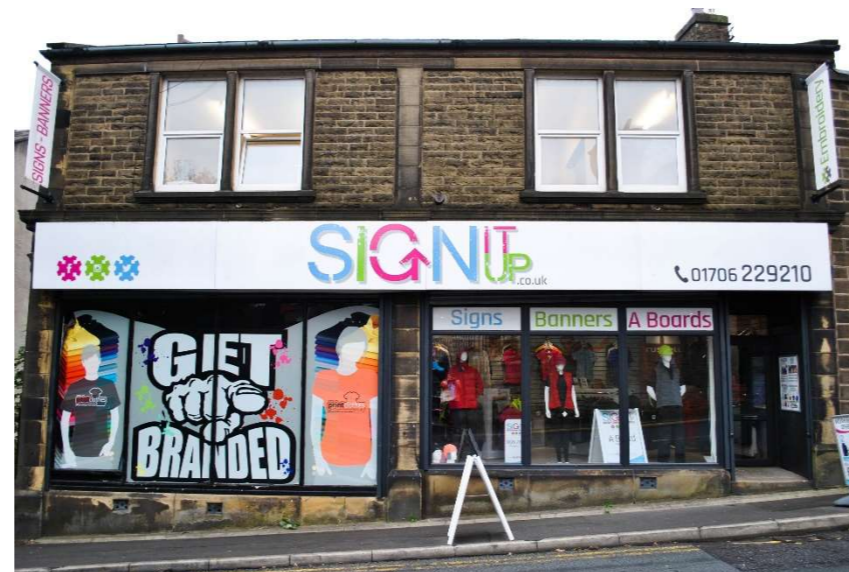
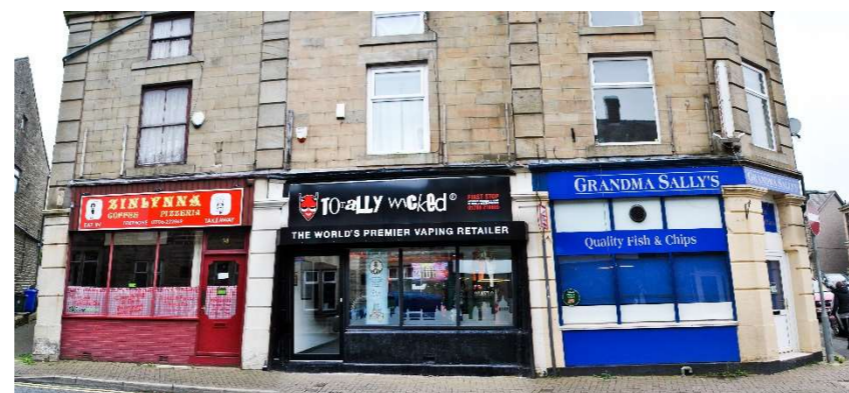
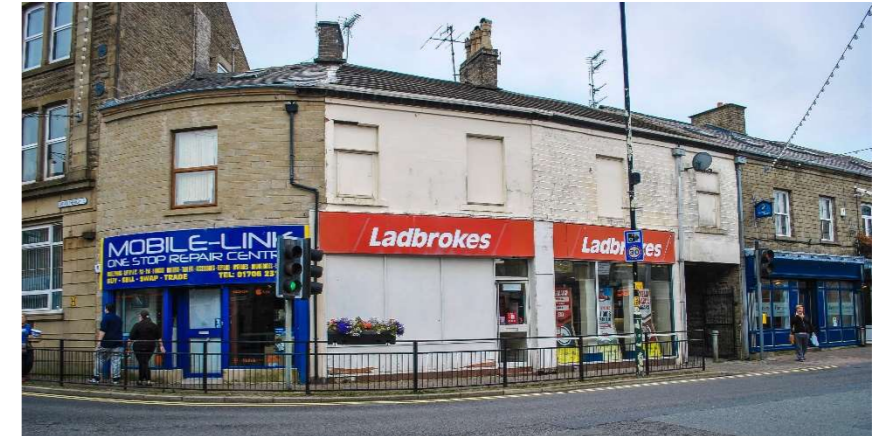
One of the principal issues reducing the quality of spaces in Haslingden is inappropriate shopfronts, particularly where modern shopfronts have replaced Victorian interventions 18th and early 19th century buildings. Inappropriate shopfronts can both harm existing fabric, and draw attention from the historic buildings above and surrounding them. There are many examples throughout the town, with a few used here for reference.

- Shopfronts.
Poor quality and inappropriate shopfronts in historic buildings are one of the key factors contributing to the degradation of Haslingden's character and sense of place. There is some potential for evidence of historic shopfronts behind modern alterations, which should be explored. Shopfront Design Guidance should be developed specifically for Haslingden to control the management of change in the town centre.

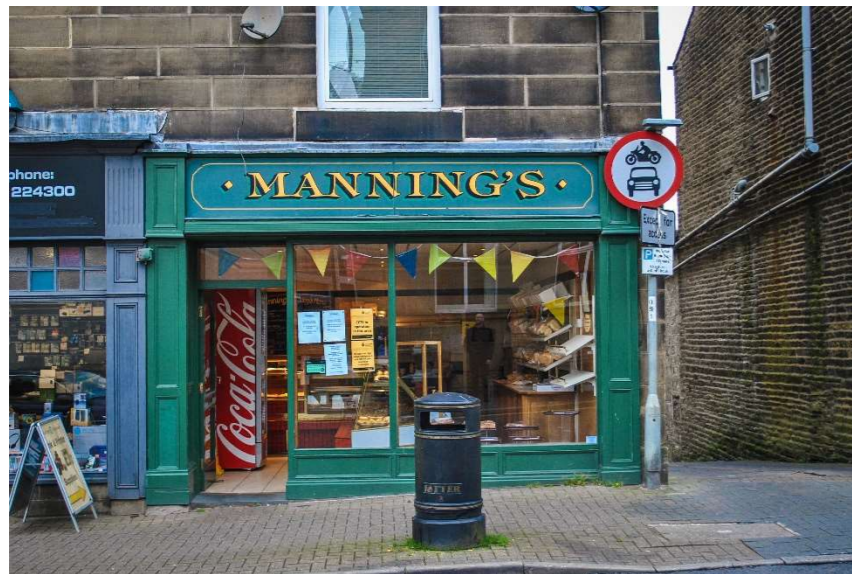
Figure 95 Mannings, 33 Deardengate

33 Deardengate retains many of its key features, including timber plinth, moulded panel pilasters and corbels, a large window with narrow mullions, an appropriate fascia size and typography and a retractable canopy.

Unfortunately, the shopfront is obscured by a bin in front of principal window, and highway signage at fascia level.

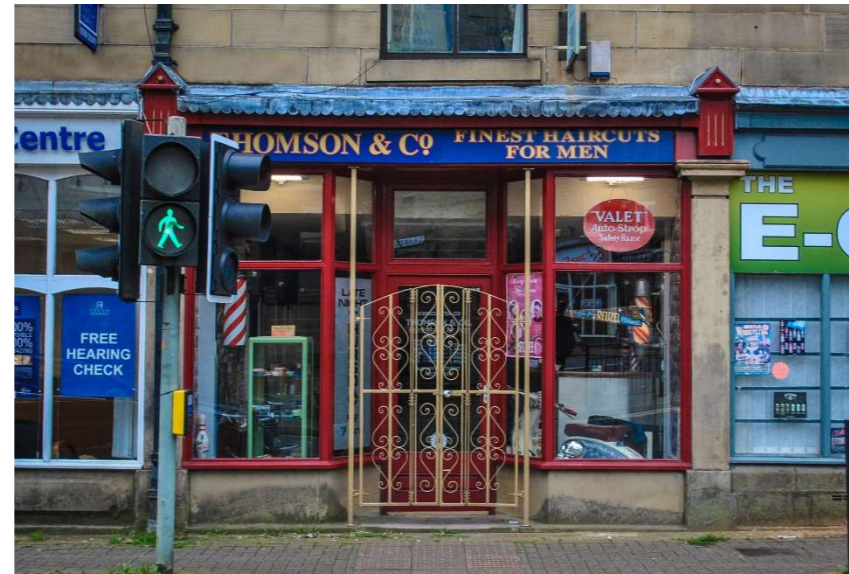
Figure 96 Thomson Barber Shop, 63 Deardengate

63 Deardengate retains many of the desirable shopfront features, including a recessed door, fanlight, large windows with slim millions and transoms, stone pilaster, timber corbels and an appropriately sized fascia.

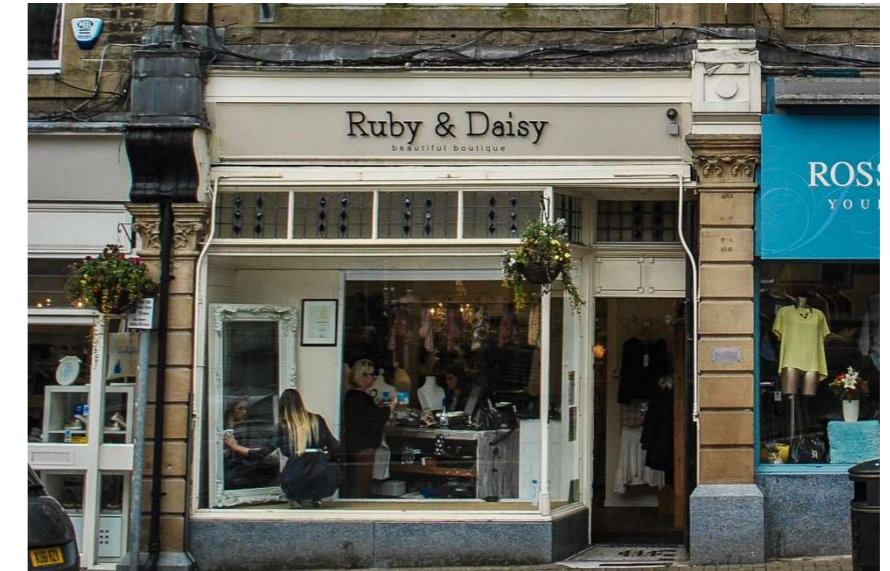
Figure 98 Ruby & Daisy, 15 Deardengate

Ruby & Daisy, and its associated premises, have made good use of their historic shopfronts to present contemporary designs. Unlike shopfront properties further south, these have stone ashlar pilasters with carved corbels. The fascia sizes, typography and colouring are all appropriate. They have retained the large windows, with details in the window lights and recessed doorways.

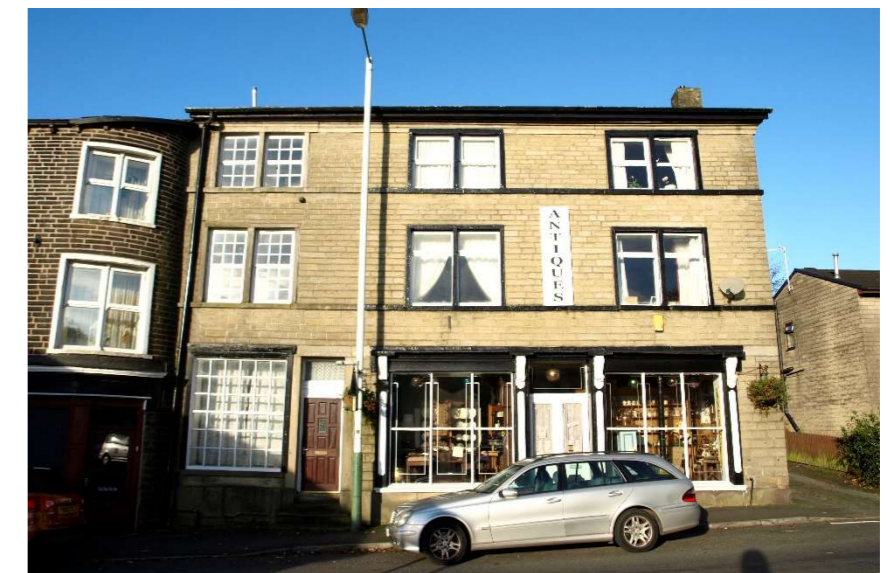
6.9.5 PJ Brown Antiques, 6 and 8, Church Street

Figure 99 PJ Brown Antiques, 6 & 8 Church Street

& 8 Church Street is perhaps the most complete example of a historic shopfront in Haslingden. It retains its 17th century proportions, but alterations in the 19th century gave the ground floor its extensively glazed shopfront. It retains its stone plinths, recessed doors, pilasters and corbels, though its fascias are narrow and unused.

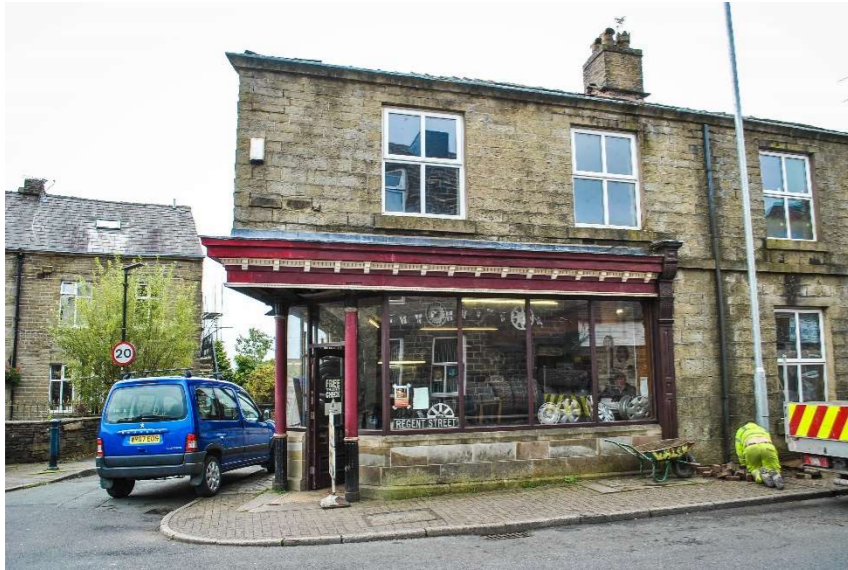
Figure 100 Haslingden Tyres, 2-4 Regent Street

A unique and characterful shopfront, retaining many original features, but requiring some fabric repair. This shopfront makes interesting use of its corner position by angling the door and using feature columns to mark the entrance, along with tile work. The cornice is richly dentilled and corbelled, and the paint scheme is appropriate.

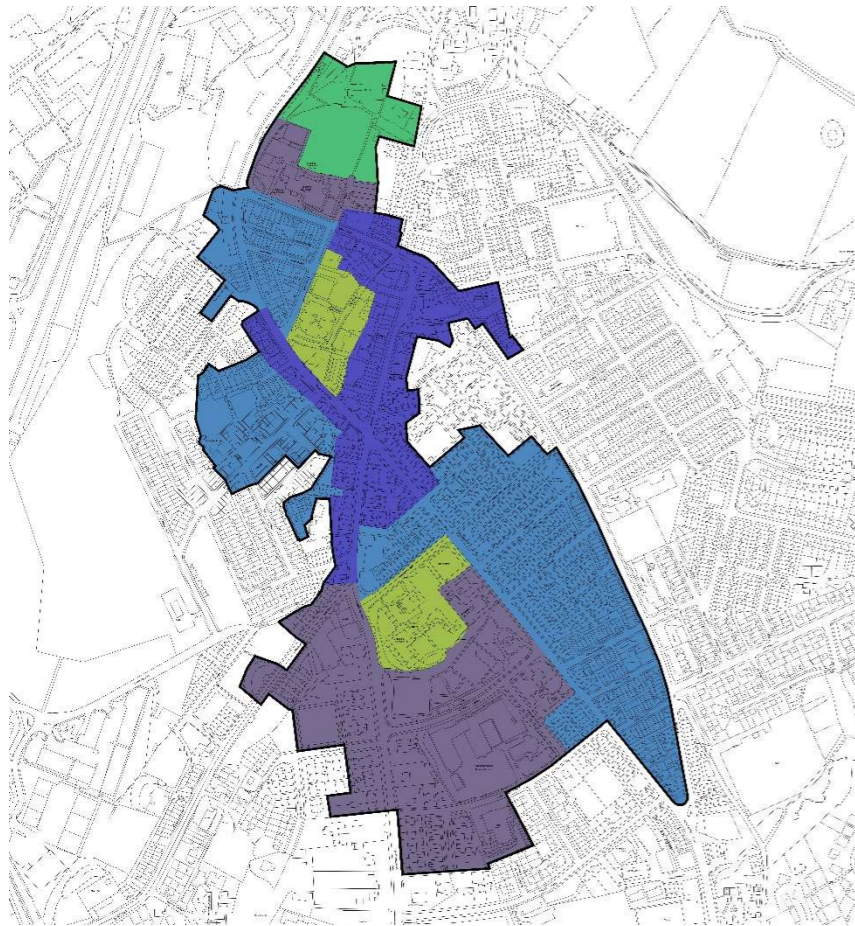
Figure 101 Character Area Map

The Haslingden Conservation Area is a complex collection of buildings and spaces that has developed over centuries. The Character Areas outlined below aim to separate the whole Conservation Area into 5 distinct parts that are defined by shared elements. 5 Character Areas have been established, with a general description and summary of positive and negative features listed here for reference.

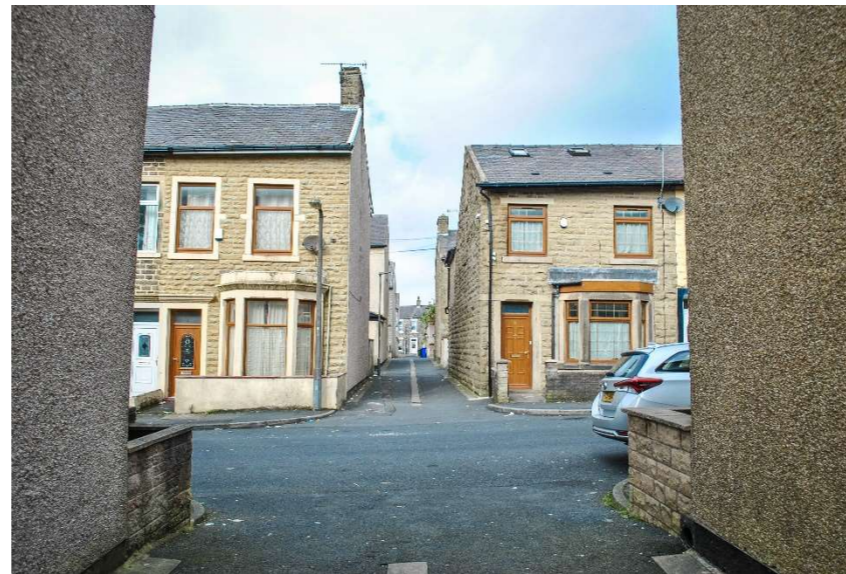
Figure 105 Example terminated view through terraces

The byelaw terraces make a valuable contribution to the understanding and character of Haslingden. Their densely packed grid system gives the area order, whilst also creating interesting and terminated views due to the street patterns in collaboration with the sloping topography of the town. Some byelaw terrace properties still have associated outhouse structures visible against the boundary walls. These areas are interspersed with ecclesiastical buildings that break up the consistency of the terrace rows. Most terraces are two storeys, but some three storey properties exist, including those on Park Street.
