WHITWORTH SQUARE CONSERVATION AREA

CHARACTER APPRAISAL AND MANAGEMENT PROPOSALS PLAN

ADOPTED FOR DEVELOPMENT CONTROL PURPOSES FROM 1st SEPTEMBER 2011

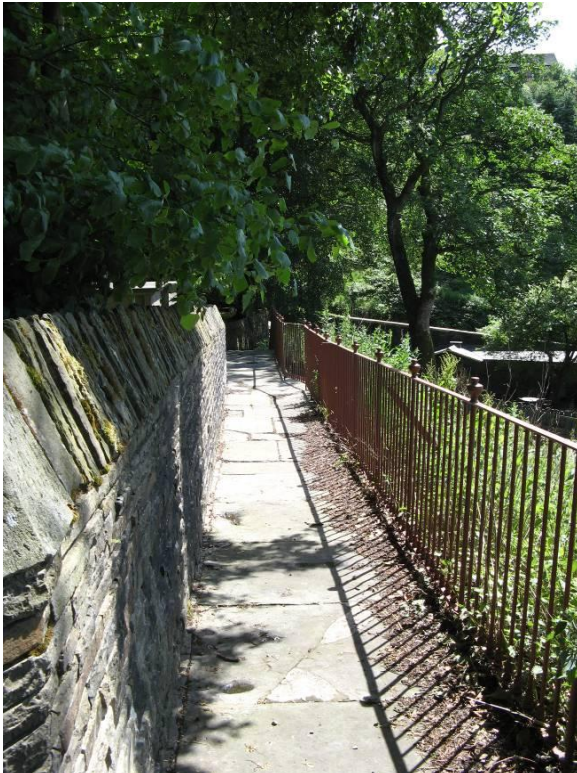
There are also examples of cast iron railings in many locations, most notably around the churchyard, where some have been replaced under the recent grant scheme. These are simple cast iron uprights, with arrow spikes. Some of these are in very poor condition and some have an undercoat but no top coat of paint (presumably the grant aid did not cover all of the necessary work). In places, modern timber fencing has been inserted to provide some level of protection. The removal of this fencing and its replacement with matching cast iron railings (as well as the repair and repainting of the existing cast iron railings), is urgently required. Traditional cast iron railings, again simple uprights with a spear head, can also be seen next to The Briars, and again in rather poor condition. Spiked cast iron railings, similar to those around the churchyard, can also be seen around the front garden to Whitworth House.

Unpainted railings on edge of churchyard

- Many of the monuments in St Bartholomew's Churchyard are in poor condition and in need of repair or restoration, including the listed village stocks
- Some of the railings around the pathways and the churchyard are in need of redecorating and modern timber fencing needs to be replaced with traditional iron railings

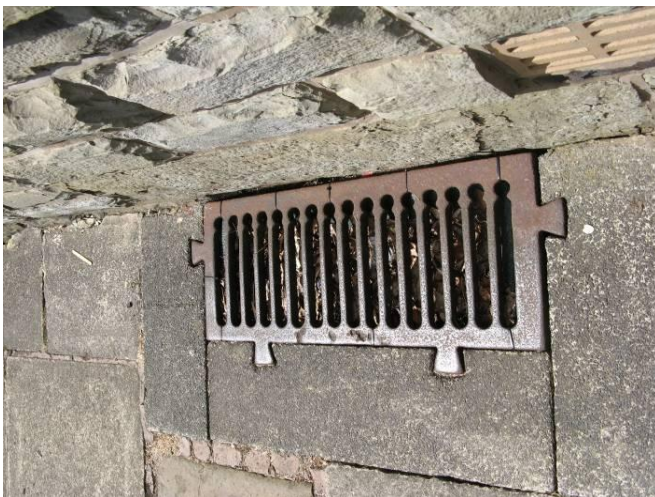
Whilst modern tarmacadam is used for many of the pavements and street surfaces in the Conservation Area, Whitworth Square is fortunate in retaining some substantial areas of sandstone setts which must once have ubiquitous. Examples can be seen in the pathways around the churchyard, in Whitworth Square, and at the eastern end of Taylor Street, but these areas may have been repaved, possibly under the previous grant scheme. The small rectangular setts are slightly rounded and provided an attractive 'bumpy' surface which fits well with the traditional wide stone kerbing which also predominates in this part of the Conservation Area. Their use in Whitworth Square, along the driveway on the west side of Whitworth House, and along the eastern end of Taylor Street (after the junction with Whitworth Rake), suggests that these roads are not adopted by the Highways Authority. Of note is the use of a flexible black bitumastic material for some of the joints, which is better at resisting frost and snow damage than a hard cement joint. Some of the paving in Whitworth Square is made up from concrete panels with fake stone insets, presumably an economy measure – their replacement with traditional stone paving would be very welcome.

Cast iron grille in pavement in Church Street

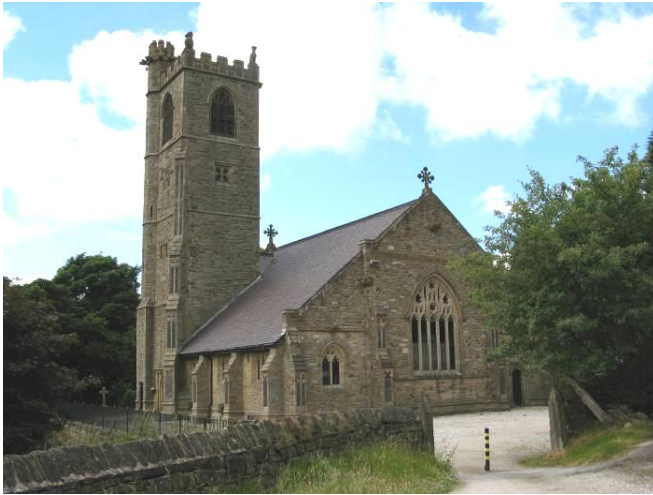
The 1840s church was designed by Joseph Clarke in the Perpendicular style but was substantially rebuilt to a reduced footprint in the 1980s following a fire. The remaining historic sections are the tower and parts of the nave. The walls are of sandstone rubble and the roof is slated.

St Bartholomew's Church

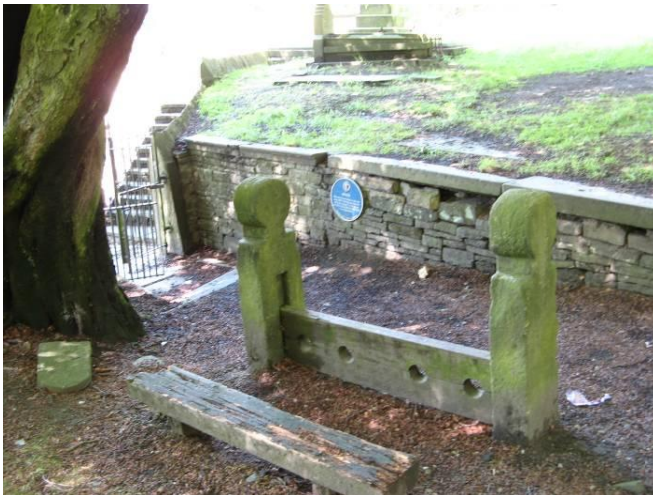
The stocks are made from wood and probably date to the 18th century.

Stocks in St Bartholomew's Churchyard

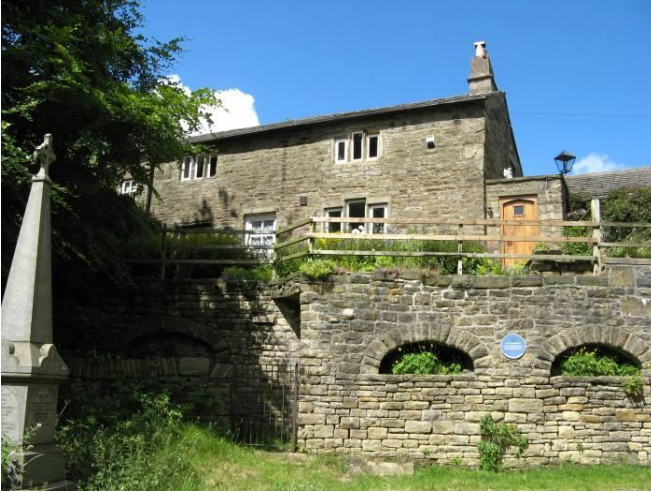
The Old Parsonage is a complex building which appears to date to the early 18th century but which the owners consider may retain late 17th century fabric. It has also been somewhat extended and altered over the years. The walls are coursed sandstone rubble with corner quoins, and there is a concrete tiled roof.

The Old Parsonage, Whitworth Rake

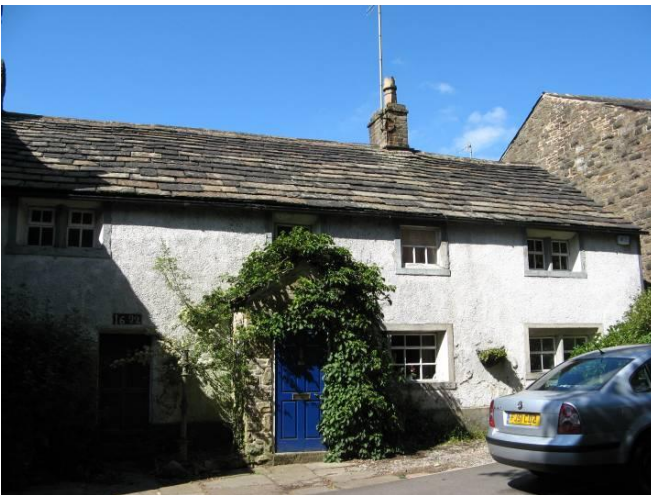
This three-bay building is dated 1692 (datestone) and is faced in painted roughcast, probably over sandstone rubble. Some of the windows retain chamfered mullions although the actual opening lights are 19th century or later. The roof is covered in stone slates.

Orchard Cottage, No. 11 Taylor Street

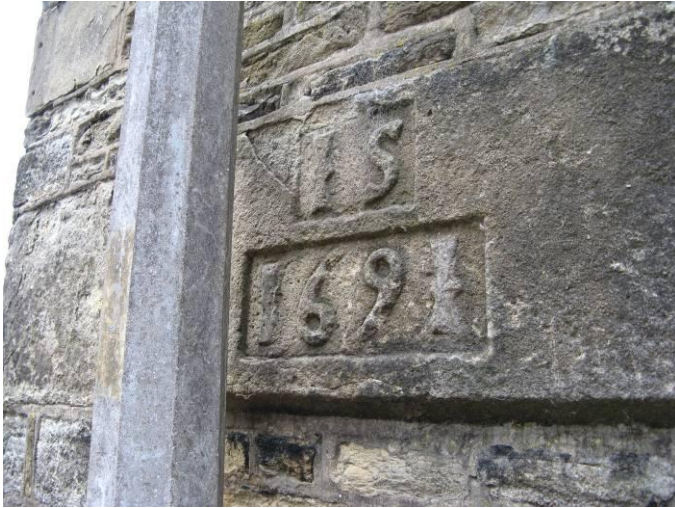
This is a relatively unaltered barn with a wide gable facing Taylor Street, on which a datestone 'IS 1691' is cut out of a large stone lintel. The building is constructed using roughly coursed sandstone rubble, with large corner quoins, and the gable end facing Taylor Street contains five ventilation slits and one owl hole. The roof is corrugated sheet. It is listed because of its association with No. 11 Taylor Street, also grade II.

Datestone 'IS 1691' on the listed barn in Taylor Street

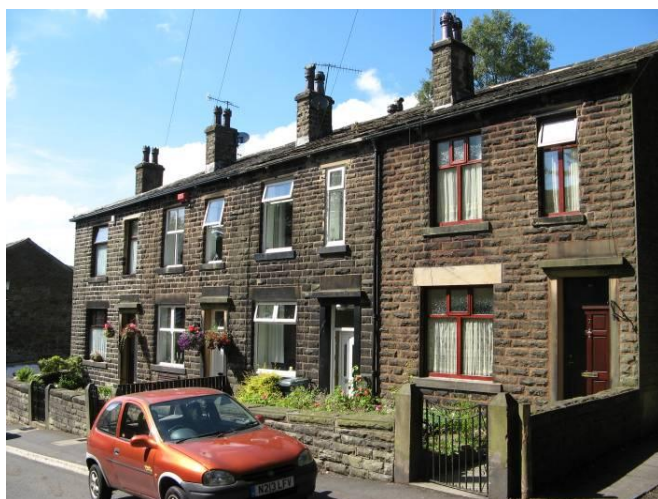
It has been noted that some of the unlisted 'positive' terraced or detached houses in the Conservation Area have been adversely affected by the alterations to the roofs, chimneys, windows and front doors. These changes are 'permitted development' which can be controlled by the Council through the imposition of an Article 4 Direction. Article 4 Directions are made under the *General Permitted Development Order 1995*, and can be served by a local planning authority to remove permitted development rights where there is a real threat to a particular residential building or area due to unsuitable alterations or additions. An Article 4 Direction is accompanied by a Schedule that specifies the various changes to family dwellings, which will now require planning permission. Usually, such Directions are used in conservation areas to protect unlisted houses in use as a family unit, rather than flats or bedsits where permitted development rights are already much fewer. It does not mean that development, such as changes to windows or doors, will necessarily be impossible. It does, however, mean that planning permission has to be sought and this allows for the merits of a proposal to be considered against the conservation interests.

Protect the roofs and chimneys of these unlisted houses in Taylor Street by an Article 4 Direction

Whilst an Article 4 Direction cannot be retrospective, the serving of one would incrementally improve the character and appearance of the conservation area. An Article 4 Direction can also be focused on groups of buildings, rather than the whole conservation area, such as unlisted buildings of particular local significance and all 'positive' buildings. Any Direction will require an up to date photographic survey to record the present condition of the buildings concerned, and written guidance will need to be provided to householders. Where resources allow, the provision of grants to help with the additional costs associated with traditional materials or the reinstatement of lost architectural features (such as the replacement of uPVC windows with windows to a traditional design) can be helpful.

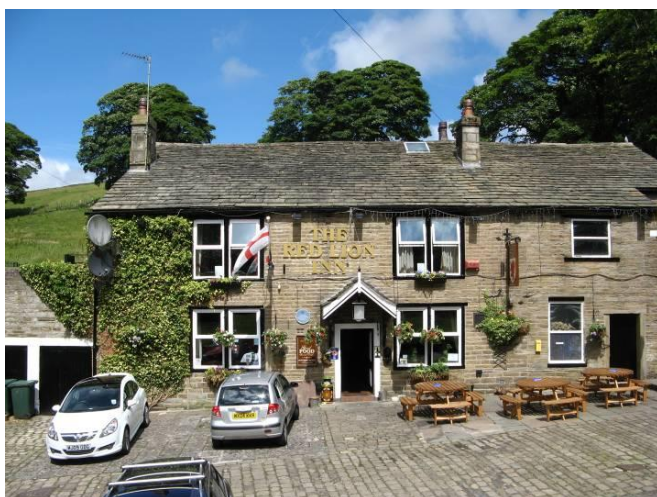
During the survey work for the Whitworth Square Character Appraisal, it was noted that a number of satellite dishes were visible which presumably had not been granted planning permission.

Satellite dishes in Whitworth Square

- Where satellite dishes have been erected without planning permission and negotiation has failed to achieve a satisfactory outcome, the Borough Council should consider taking Enforcement Action against the owners of properties.

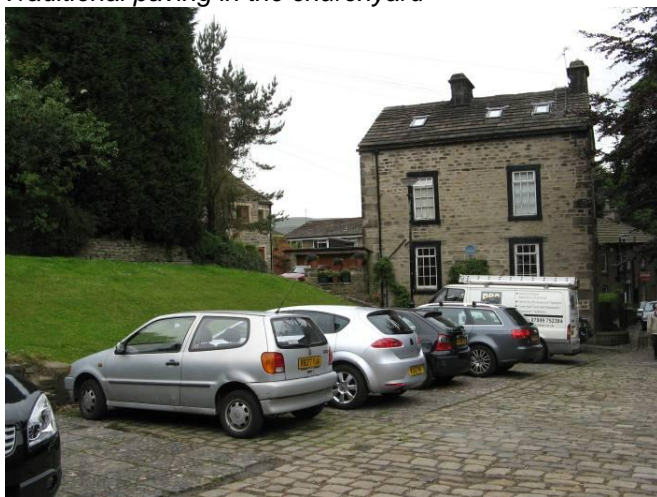
Concrete and traditional stone paving in Whitworth Square

traditional paving would be advantageous, including the replacement of the fake stone concrete paving in Whitworth Square. Funding permitting, the addition of further areas of traditional paving (stone setts and stone flags) would be advantageous.

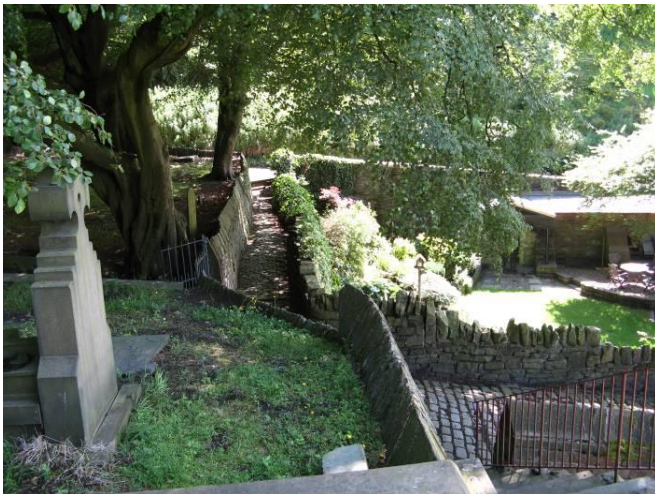
The churchyard is now in the care of Rossendale Borough Council and a certain amount of work was undertaken under the previous grant scheme. However, railings remain unpainted or are in need of renewal, some gravestones have been vandalised, the village stocks require additional repair, and some of the trees need further work. Some of this could be undertaken by local people on a voluntary basis.

Further improvements to the churchyard would be welcome

- The Borough Council should continue to monitor the condition of the buildings and monuments in the Conservation Area and when funding becomes available, should work with the local community to improve and enhance these buildings and monuments.

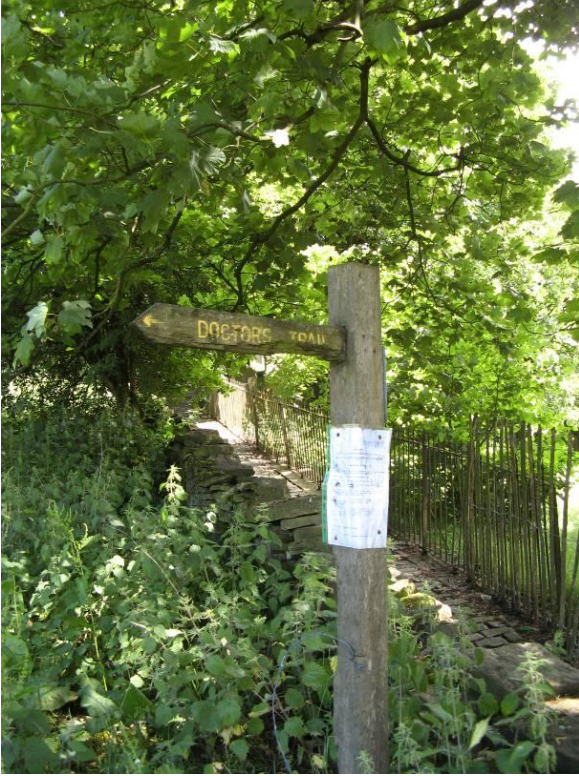
These were provided some time ago by Whitworth Town Council. Further plaques could be added to explain the significance of the Whitworth Square in greater detail. Signage for the 'Whitworth Doctors' Trail' also needs to be upgraded or replaced.

Signage to the Doctors' Trail is in need of replacement
