Draft Rosendale Local List of Non-Designated Heritage Assets

December 2024

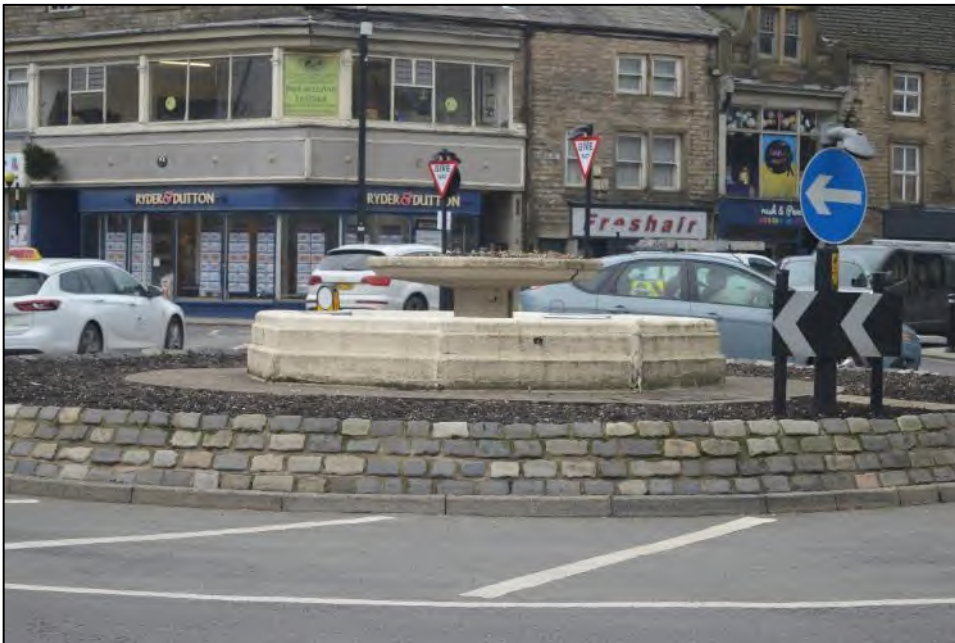
Bacup Coronation Fountain in honour of Queen Elizabeth II's Coronation. Now used as a planting area in the centre of the St James Square roundabout.

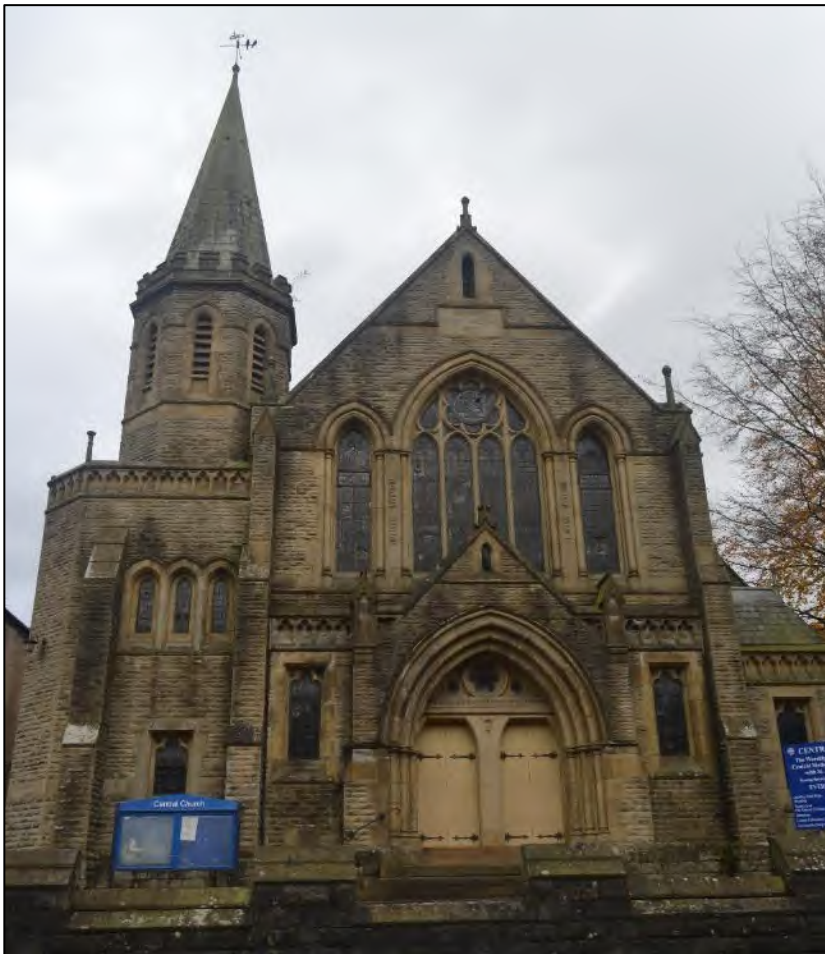
Asset Ref.	Asset Name	Address	Asset Type
NDHA_2	Central Church	32 Burnley Rd, Bacup, OL13 8AB	Building

Central Church, formerly Central Methodist Church. Late Victorian stone built church. Large Tripartite window on west gable, with geometric tracery, a wide arched portal embracing two entrances. Short octagonal north-west tower, with battlements and stone spire [Pevsner, Hartwell 2009, The Buildings of England - Lancashire North, Pg. 90].

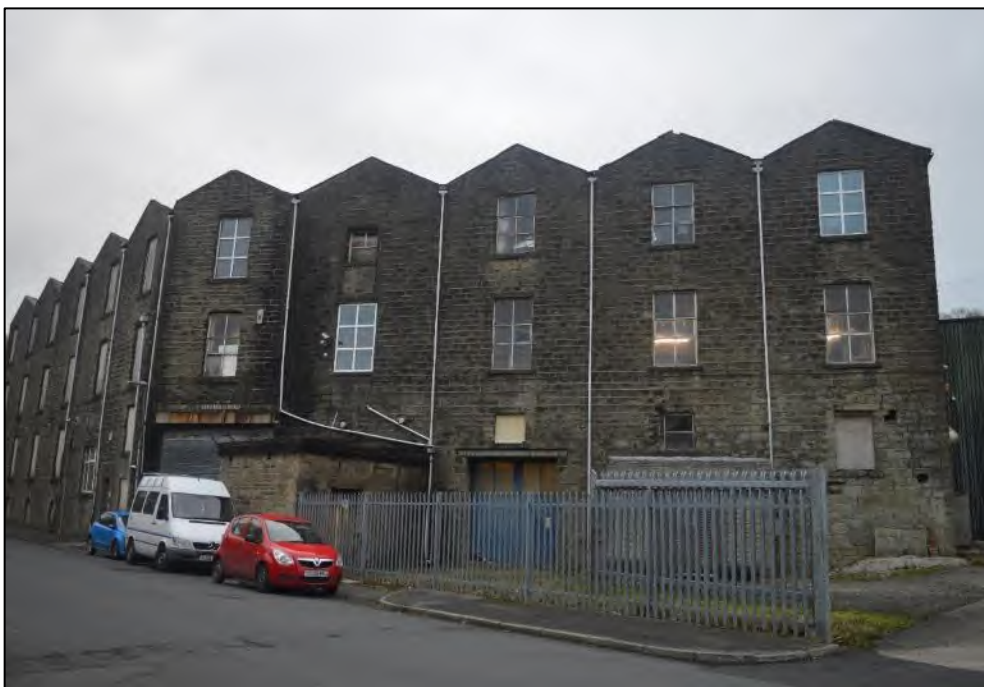
This mill is extensive, spreading across the valley floor. One of the two chimneys also remains. Far Holme Mill is an example of an integrated spinning and weaving complex.

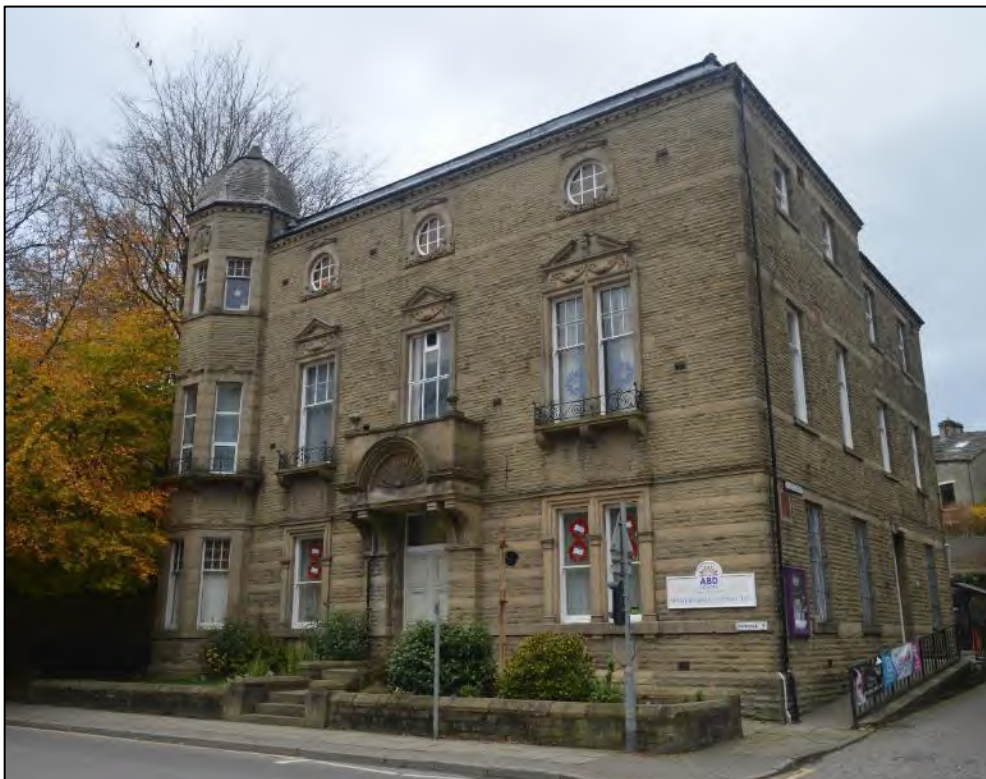
Image

A much larger and more convenient building that replaced an existing club, which had been in use since 1875. The club is three-storeys and built of rock-faced stone, with Ashlar stripes in an Idiosyncratic Baroque style (Pevsner). The design shows the principal entrance in the centre of the front elevation. Large octagonal corner tower with a dome, doorway with a shell tympanum and balcony over, windows with Adamish details and a row of bullseye windows along the top (Pevsner).

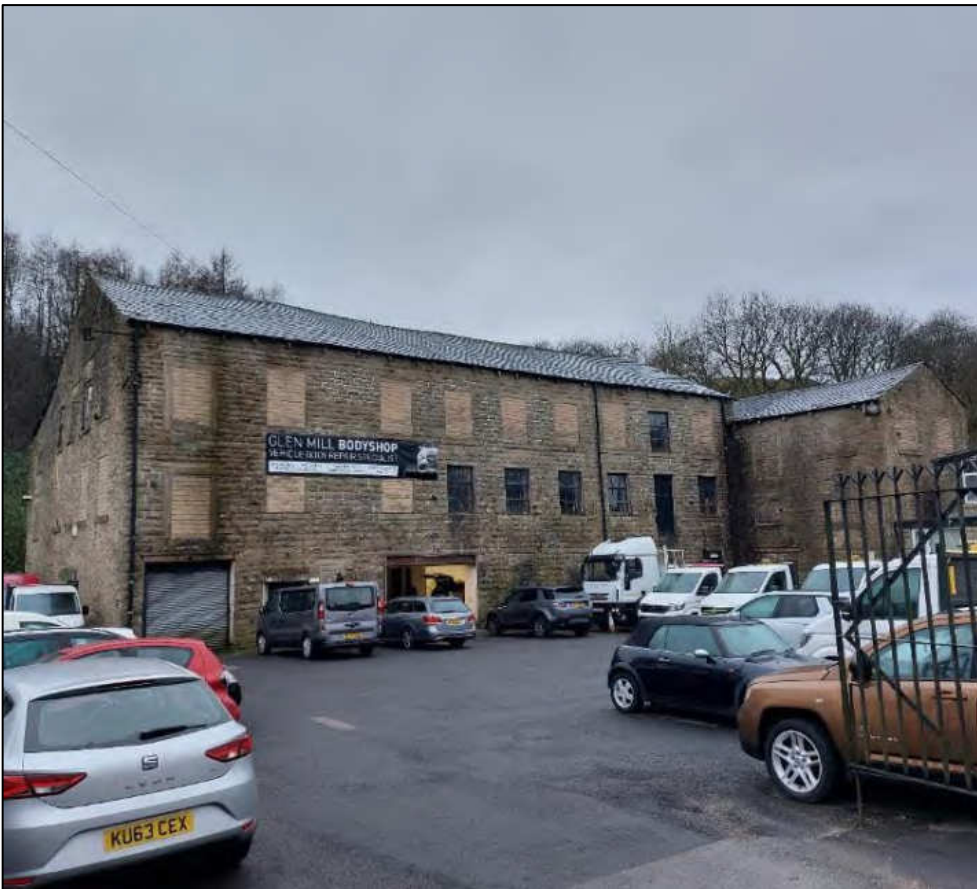
Image

Built in 1854. Three storey, stone built, original slate roof, some windows filled in modern times. Built for cotton spinning and manufacture by Henry Duckworth (Mannex, 1854). Later used for slipper manufacture. Currently still in industrial use as a auto body repair shop.

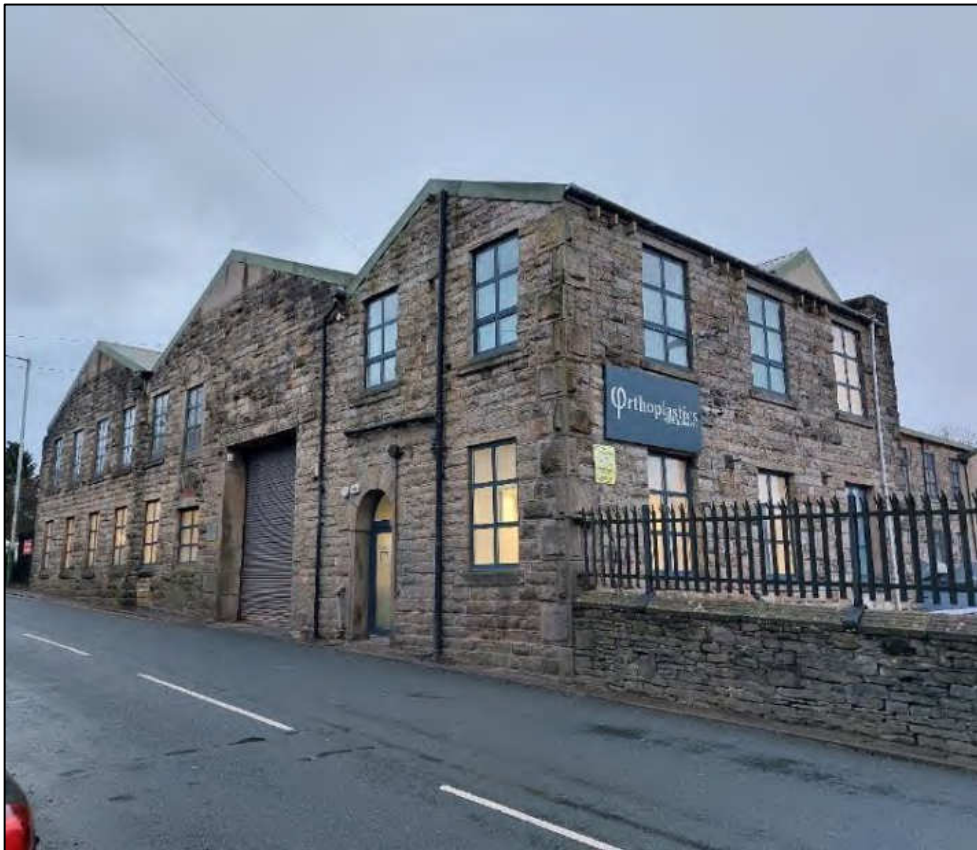
Asset Ref.	Asset Name	Address	Asset Type
NDHA_6	Grove Mill	Todmorden Road, Bacup	Building

Although the original roof has been replaced and a modern stairwell/lift shaft added, much of the original material remains including an arched doorway.

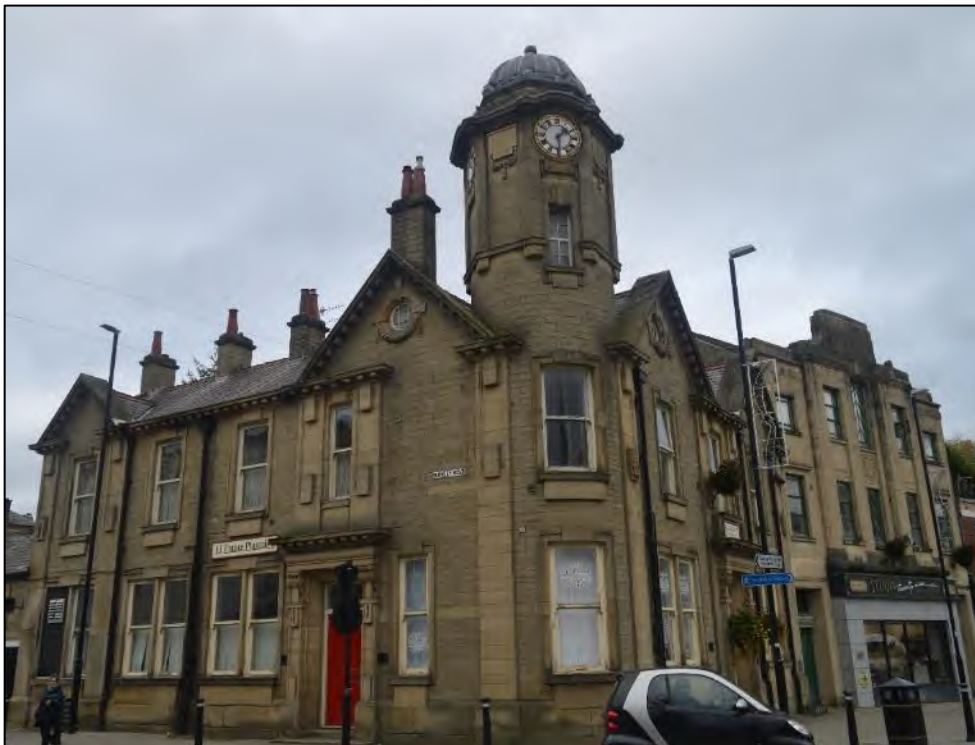
Blocky, playful, slightly irreverent Baroque style of the period just before the Great War. Tall circular corner tower, which becomes octagonal, with a lead dome. (Pevsner, Hartwell 2009) This building has a prominent location being in the intersection of major routes in and out of Bacup.

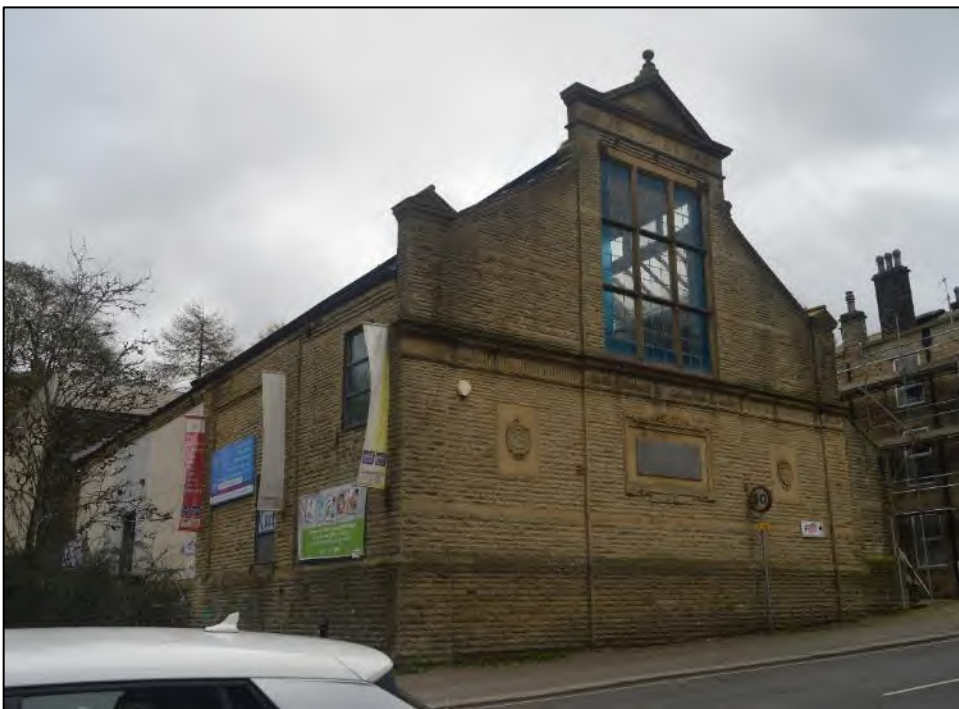
Each swimming bath was well-lighted from the roof with inclined vertical lights and by large end windows. The front and two principal side elevations are faced with Yorkshire parpoints, backed up with common brick work and Yorkshire stone used for the Ashlar work, which was tooled. The steps, flags, and copings were from neighbouring quarries. [Architects of Greater Manchester 1800 - 1940][Building News 22 December 1893].

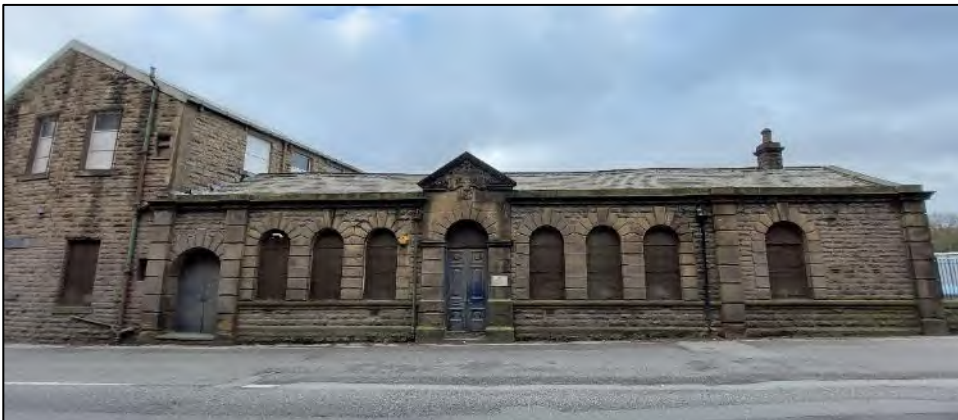
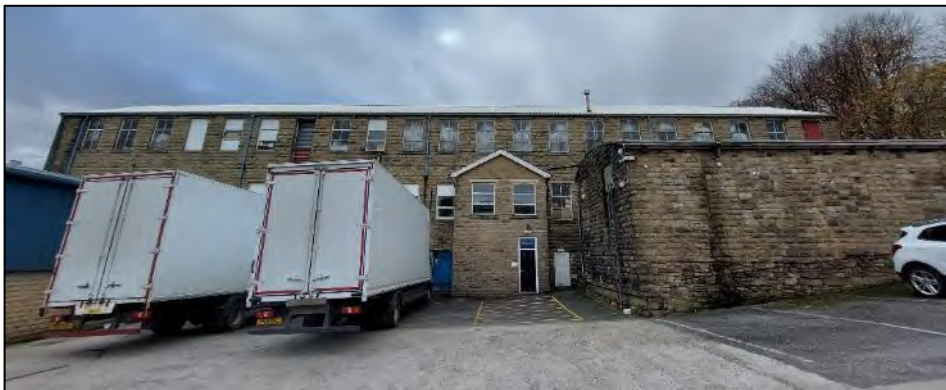
Stone built one and two storey mill with arched windows and doors to front elevation with large stone keystones and a slate roof. Large extant weaving shed with typical north lights below level of road. According to the All District report, it was first recorded in 1833 and was built on the site of an earlier mill, Spring Mill. It was originally a woollen manufacturer which was converted later in the C19th to cotton. In 1900, after being empty for a number of years, it was converted for slipper manufacture.

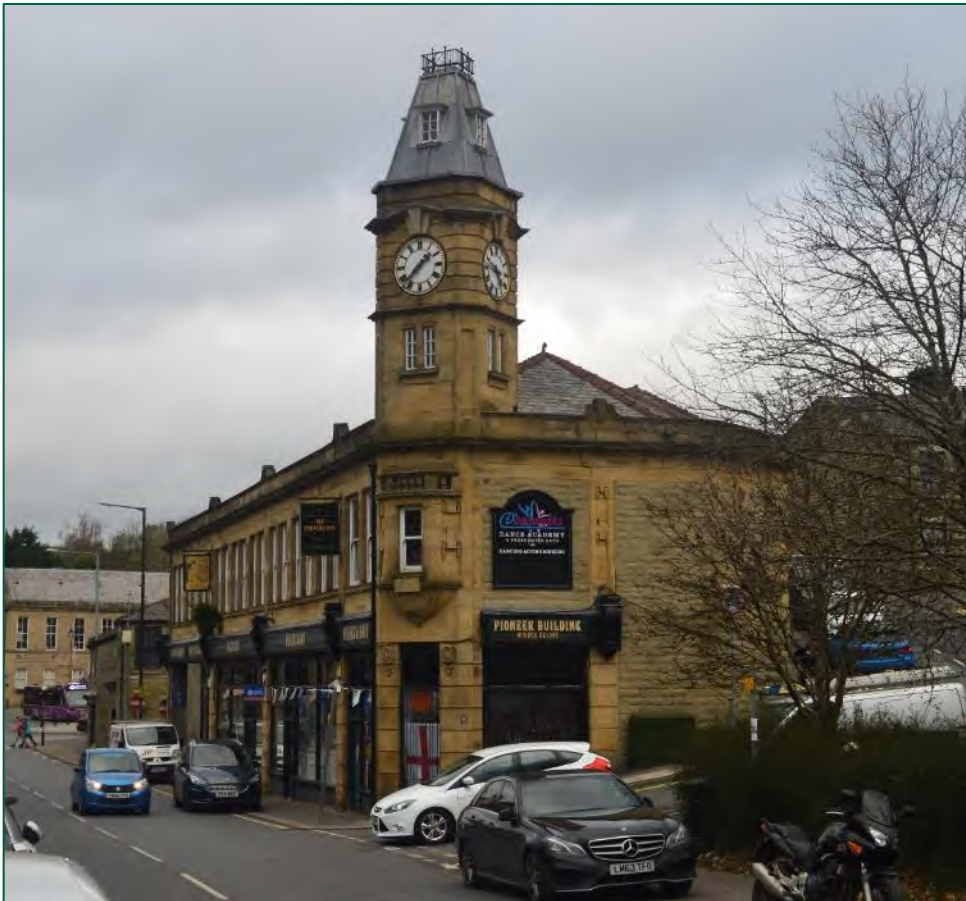
Image

Purpose-built department store of 1914. Pioneer Buildings is a large purpose-built shop, built by the Bacup Co-operative Society with a corner tower and clock which forms an important focal point. Previously the building was stripped of original features replaced by a large acrylic fascia and had clashing shop signs. The original features have now been restored by Bacup THI.

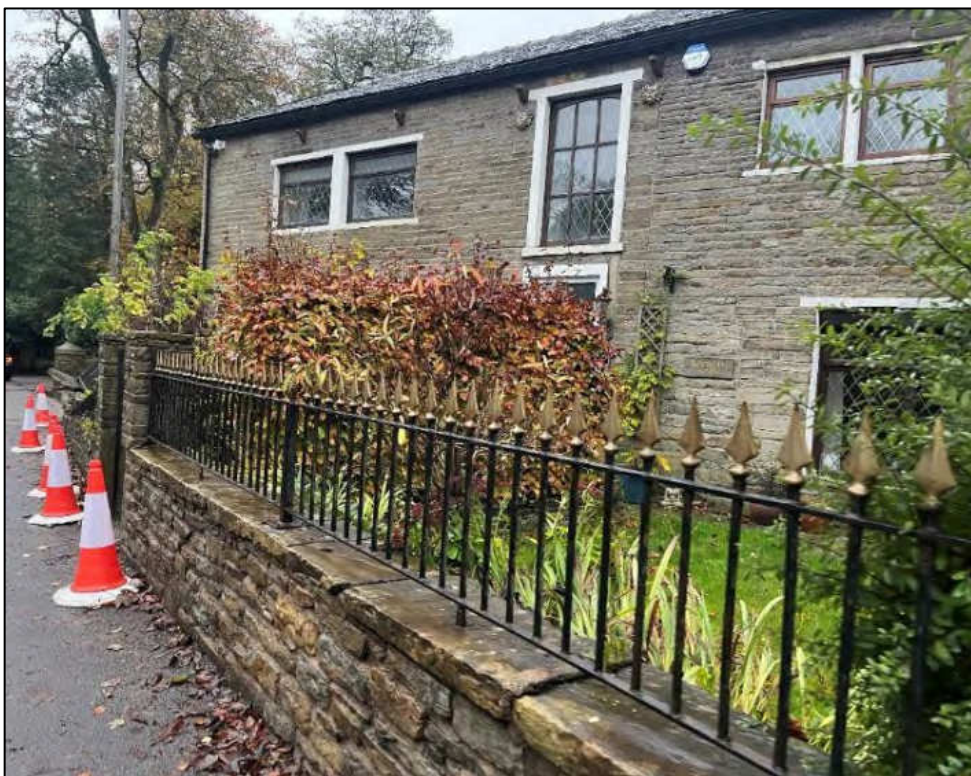
Asset Ref.	Asset Name	Address	Asset Type
NDHA_12	Rookery Nook	Burnley Road, Broadclough	Building

Rookery Nook is an early 18th century dwelling, with later additions. It is constructed from stone with a slate roof and a chimney stack sits centrally on the ridgeline. The cottage has been built in three stages made evident by the differing stonework. Most windows have stone lintels and cills, some sit in pairs with stone mullions. Two windows on the ground floor in the third and fourth bay have timber headers. There is evidence of windows which have been blocked up with stonework on the first floor of the third bay, here a stone lintel, cill and mullion is evident. The door has a stone surround and transom window and sits in the second bay, above the doorway sits a large nine light window. Rookery Nook is set behind a stone wall with piers and railings and a front garden.

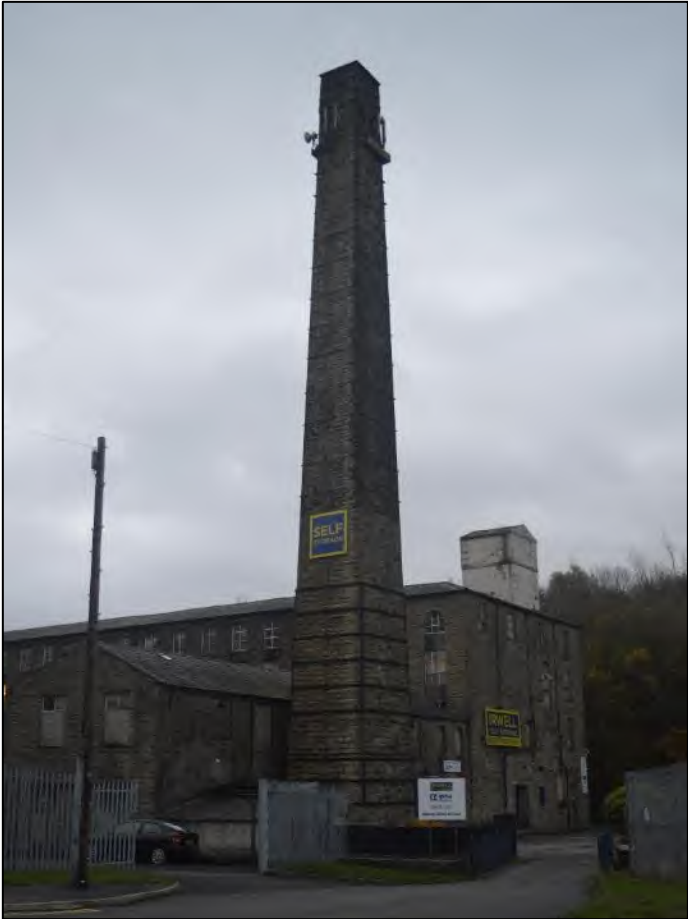
Description
 Stone built four storey mill, chimney still intact, some arched windows and stone detailing. A very large site, which the All District Report states was built in 1860 and had 28,000 spindles and 752 looms (Worrall, 1891). Cotton spinning ceased in 1836 (Bacup Times, 2 July 1938). It is currently still in use for various purposes including storage facilities and is now called Atherton Holme Works.

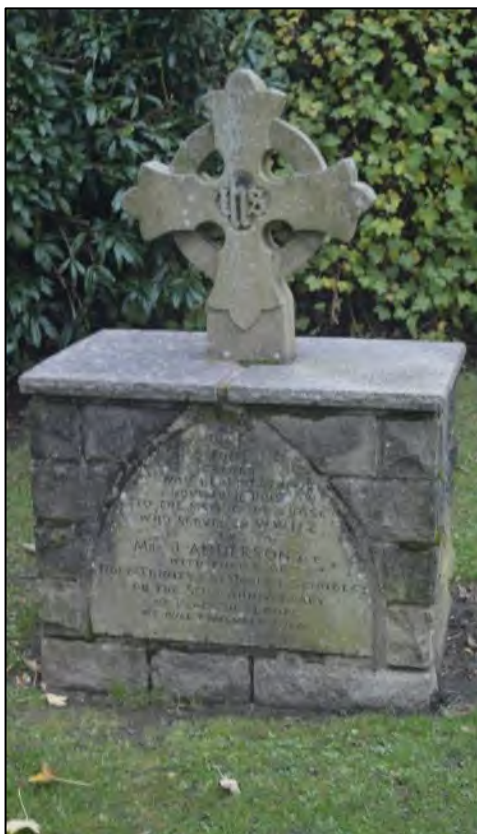
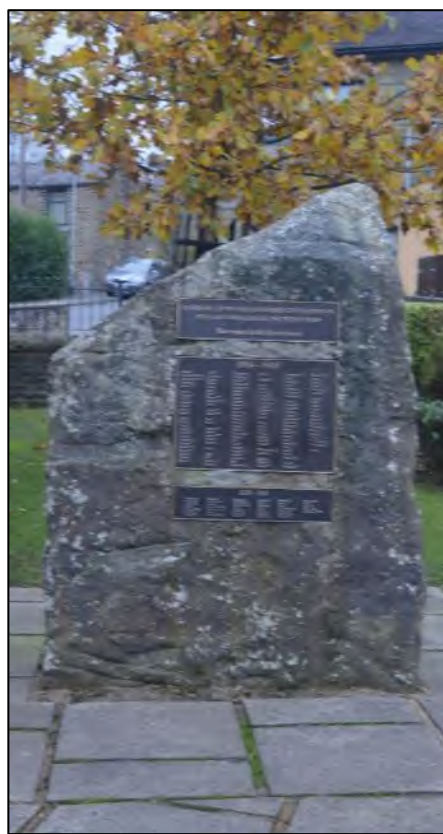
Asset Ref.	Asset Name	Address	Asset Type
NDHA_14	Stacksteads War Memorial	Stacksteads Memorial Garden, Newchurch Rd, Stacksteads, OL13 8LG	Landmark, art work or way finder

Stacksteads war memorial is located in a walled memorial garden. The garden contains a dedicatory stone plinth surmounted by a Celtic cross with a dedication engraved on the front face of the plinth. Alongside the plinth is a stone of remembrance with three plaques attached to the front face. In front of the stone of remembrance is a flagpole and an adapted bus shelter is used as an entrance to the garden.

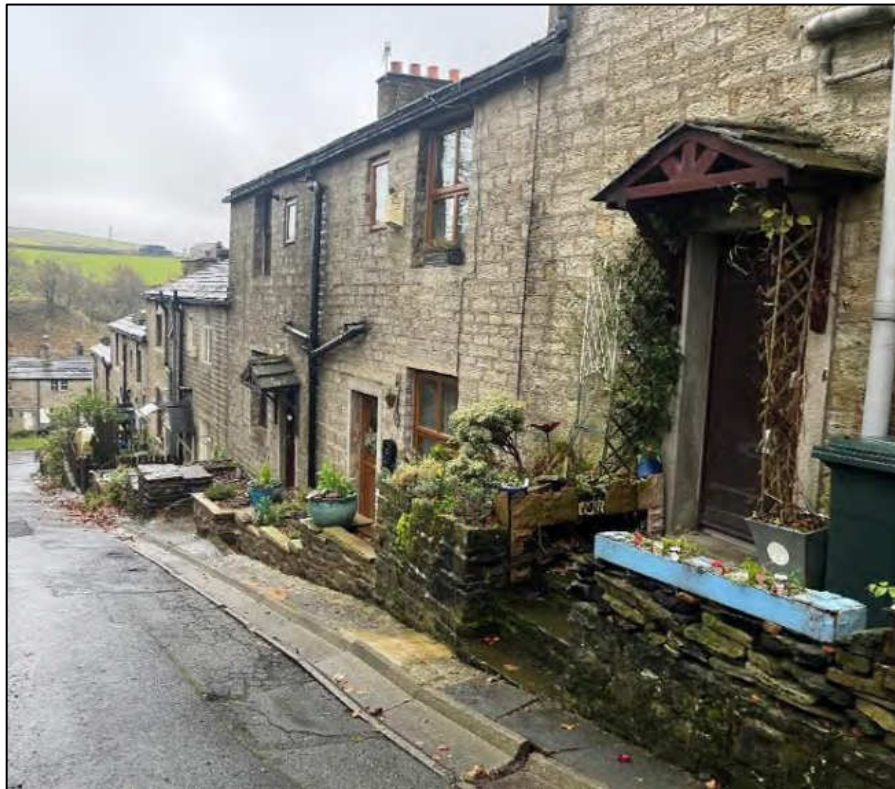
Step Row is a terraced row of ten single fronted houses in pairs stepped up the hillside. The houses were built in the early 19th century. The first eight houses are reflected pairs, the top two, a repeated pair, were added later. All of the houses are double depth with stone roofs and walls, the windows have stone lintels and cills and the doors have stone door surrounds, some doors have gabled canopies above, all of which were added at a later date. The houses have small front gardens behind dwarf stone walls. Built by the old road to Deerplay, this links the Old Bacup Road on the hillside with the later Turnpike road.

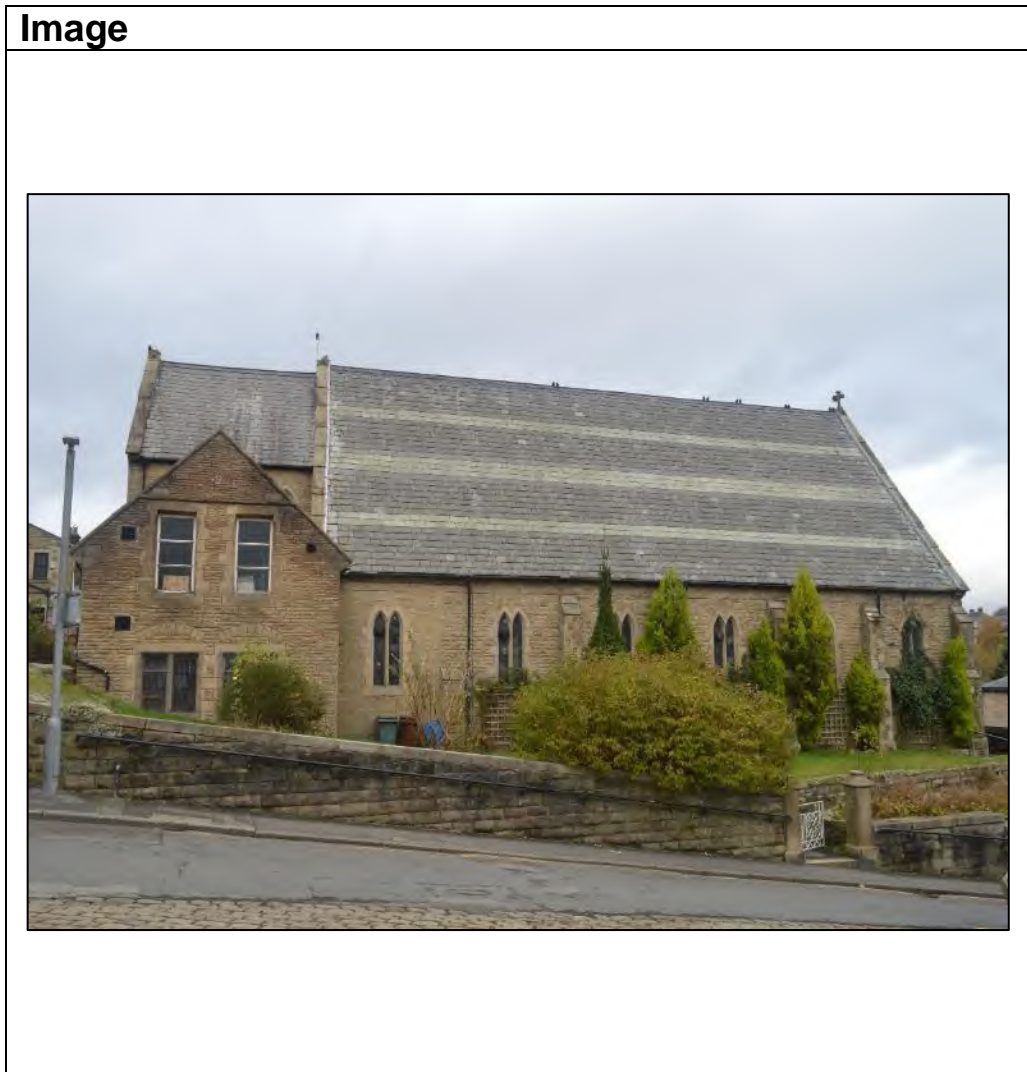
Asset Ref.	Asset Name	Address	Asset Type
NDHA_16	St. Mary's Roman Catholic Church	Dale St, Bacup, OL13 8AP	Building

Description
 A compact urban church in the Early English Gothic Revival style. The only Roman Catholic Church for Bacup, St Mary's is within a semi-enclosed square with the former Police Station and the Old Market Hall.

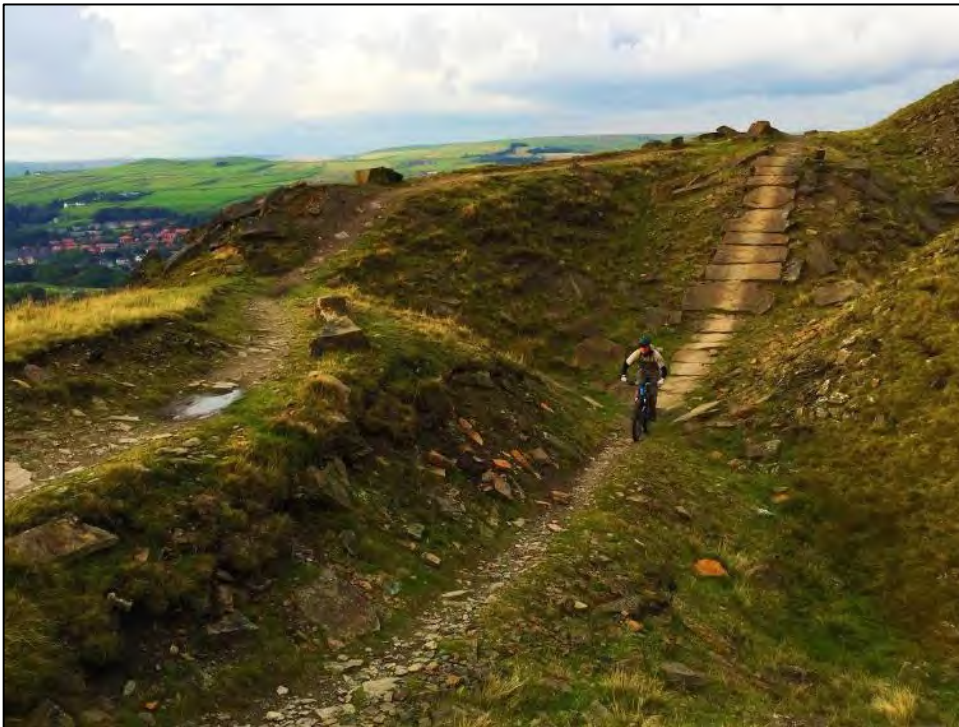
Lee Quarry History: hillside outcroppings, open pit working and mining. Extensive mechanisation from at least the 1880s, included steam powered cranes, blasting, pneumatic rock drills. Electricity was used from c1919. Transport: prior to 1880s, horse and cart was used to transport stone away. From c 1880, there was a large inclined plane down to Holts sidings, Lee Mill, on the mainline railway; with extensive tramway networks in the quarry (Roberts, 1974). In twentieth century, road haulage was employed, including early steam wagons (Taylor, 1991).

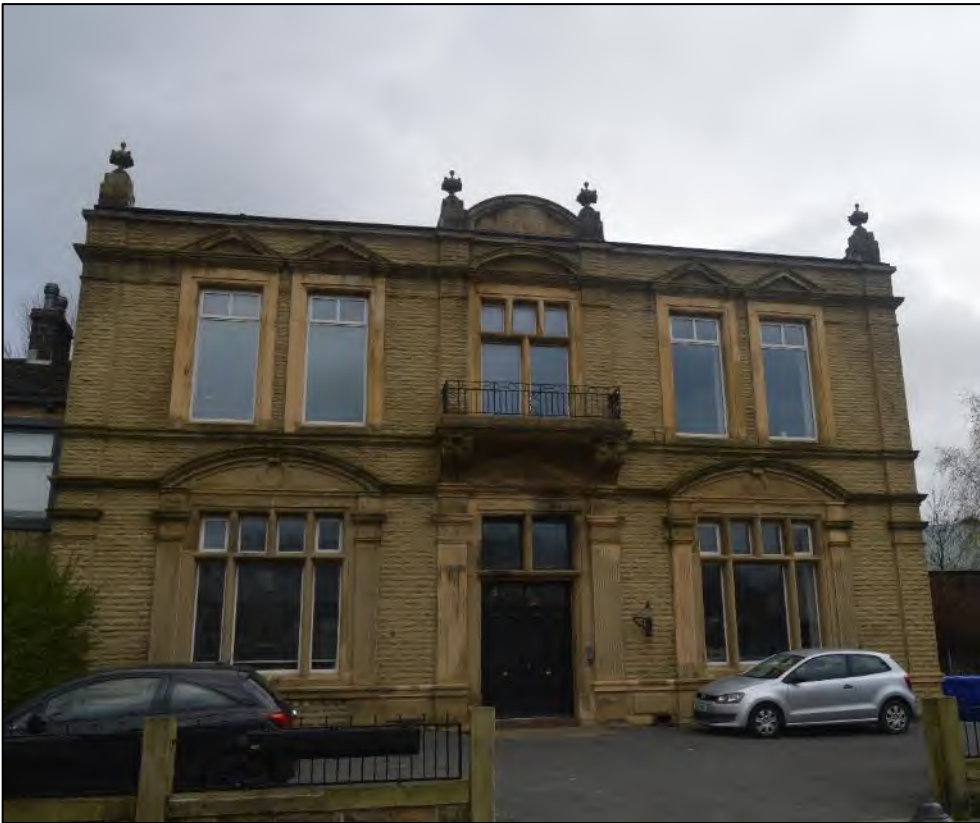
Former Conservative Club. Designed in a strait-laced Eclectic style. Upper windows triangular and segmental pediments. Lower windows shallow segmental pediments and mullions and transoms [Pevsner].

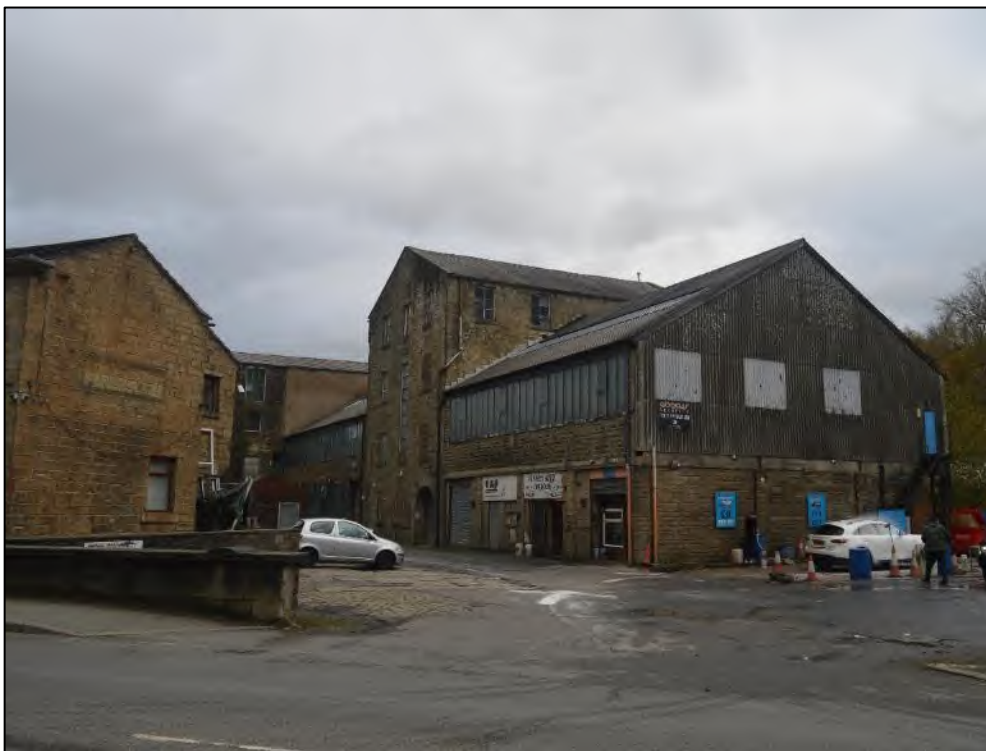
Image

Part 2 and 4 storey stone built mill with some clad sections and an arched door detail. Throstle Mill is part of a group of mills situated on the southern fringe of Bacup town centre, along Market St / Newchurch Rd.

Throstle Mill was built by Maden, Hoyle, Baron & Bridge in 1837, and was operated under the style of The Throstle Mill Company (Taylor, 1991).

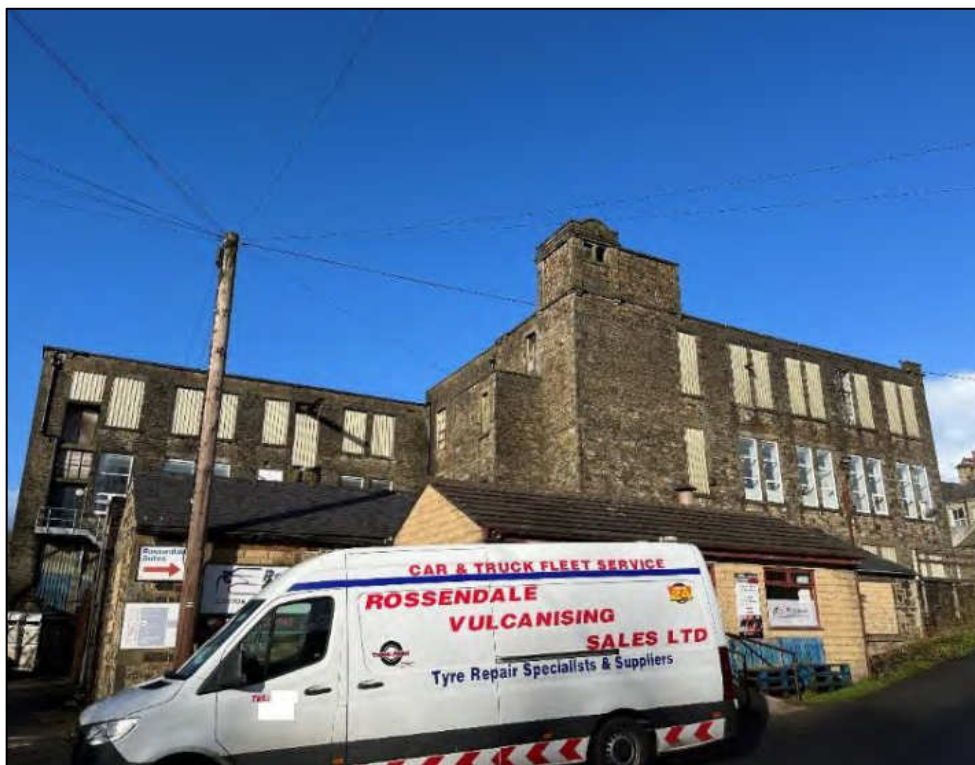
Britannia Mill is a four storey mill of random stone construction. 'Britannia Mill 1925' is engraved onto an arched parapet, perhaps on an extension to the mill building as the Lancashire Textile Mill Gazetteer notes the mill to be present on the 1894 Ordinance Survey map. Some sections of walling are clad in corrugated metal, some sections appear to have been demolished (some walls remain as evidence) with modern buildings erected in their place. (Lancashire Textile Sites: Buildings at Risk Assessment Survey Report, 2018).

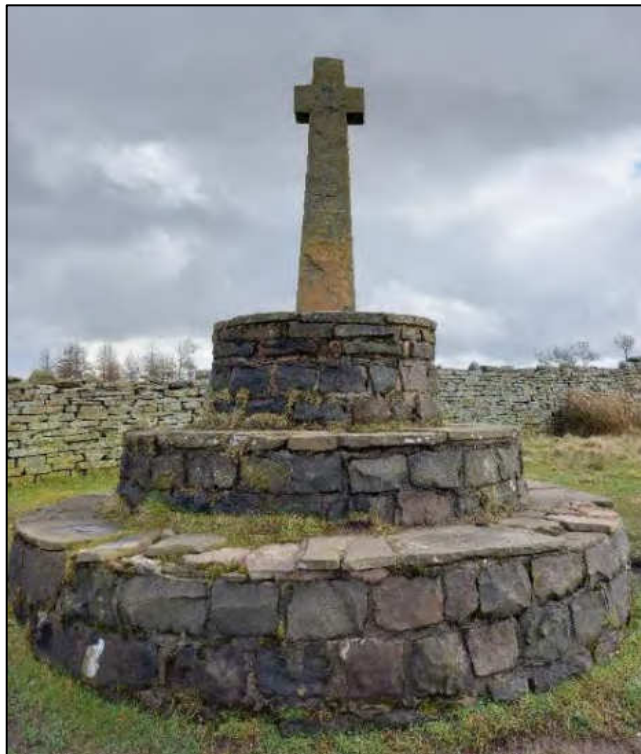
There is a marker stone to mark the position of the Western Cross (also known as Higher Cross or the Cross) which is 250 yards away. The Western cross was thought to be at the cross roads of two ancient tracks, one from Whalley Abbey to the Abbey's Estates at Brandtwood, near Bacup. This would also be on a straight line almost to Pilgrims Cross on Bull Hill, near Holcombe and perhaps the Affetside Cross too.

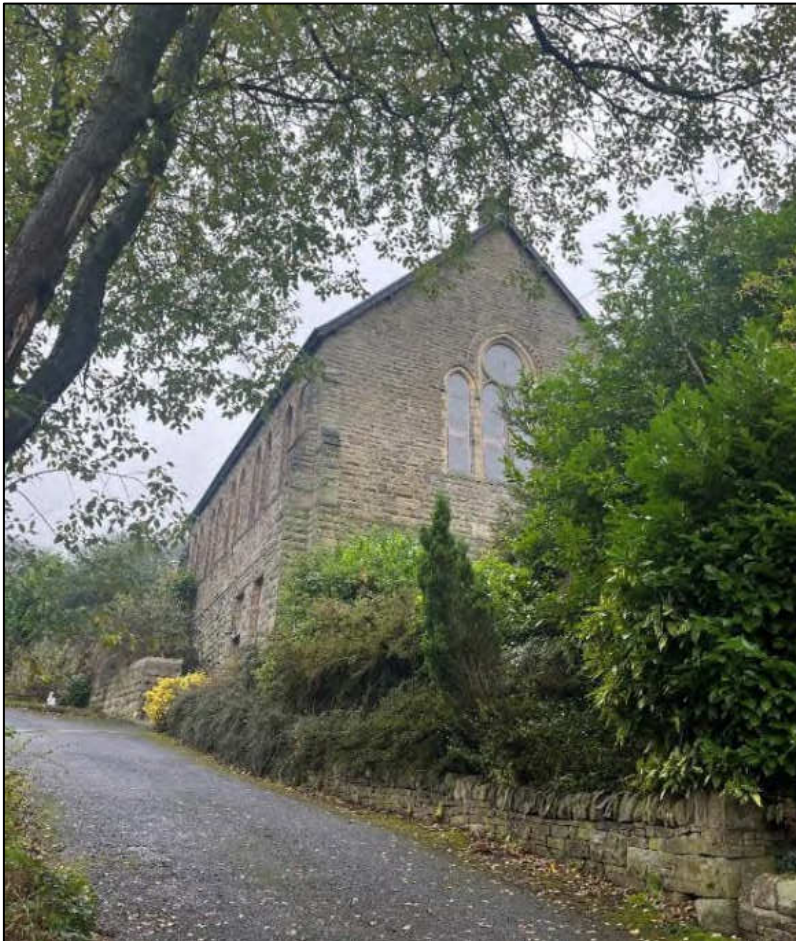
Plain, box-like building (c.1870), enhanced by steep pitched roof and gothic style windows. Located on the side of a steep hill behind the main village. Used for many years as an engineering workshop, now converted back into a house with several internal features surviving.

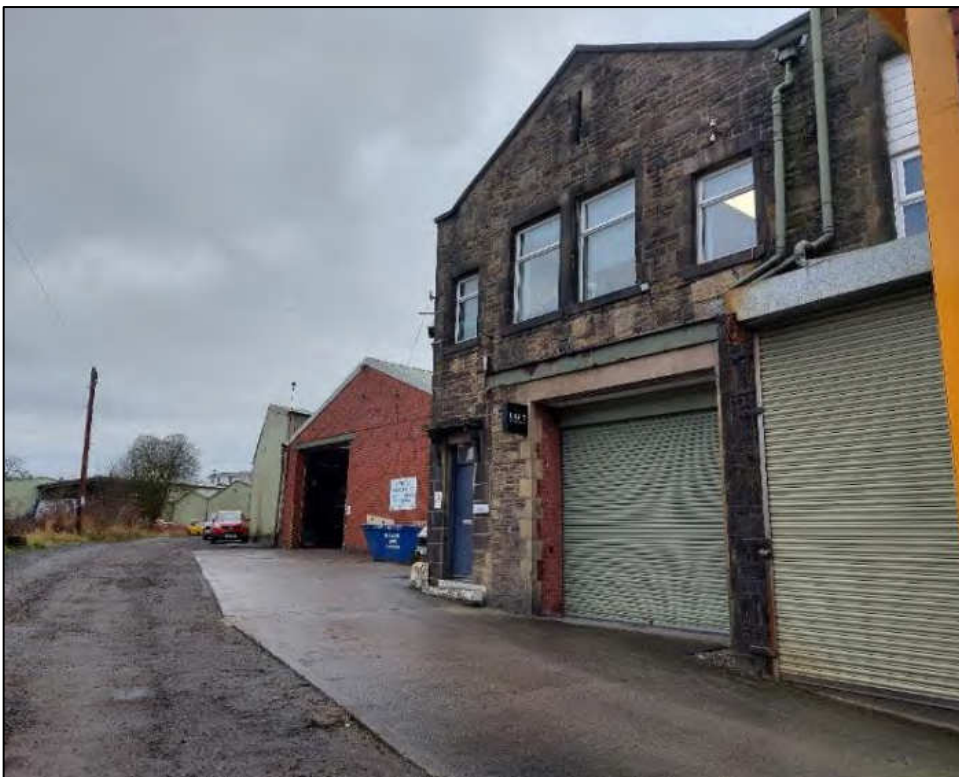
The mill, along with a dye house and mill ponds is shown on the Ordnance Survey first edition map of 1849. On the Ordnance Survey map for 1894 it is noted as being a cotton mill. The 1930 Ordnance Survey map shows it as having been enlarged (or replaced) and renamed 'Kippax Mill (Cotton Waste)'.

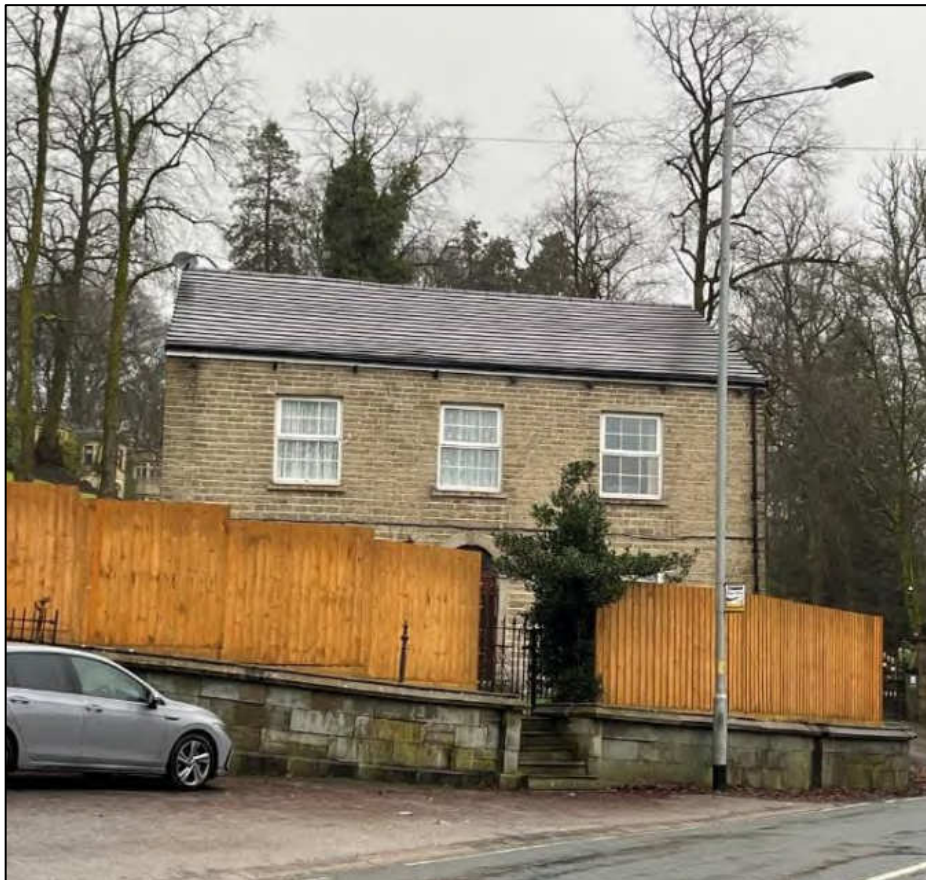
Image

Stone built house with symmetrical frontage and arched door dating from c.1830-1850. Former house of estate agent to Brooks family of Crawshaw Hall. Façade faces directly down Burnley Road and forms an important feature at entrance to Crawshawbooth village. The asset forms an important feature at entrance to Crawshawbooth village.

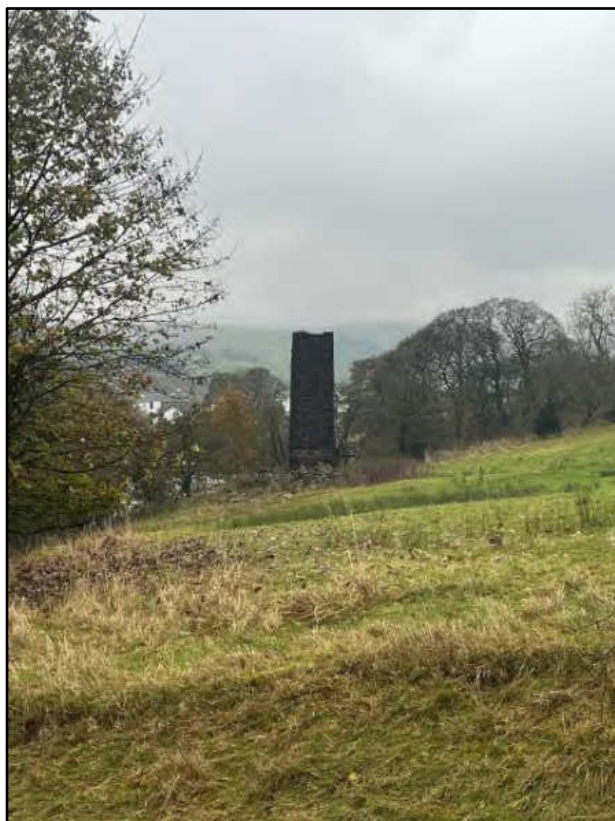
The detached chimney belongs to the 19th-century Kippax Mill. Built of stone, it is square in plan. The chimney and an adjoining stone building are all that is left of the original buildings. The mill has been used for different purposes since it was built in the early 19th century. It used to be known as Hargreaves Bleaching Mill and can be seen in the 1849 OS map together with a dye house and mill ponds. In the 1894 OS map it is noted as a cotton mill, and later in the 1930 OS map shows that it was renamed as Kippax Mill (Cotton Waste) and was enlarged.

The Goodshaw Fold Manufacturing Company (1908) Ltd. of Kippax Mill ran 11000 mule spindles and 380 looms in the 1920s (Heritage Gateway).

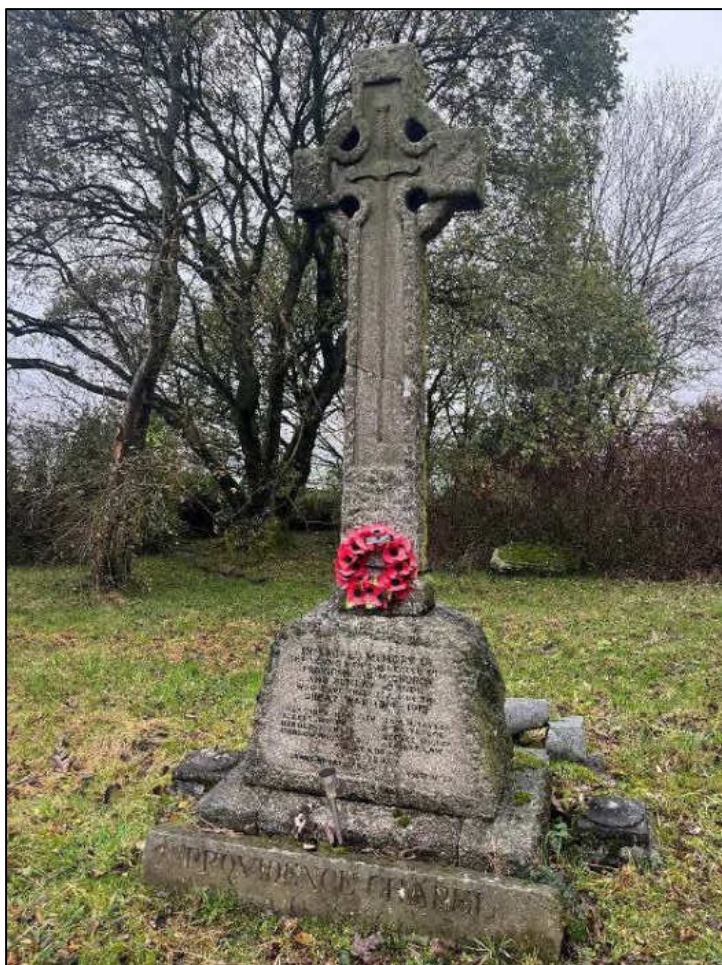
Asset Ref.	Asset Name	Address	Asset Type
NDHA_29	Loveclough War Memorial (Providence United Methodist Church War Memorial)	Burnley Road, Loveclough, Rossendale, BB4 8QZ	Landmark, art work or way finder

Celtic wheel cross, surmounting a plinth set on a single step base. A longsword, blade down, is engraved on the front of the cross. First World War (1914-1918), Second World War (1939-1945).

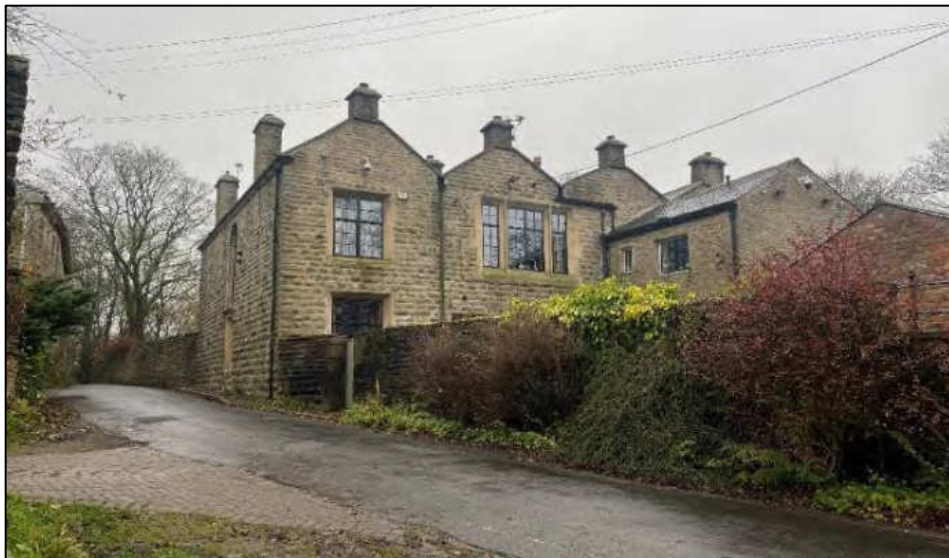
Image

Swinshaw Hall has existed since the late 16th century and is mainly associated with the Towneley family of Hurstwood / Burnley. The present house was rebuilt in 1847 by Richard Eastwood, who was a legal adviser and estate agent of Colonel Towneley, and lived at the Hall.

Original features such as stained glass and others remain. The Hall has extensive arched cellars which indicate two separate phases of building. (Heritage Appraisal by Graeme Ives Heritage Planning in "Swinshaw Hall (2020/0014) – Binder 1" & Burnley Civic Trust)

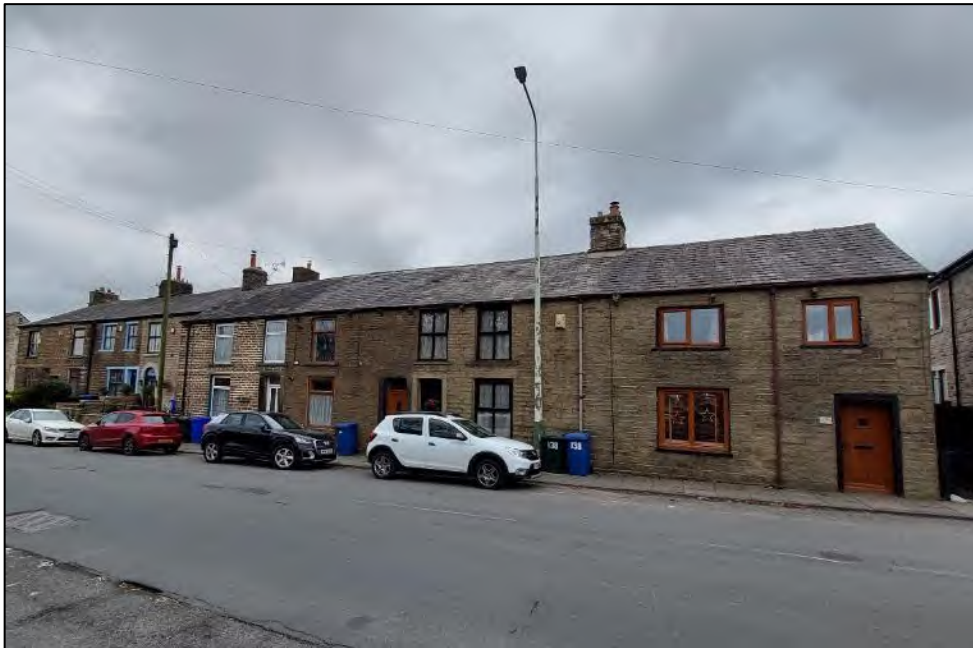
Nos.144-150 are set back behind small gardens. Again, they are constructed from coursed stone and have slate roofs. Nos.144 and 146 have a singular window at ground floor level and two at first floor level whilst nos.148 and 150 have a singular window at both ground and first floor level. Nos.146-150 have square door surrounds, though the door at no.148 is much shorter in height. No.144 has an arched door surround with a keystone, though this appears to have been added at a later date as it sits next to a blocked up, smaller door opening.
