Draft Rosendale Local List of Non-Designated Heritage Assets

December 2024

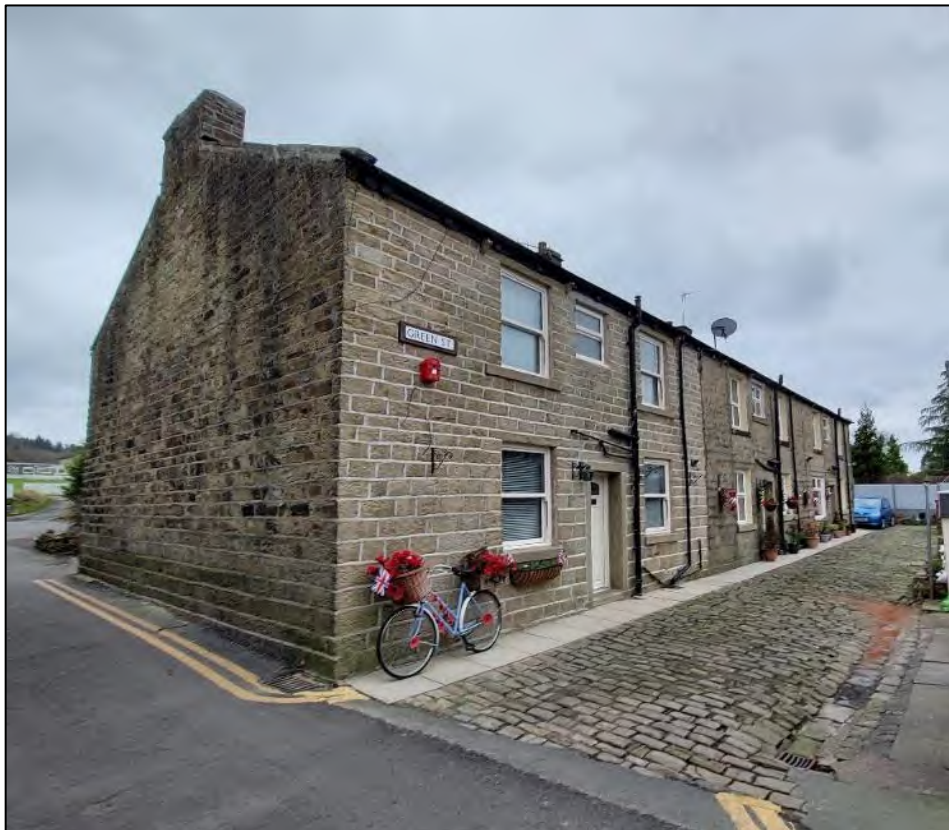
Well-built back-to-back cottages. They are constructed from coursed stone and are two-storey. The cottages on both Green Street and Sarah Street have front elevations of the same design. There are three cottages on both streets, on the ground floor they have a central door with a window either side. On the first floor, a smaller window is located directly above the door and two windows sit directly above the windows on the ground floor. The houses have stone door surrounds and stone headers and cills. Both streets are cobbled. None of the original joinery appears to survive. There have been some alterations to the houses on Sarah Street, no.2 has a window opening on the first floor made larger to accommodate a balcony and no.6 has a small gabled-fronted porch.

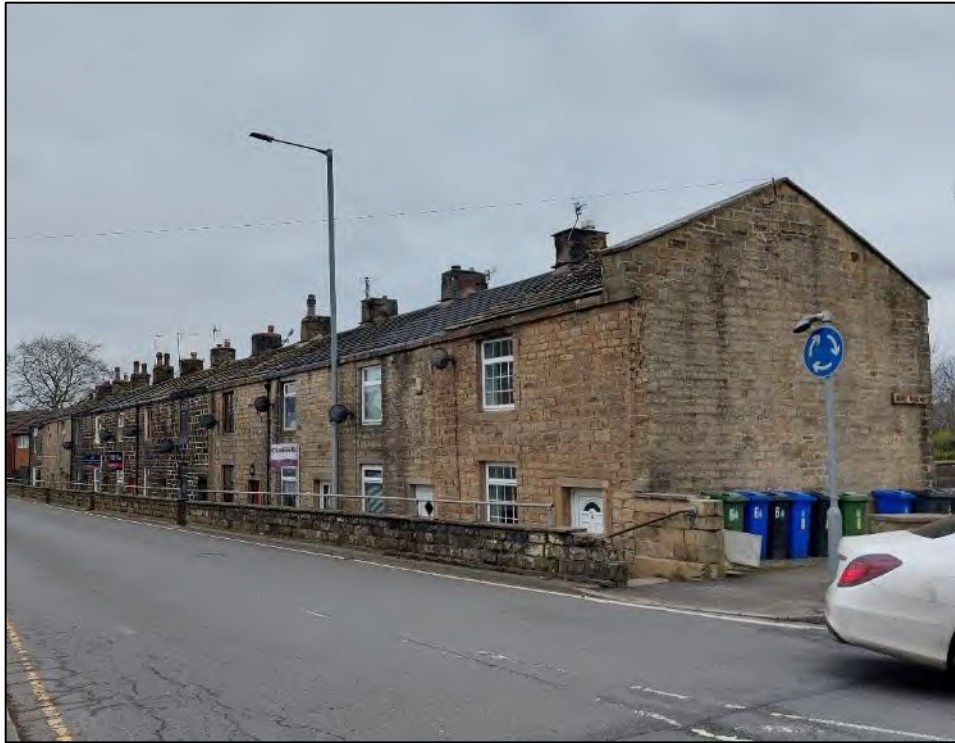
A row of two-storey terraced houses which are constructed from coursed stone, the stones however are of varying sizes on each row. The dwellings have stone chimney stacks on each dividing wall. Each dwelling has the same front elevation design, on the ground floor this includes a door situated to the right, and a window to the left, above the window on the first floor sits a second window. The windows have stone headers and cills and the door has a stone surround, the doors themselves are slightly recessed. None of the original joinery appears to survive.

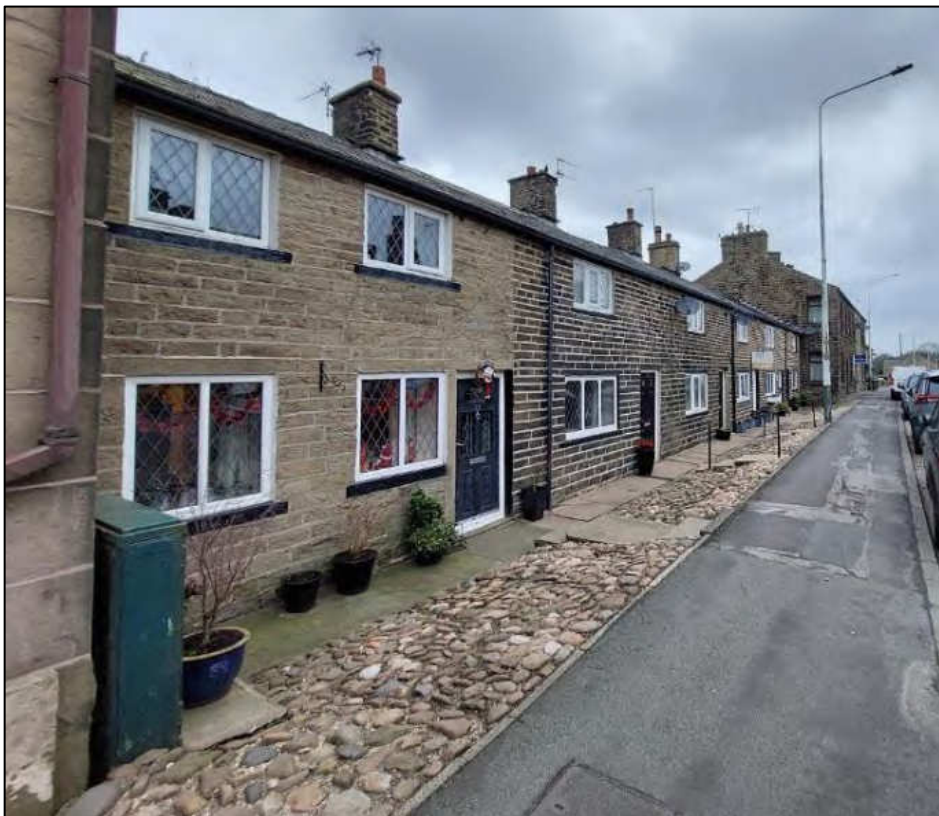
Asset Ref.	Asset Name	Address	Asset Type
NDHA_34	59 - 69 (odd) Market Street	Market Street, Edenfield	Building

This is a row of six terrace houses. The houses are two storey and are constructed from coursed stone with slate roofs. No.61-67 share the same design, on the ground floor, this consists of a door to the right of the façade and a three-light window to the left and a three-light window directly above on the first floor. No.69 has this same design, however the door sits to the left instead of the right. On No.59, the door is to the right of the façade, it has two windows at ground floor level and two windows directly above at first floor level. None of the original joinery appears to survive, though some of the cottages share an interesting mullion design which gives the windows a shouldered arch.

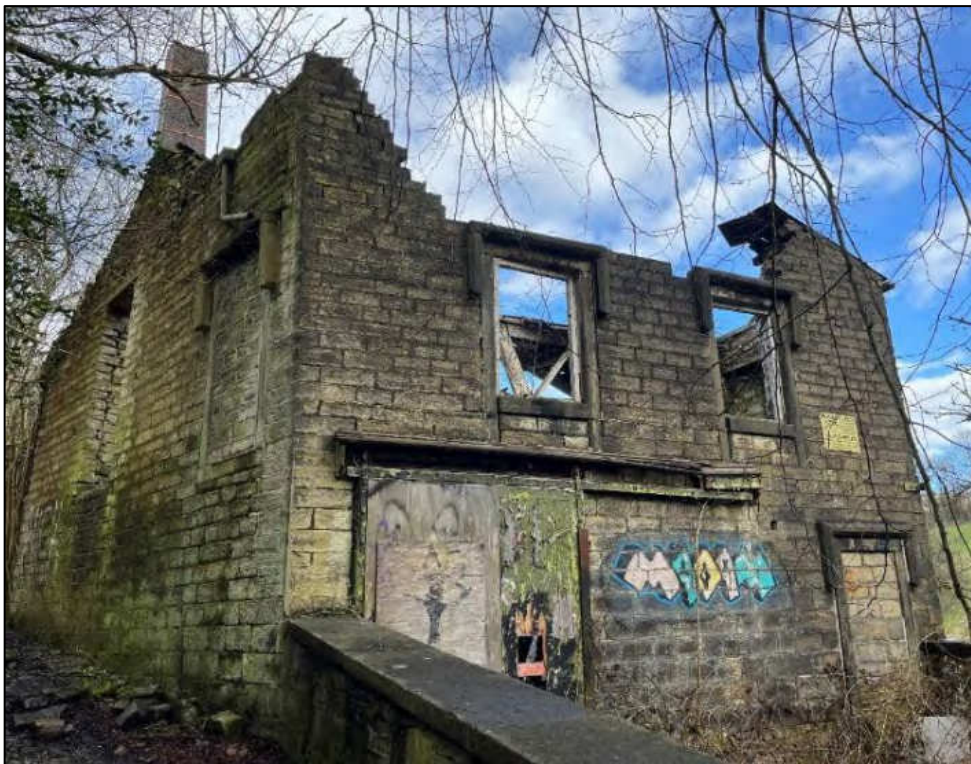
Eden Wood Mill is a one and two storey mill building constructed from coursed stone with a square chimney. It was built between c 1796-1806, and is shown on the Ordnance Survey first edition 1:10,560 map with a large millpond to the north and a gasometer to the south.

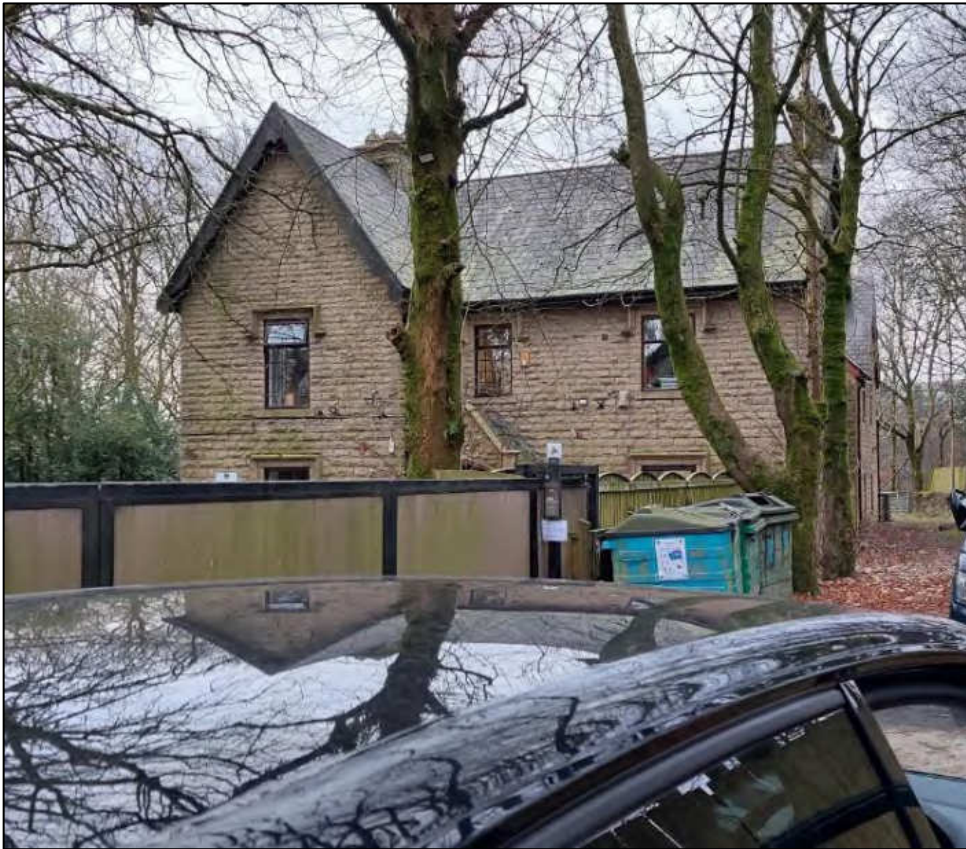
The former Vicarage is constructed from coursed stone with a slate roof and has chimneys at its ridge, it is partially gable fronted on its principal elevation. It has four windows on its front elevation with stone cills and carved hood moulds above. The Vicarage has a gabled porch with a pointed arched doorway. The building has been extended to the west, likely during its use as a nursing home in the 1980s.

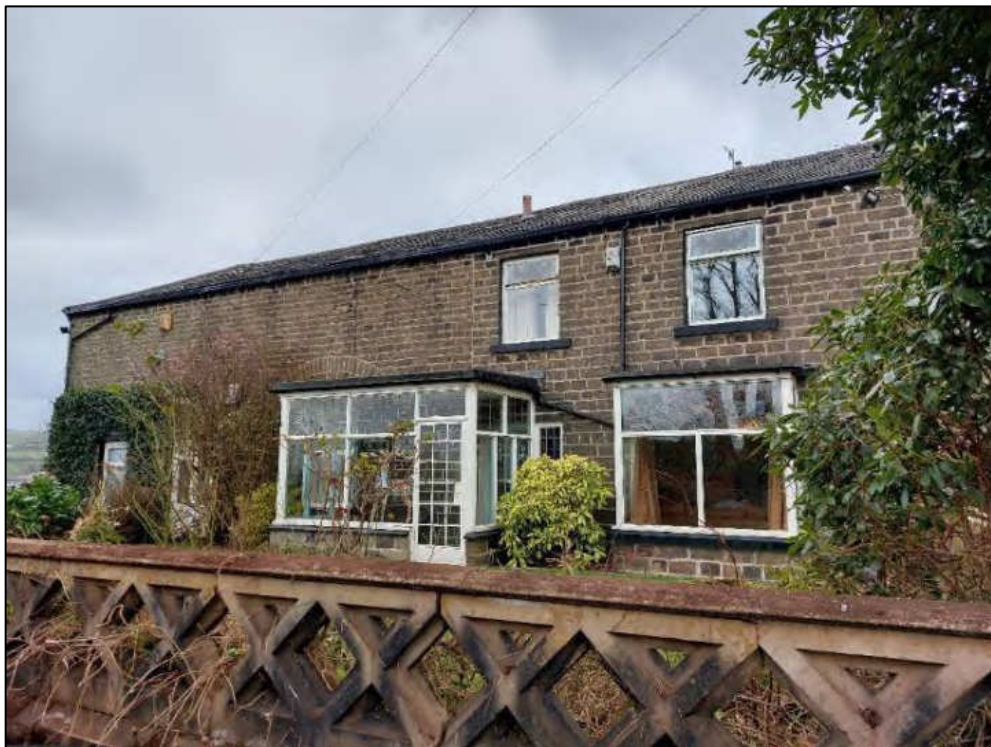
Asset Ref.	Asset Name	Address	Asset Type
NDHA_40	Mushroom House	Market Street, Edenfield, BL0 0JG	Building

Mushroom House is a two storey farmhouse with an attached barn, built c.1830. The farmhouse is located within a stone wall garden with timber fences and mature hedges and trees. It is constructed from coursed stone with a slate roof, a chimney stack is located on the gable end and a second chimney stack is located on the ridge. An arched barn entry doorway is located in the centre of the principal elevation, it has since been completely glazed and is now used as a one and a half storey window. The building features numerous window openings with stone headers and cills as well as a double height square bay window to the left side of the principal elevation. A glazed porch has also been introduced to this elevation and a second door with side lights has been introduced to the right of the principal elevation. The west gable features a single storey lean-to extension which does not appear to be part of the original farmhouse and barn.

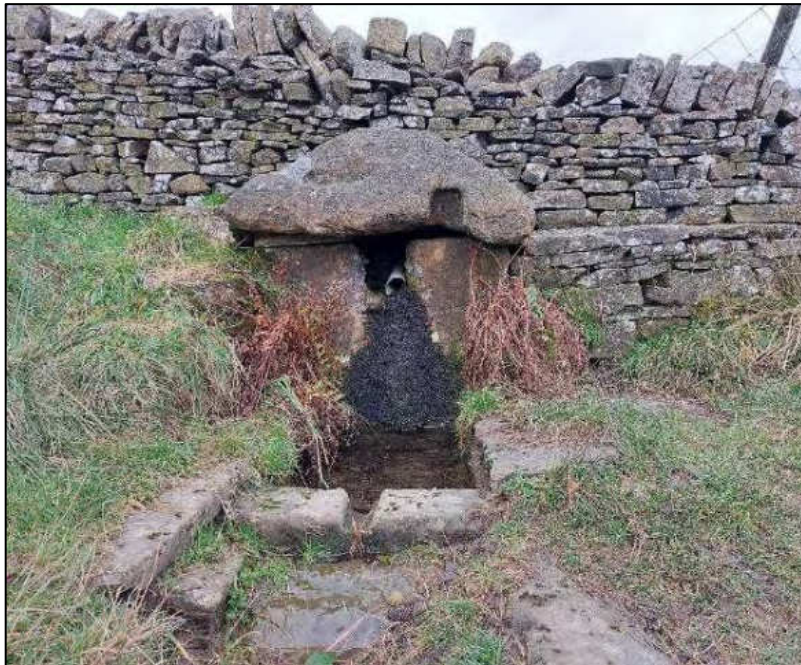
On the Helmshore side of Holcombe Moor stands Robin Hood's Well. It would have been a welcome place for pilgrims to rest and take a drink on their way to Whalley Abbey or Sawley Abbey. This medieval route is marked by the nearby Pilgrims Cross or at least the modern stone that rests in its original place. Later, after the abbeys were dissolved and the pilgrims no longer passed along this path, the well found new users. These would have been drovers and packhorse men on their route to Haslingden.

Water now comes out of a central plastic pipe, and a look over the drystone wall, that the well is built into, shows that a modern grid provides access to the spring. Most intriguing of all is the very large, old stone cap. This has many irregular cup shaped marks on it, as if parts of the stone has been scooped out. On the right hand side of the cap stone is a big void, as if this was carved to hold something. The rest of the well looks more modern, with a trough and a central carved opening allowing excess water to drain out down small steps and across the lane (Lancashire Past).

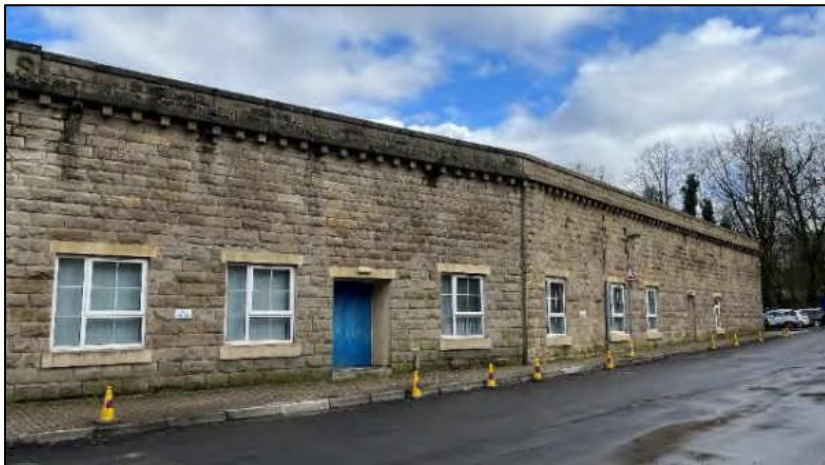
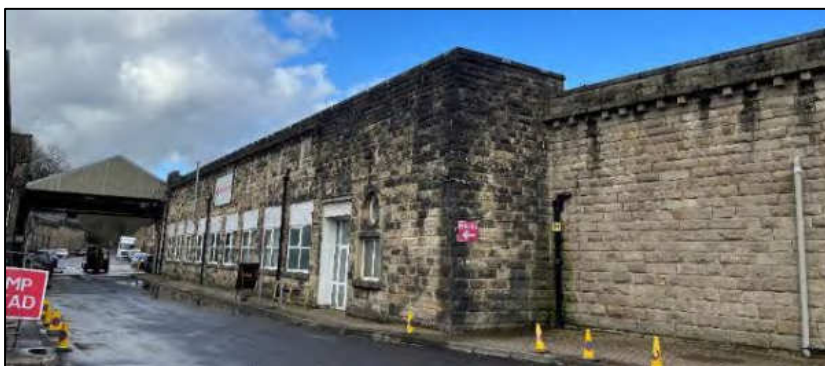
Images

Stubbins Vale Mill is not shown on the Ordnance Survey first edition 6" 1850, but is on the slightly later Ordnance Survey first edition 6" (Revised), and is annotated 'woollen'. A square reservoir is shown to its north. The original buildings appear to have been replaced with a larger complex of buildings by the time of the 1894 map (GAZETEER OF ALL MILLS - Lancashire Textile Mills (2010)).

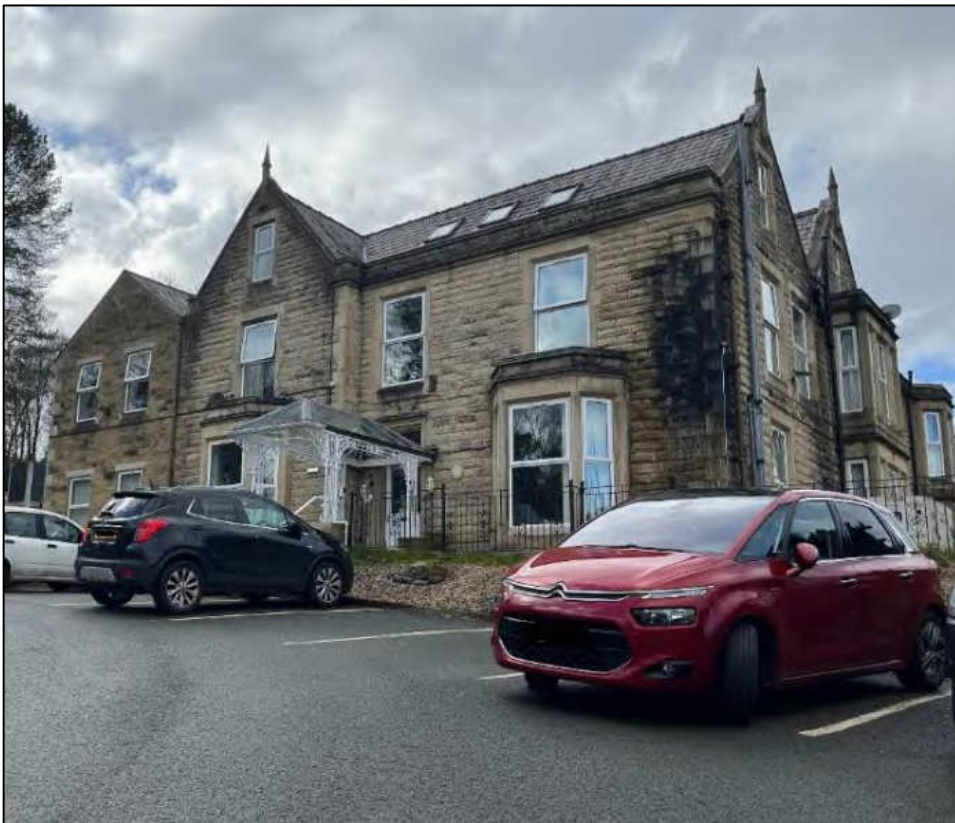
Image

The Cliffe is two storey and constructed from coursed stone, the front elevation is partially gabled and there appears to be an extension to the left of the property, this mimics the gable to the right which is part of the original building. The original part of the building has a central entry door which is accessed via a set of steps, either side sit two bay windows. The first floor has three windows and another window can be found in the gable. Both gables are decorated with spires. The extension to the left has two windows at ground floor level and two at first floor level. None of the original joinery appears to remain on the front elevation. The asset was built in the 1850s with considerable additions in 1892, it has been altered again more recently.

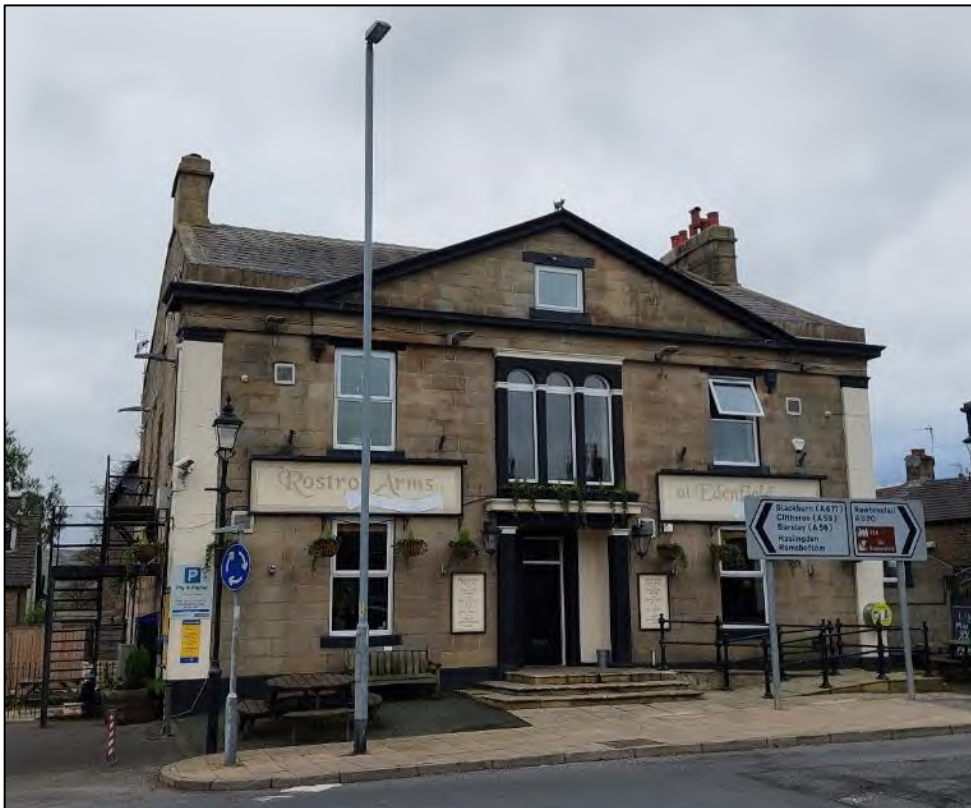
Image

The asset is constructed from coursed stone, is two storey and has a symmetrical façade. The front door sits centrally in a recessed entryway which is supported by simple pillars, it is accessed by steps. The entry door is flanked by a window each side. On the first floor, directly above the entry door, sits three slender arched mullioned windows. Two windows sit either side. The façade has a large pediment within which sits a window. The stone dressings have been painted black, with some details painted white. Large impostes are located on the corners of the façade, these have been painted white. The building has a slate roof and two gable end chimneys.

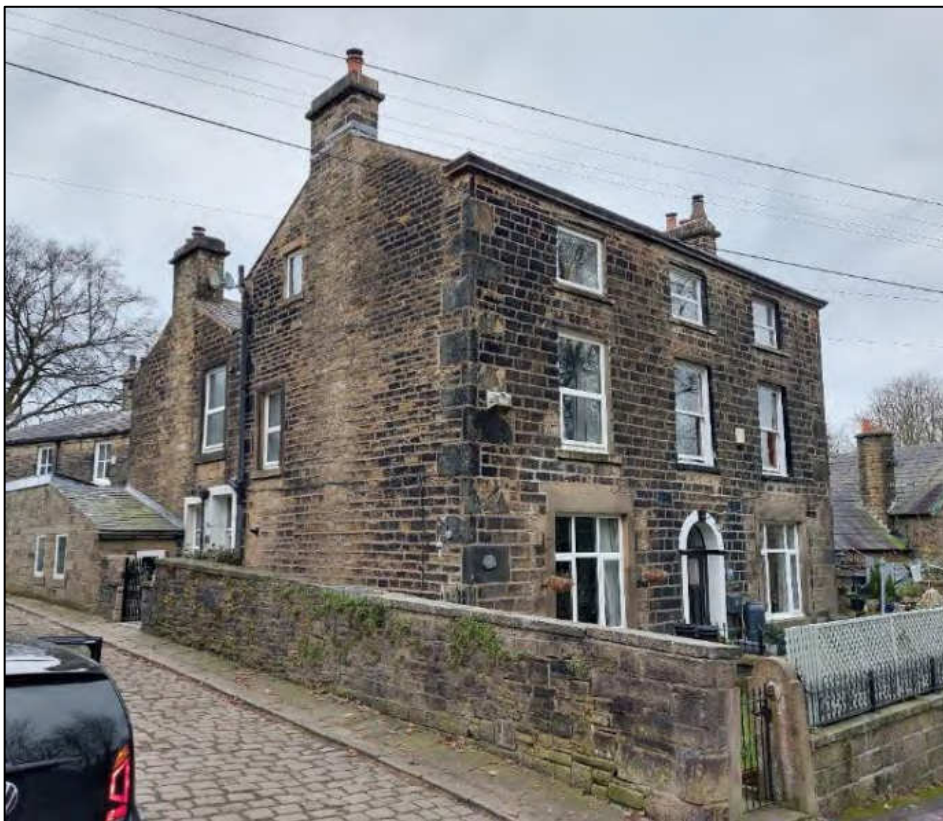
Image

Numbers 56 and 58 Stubbins Street date to the early C19 and is a single building that has historically been subdivided into two properties, although this is not readily legible externally. It is of three bays and three storeys, with the eastern two bays of the front elevation occupied internally by number 56 and the western bay by number 58. There is some degree of group value with nearby listed buildings, including numbers 52 and 54 Stubbins Street and numbers 60 and 62 Stubbins Street (Historic England).

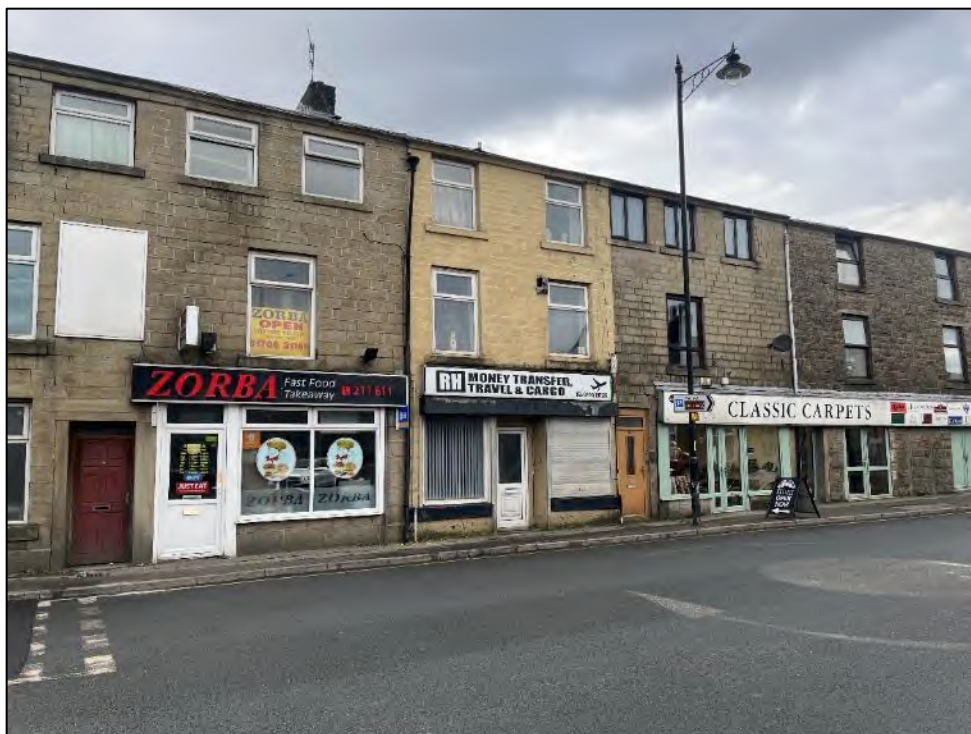
Image

Block of mid-19th century properties, all three storeys. The top floor of one building was used as a textile warehouse. The third storey of another was a loomshop. The outline of a taking-in door survives on the façade. This is one of the few remaining former loomshops in Haslingden. From looking at historic mapping and the façade it appears 34-36 are from pre-1844 and 38-44 were added before 1890. No 36 appears to have had back-to-back units by 1890. 34 has an original garden space at side and some beams protruding from the rear.

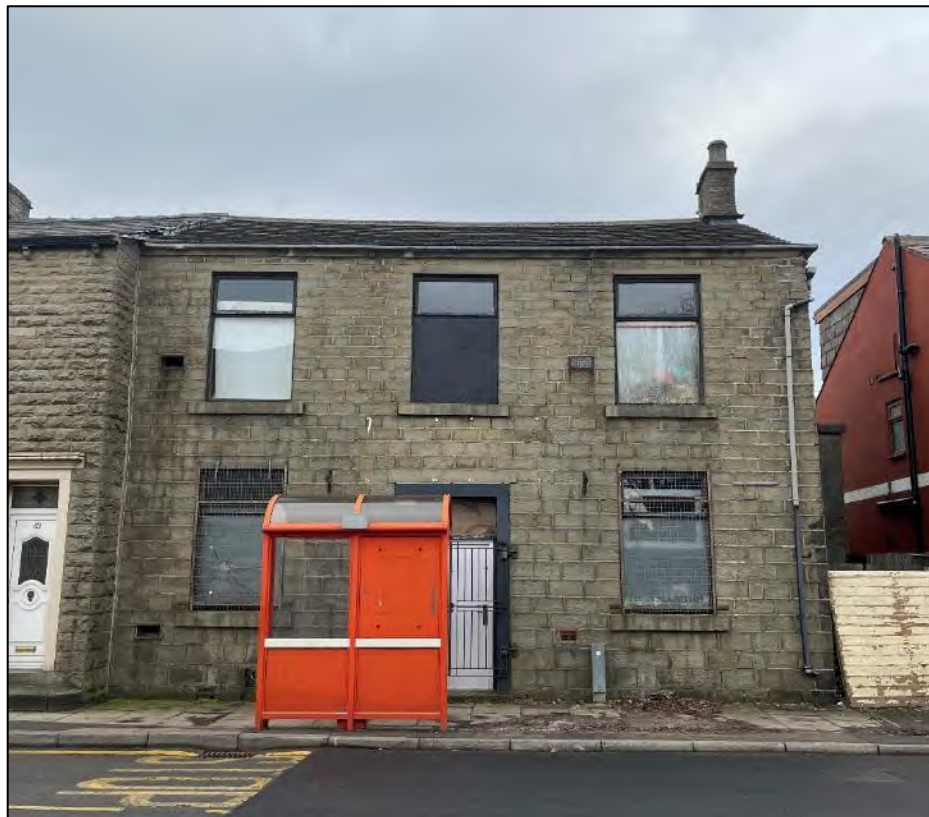
Image

A double fronted building, constructed from stone. Large arched windows (the height of both storeys) survive at the rear and some original features survive in the interior. Early OS maps suggest that it was originally a detached building, later becoming an end terrace property stepped back from the later row.

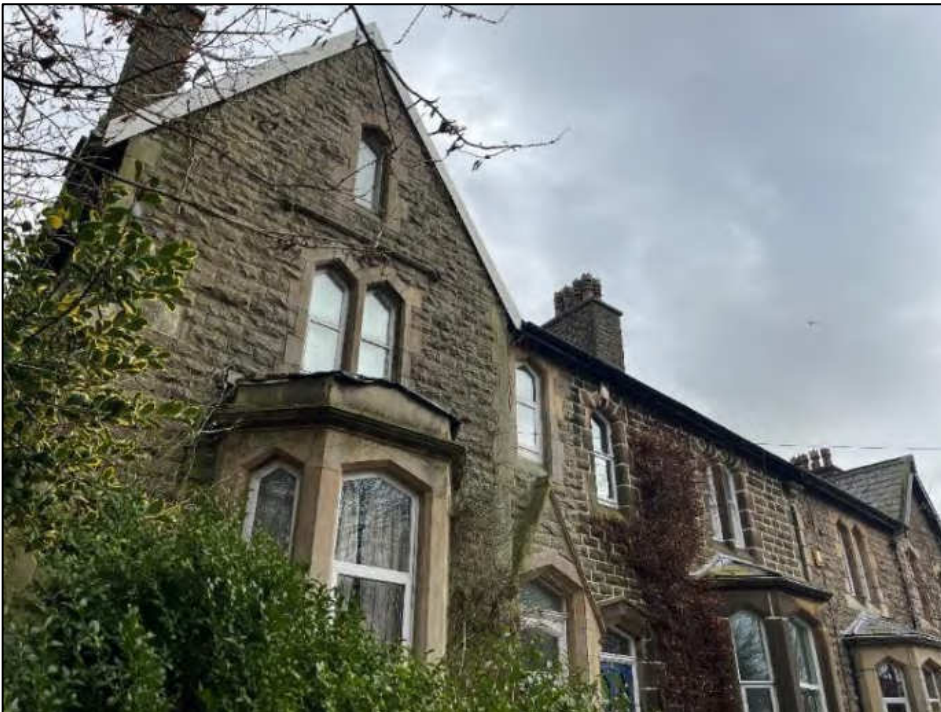
Image

Alexandra Terrace is a row of elegant mid-19th century terraced houses. The two end houses have gabled fronts, there is also a small gabled section between no.14 and no.16. The gable of no.20 has an ornate bargeboard. The terrace is built from stone with ashlar stone making up quoins to the edges of each dwelling, the door surrounds and windows. The ground floor of each dwelling has a bay window with pointed arched windows and stone mullions. On the first floor there are stone pointed arch windows set in pairs with a stone mullion or individually. The gables of no.10 and no.20 have a pointed arch window within the second floor. The front doors of nos.12-18 also have a pointed stone header above a pointed arch fanlight. Nos.10 and 20 have slightly different doorways, here they have steep pointed stone detailing, stepped forward slightly creating a gabled door surround. The roof is constructed from slate and chimneys are tall and sit in pairs along the terrace. The terrace is located on a sloping road and it sat behind a large stone retaining wall, accessed through a doorway with a pointed arch header. No.10 Alexandra Terrace is dated 1864.

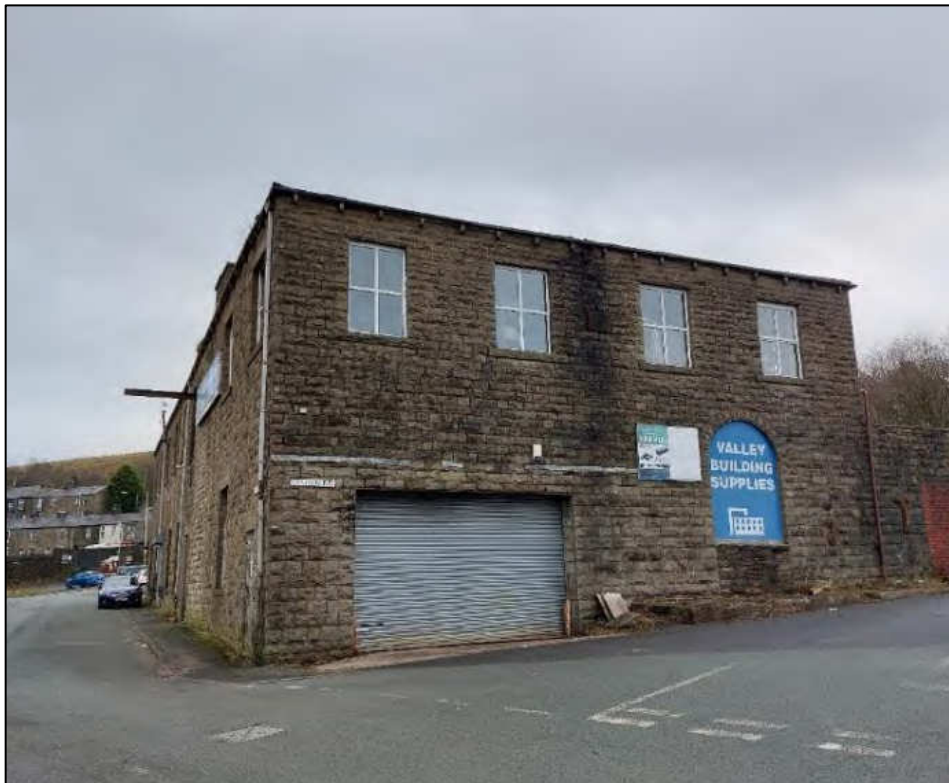
Image

Barnes or Holden Vale Mill was a spinning and weaving mill built in 1854-5. A two-storey preparation and warehousing range (c1882) stands in the north-west corner of the site. Its facade is constructed from par-point with stone brackets supporting the gutter. The rear wall, built with random stone, retains the outline of a northern light roof. An integral chimney base can be seen on the roof. The boiler house was sited below at ground floor level. The engine house, with a round-headed window to Station Road is situated behind the preparation department. A date stone in the wall reading 'Vale Mill, 1919' marks a restoration after a fire. Prior to this work there was a second, matching window over the boiler house. Both preparation and engine house buildings have slate, hipped roofs. The weaving shed has been demolished, although the perimeter walls, forming the yard, survive. The remains of the spinning mill are evident as blocked window openings along Station Road (Rothwell, 2009).

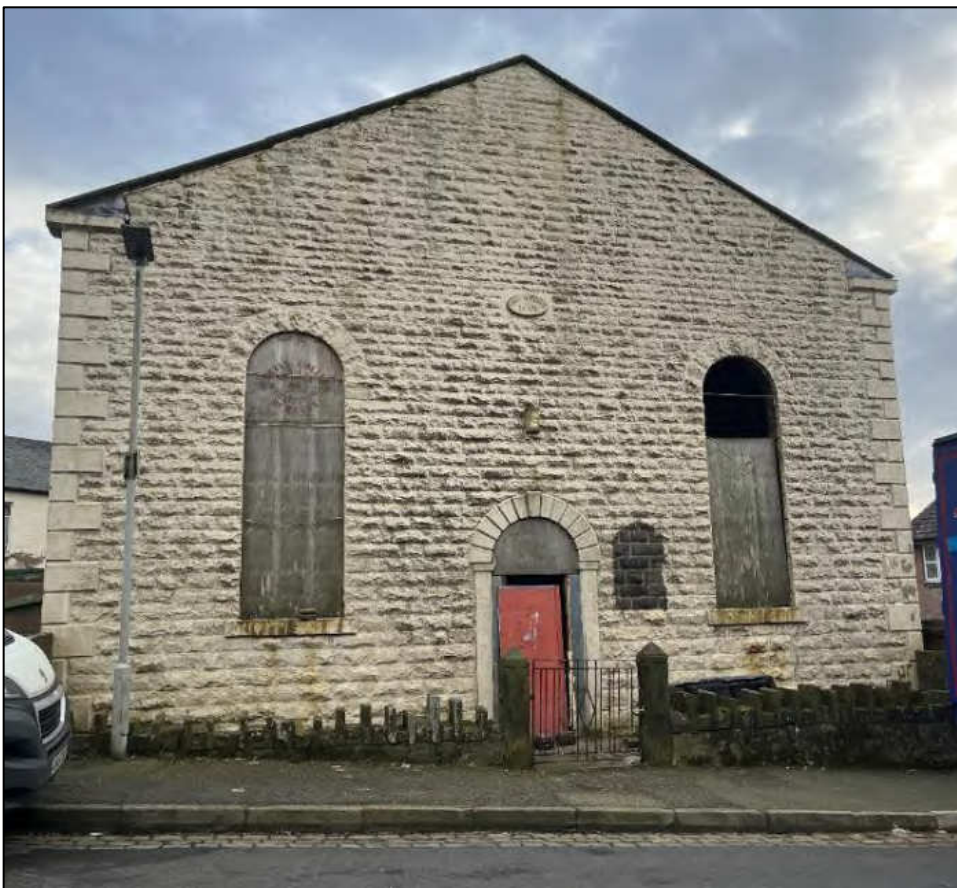
Image

An example of a plain mid-19th century Nonconformist chapel (built 1859). Constructed from stone with a gabled frontage, the building has been painted white. It has a central round-headed doorway and two large round-headed windows.

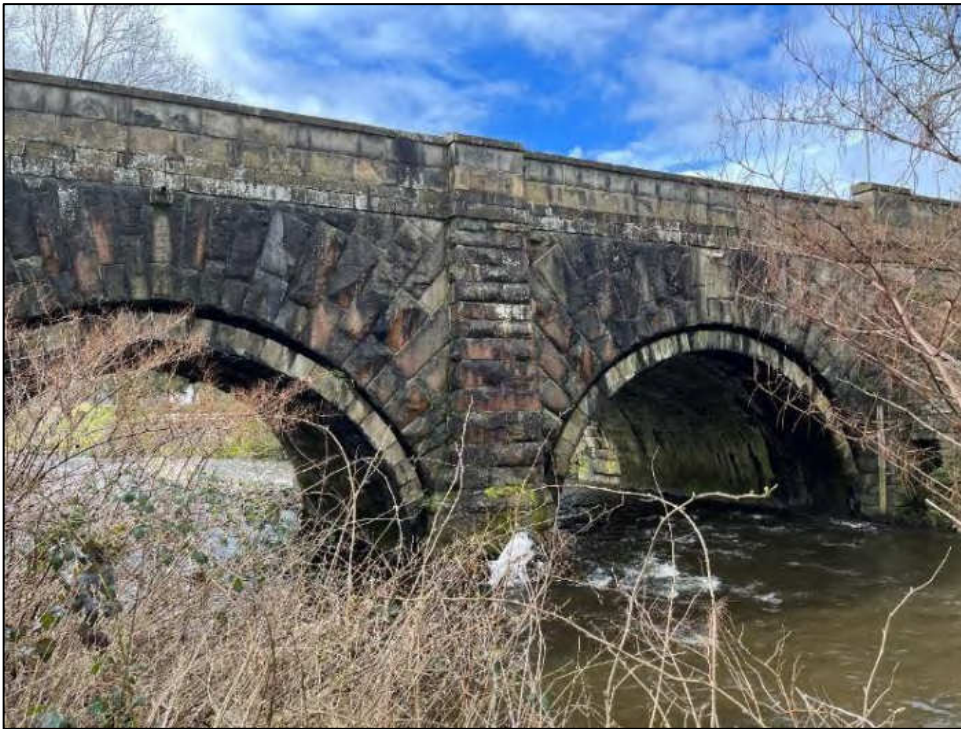
Image

Stone-built, two arched bridge at ancient bridging point over the Irwell. It consists of two bridges, one on top of the other. The lower one is said to have been built in about 1790 by John Metcalfe when he was constructing the turnpike road over it. It carries many interesting masons' marks.

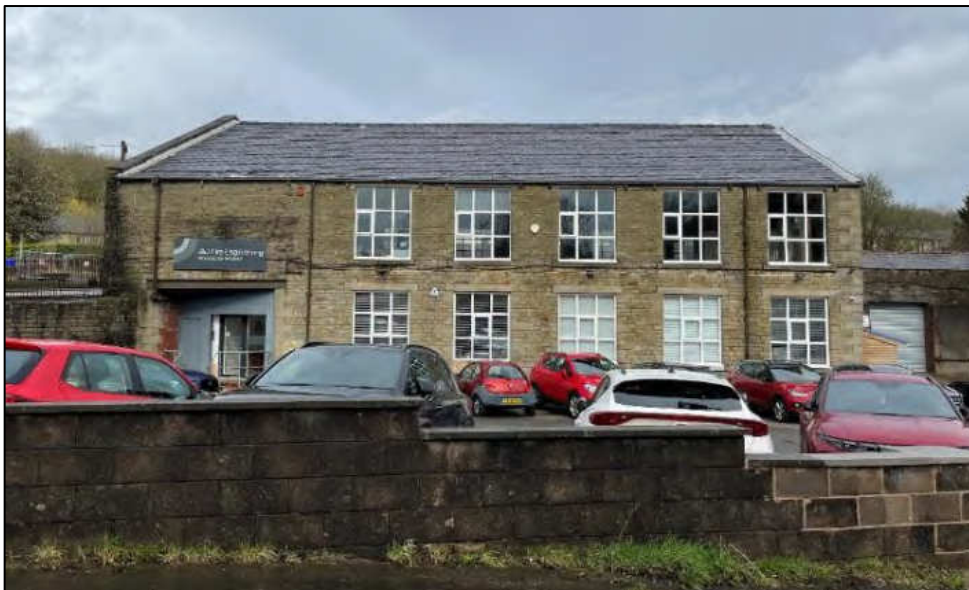
Image

Ewood Bridge Mill dates to the late eighteenth-century and is linked to three short rows of terraced housing in the village of Irwell Vale for mill workers (The Textile Mills of Lancashire: The Legacy by A Phelps, R Gregory, I Miller & C Wild). The mill closed in 1959 and it has subsequently been occupied by non-textile companies. A car park now occupies the area of some of the former buildings of the mill, including the spinning mill. Stone retaining walls can be seen along the bank of the river Irwell. To the north are the 1905-07 extensions made by Anderton and Halstead. A rectangular 10 bay weaving shed with latrines is located to the north-east. This is separated from a smaller 10 bay shed by an internal gearing alley. This was formerly a warehouse and tape room. Both of these buildings are constructed in engineering brick. The 1906-07 engine house adjoins the southern perimeter wall of the weaving shed and warehouse, this is also possibly of brick, but is rendered. In the south-west area of the site, adjacent to the warehouse, is a two storey block with a cellar, built in dressed stone and brick. It has a loading door on the south wall, facing the yard. In front of this is an area of stone setts, which was once covered with a canopy. On Manchester Road the gable end is three windows wide. This building was possibly a warehouse and preparation department, with yarn conditioning in the cellar. The reservoir has been filled in, but the earthworks of a long goit can be followed along the north side of the river and there is a wide stone built weir (Rothwell, 2009).

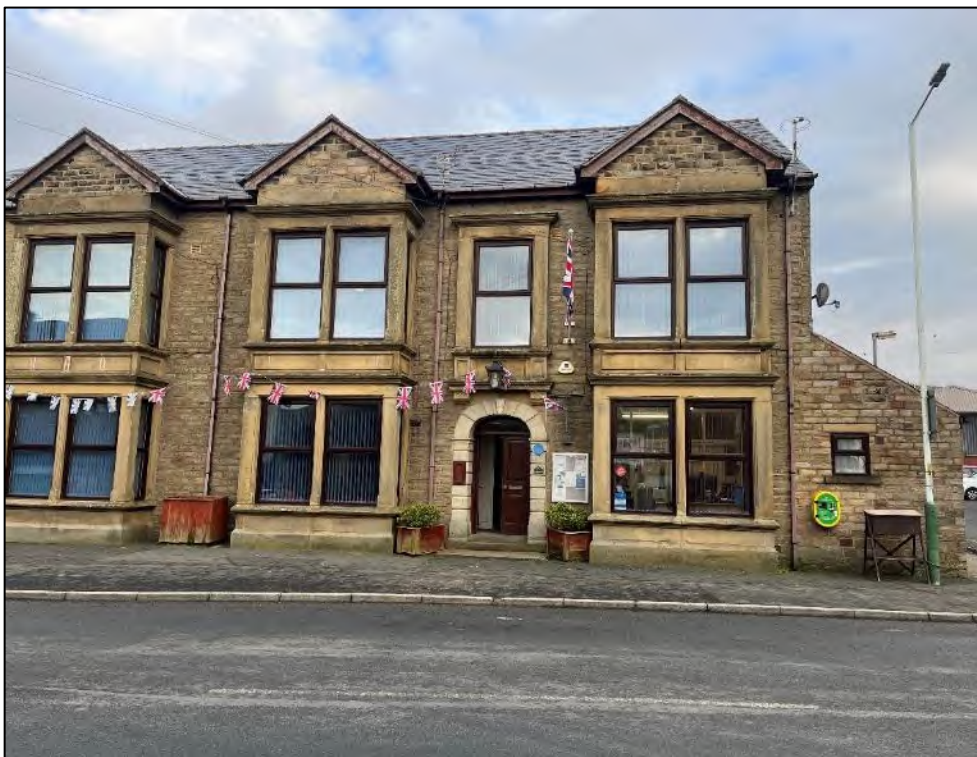
Image

Public house formerly known as the New Inn built c.1790. Two-storeys, constructed from stone, now altered, although the original doorway survives. The New Inn is an 18th century building with 19th century frontage. Has been extensively altered, with the façade of the New Inn being reconfigured, which is when the first-floor bays and associated gables were constructed. Later renamed the Thorn Inn and nicknamed "The Broken Jaw".

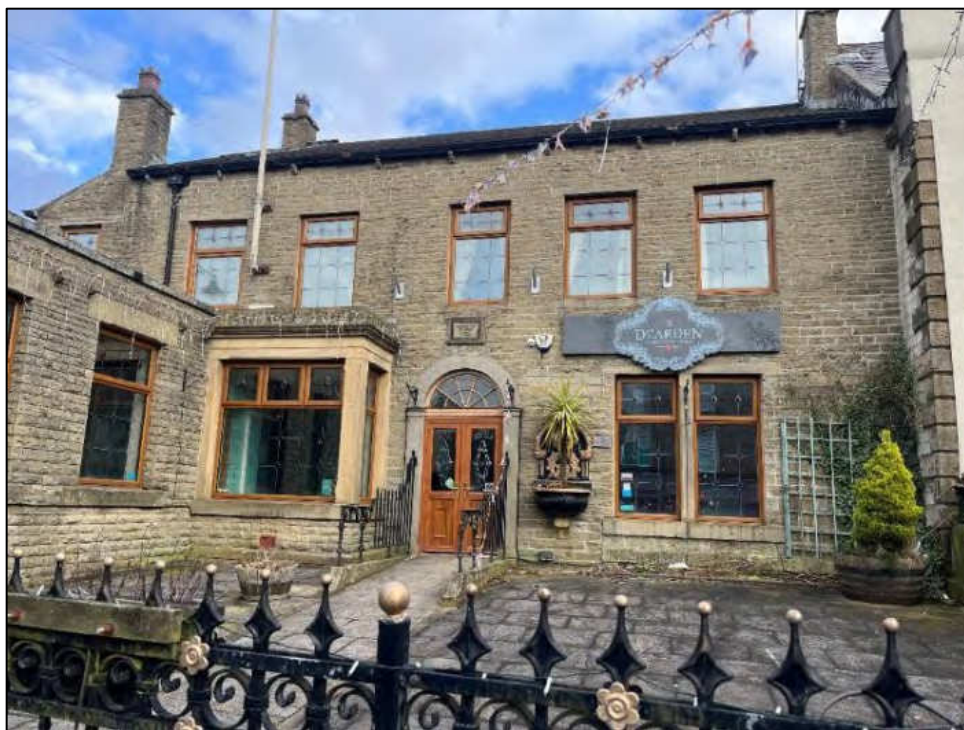
Image

Former warehouse and stable possibly in the mid-18th century (according to the date stone). Converted to a house and plumbers and glaziers shop in the 1840s or 1850s. A stone built double fronted property, with later alterations including front annex and front canted bay window. Recent alterations have introduced more modern window frames but the openings remain unaltered, with the exceptions of the loss of a former front door, which may in itself have been a later addition as part of its conversion to a house and plumbers and glaziers shop.

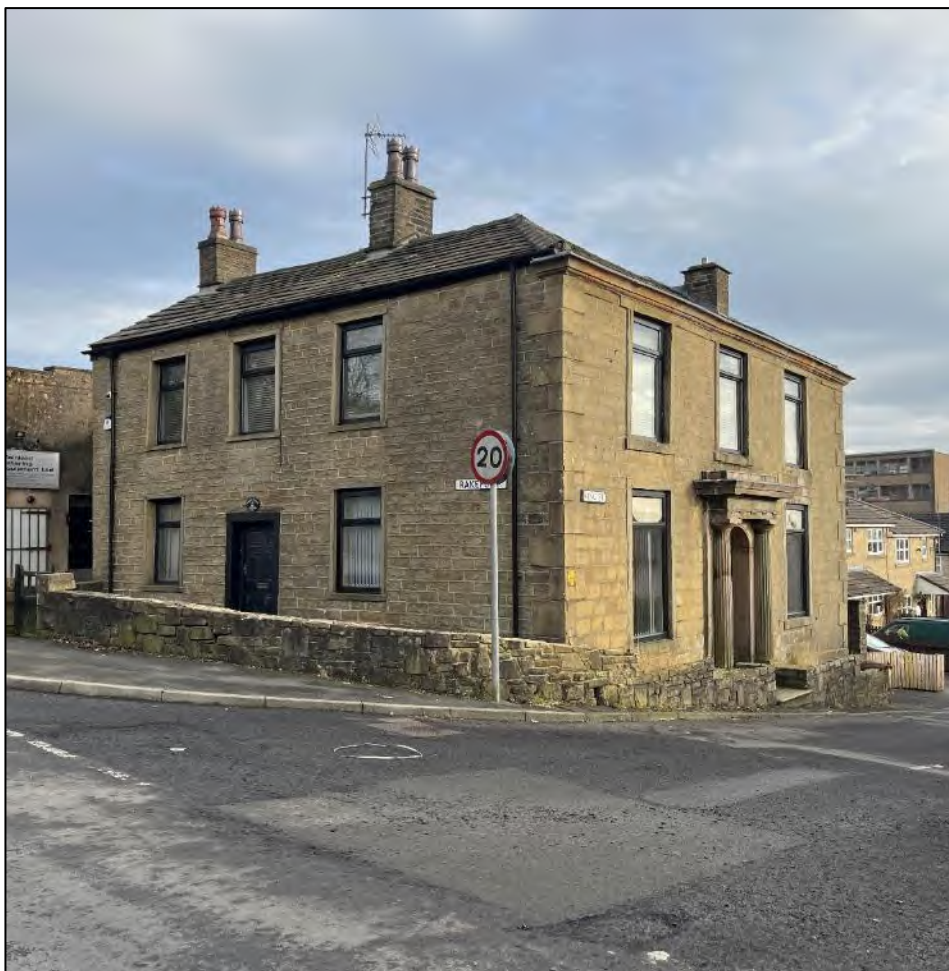
Image

Substantial stone house with attractive front possibly built by a merchant or mill owner in the early 19th century. The front door is flanked by a pair of fluted columns with a pediment over. Part of the old centre of Haslingden before the centre moved south to the Turnpike Roads.

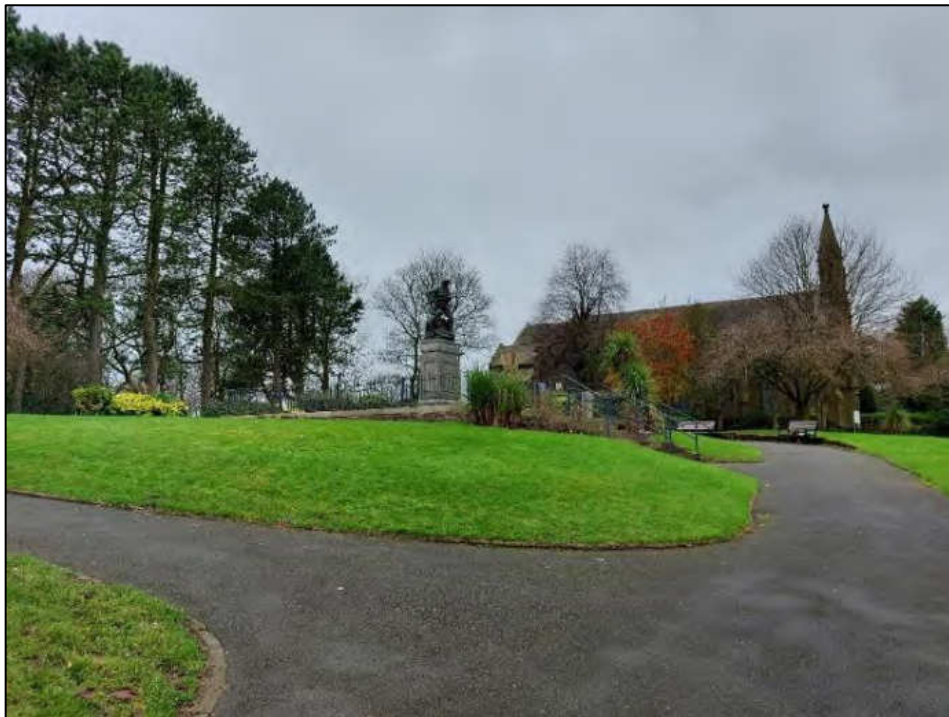
Image

Set slightly above and separated by a low retaining wall from Manchester Road and a row of terraced houses, the memorial stands on a flagged area enclosed by low railings, approached by a flight of eight steps. Gates in the railings, one to the front and one to the rear give access to the flagged area.

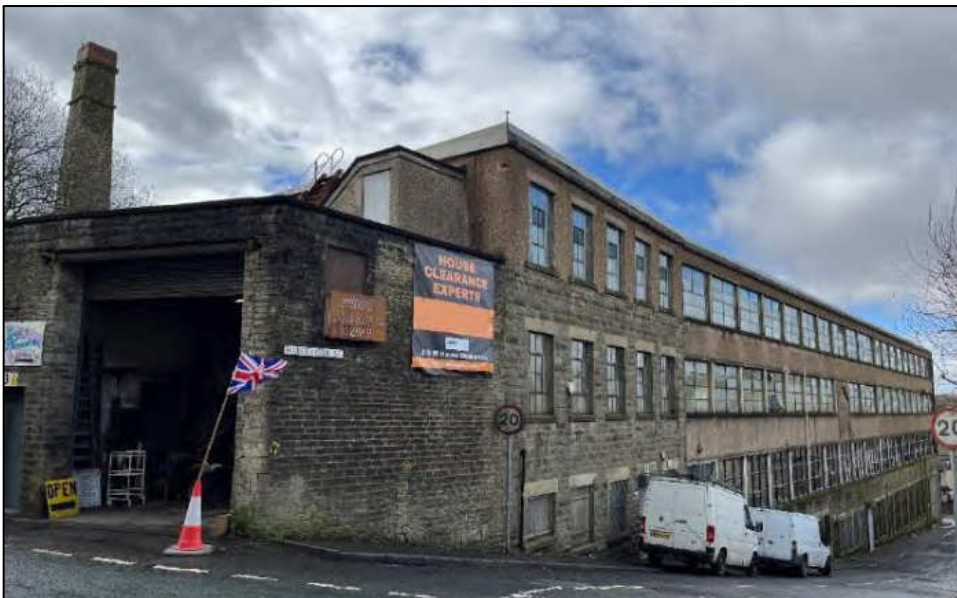
Image

On Hargreaves Street is a three-storey making up department, which also has a basement. The building has a flat steel-framed roof, and is constructed with Accrington brick with dressed stone at street level. The north wall has ranges of metal-framed windows. There is a wider bay at the eastern end, which includes a brick lift tower and garage. Two weaving sheds extend from the south wall to Chapel Street. The older on the west is built with random stone and retains eight original bays. The larger, ten bay shed, dating from the mid-1870s is to the east side, and has a par-point frontage. A square, stone chimney, heightened in brick, projects from the shed's eastern side. Engine and boiler houses face Chapel Street; the latter has two round-headed firing doors, with a room above and a northern light roof extends over this. The engine house has a round-headed window in its facade, and is topped with a cast iron water tank inscribed 'Hargreaves Street Manufacturing Company Ltd 1875'. Large stone blocks built into the front supported a second motion drive to the top shed. Below is a double bay, steel framed extension, with rendered walls on a stone plinth, which occupies the site of the mill pond. A detached weaving shed with an undercroft is located on the opposite side of Hargreaves Street. It has a fire-proof ceiling with brick vaults. Above this, the nine bay northern light roof is supported by two rows of cast iron columns, each with a bolting face. A drive shaft from the main mill possibly powered the shed's looms (Rothwell, 2009)

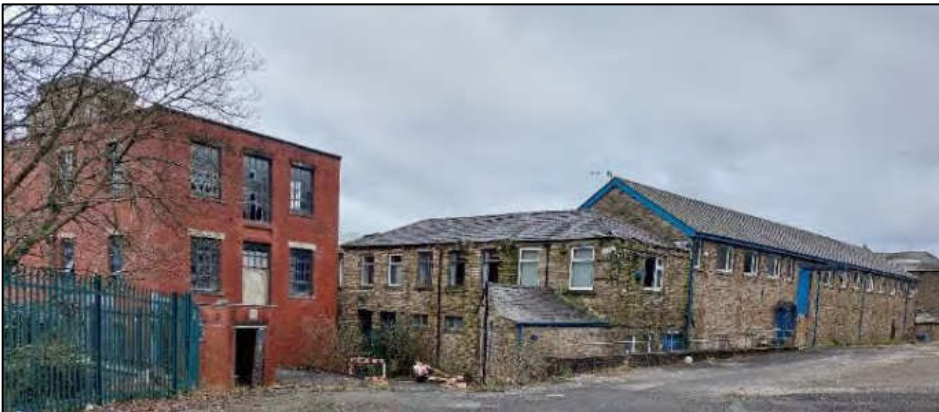
Image

Further additions including a single storey drawing in room and a two bay warehouse, stone clad, with a hipped slate roof, can be seen at the far end of the mill. Swinnel Brook was culverted during the mid-twentieth century and large extensions were erected along the eastern perimeter of the older mill. The major building is a steel framed weaving shed with a ten bay, northern light roof. A beam store ran along the western side, roughly over the course of the stream. Single storey sheds at the northern end comprise loading bays, warehousing and a three bay shed, formerly a card room (Rothwell, 2009).

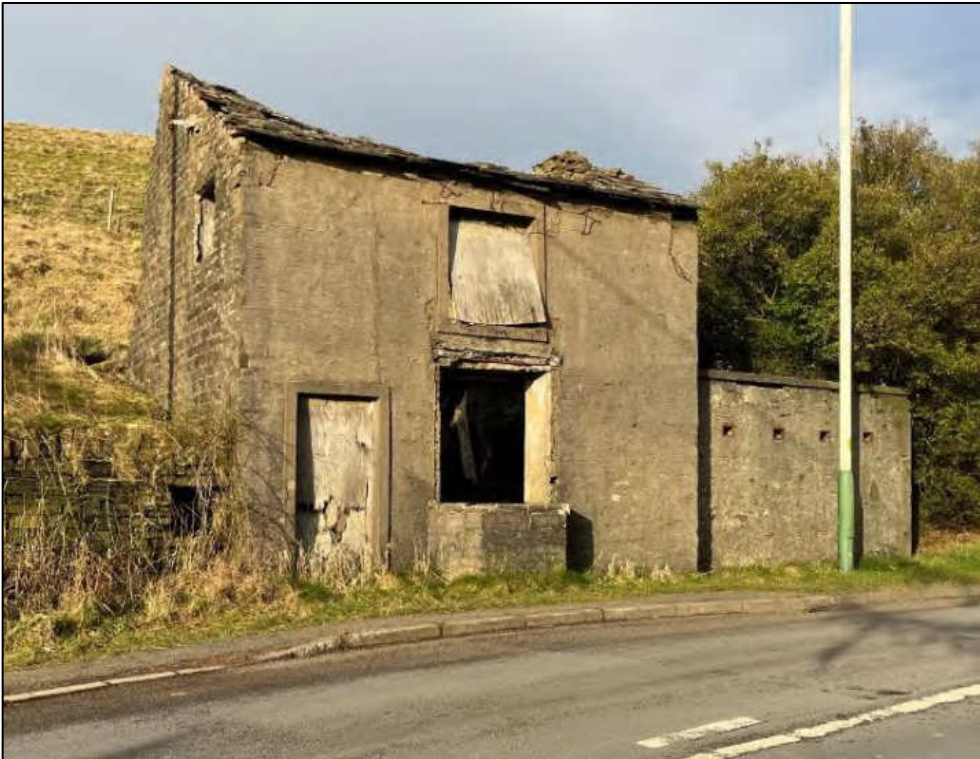
Image

Last surviving toll house in the Haslingden district. Small two-storey building, constructed from stone, with a rendered façade. Unaltered apart from the removal of the upper part of the projecting bay at the front. Built under the terms of the 1789 act for turnpiking the road from Haslingden to Todmorden.
