Draft Rosendale Local List of Non-Designated Heritage Assets

December 2024

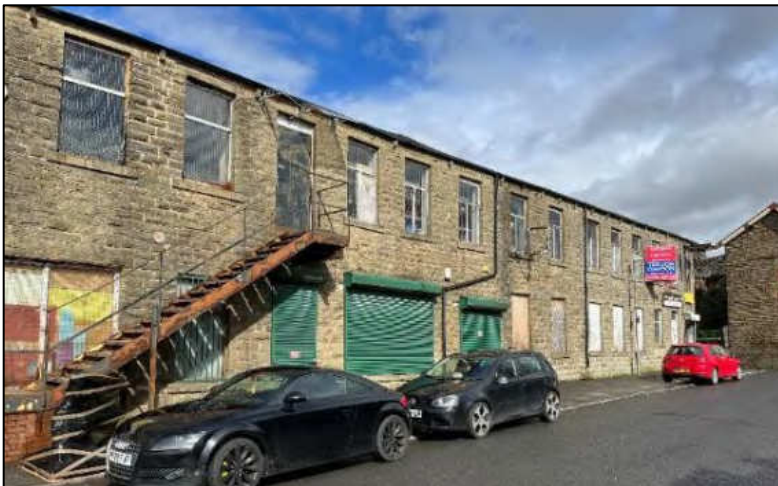
Image

In 1880, the works were driven by a high-pressure horizontal engine, which was replaced in 1898 when extensions were made. These extensions comprised a three-bay structure abutting the southern end of the earlier building range, constructed of locally produced machine-made brick. In this part of the mill, an adjacent brick-built, single-storey boiler house is also present, with a decorative cast-iron water tank on its roof. Associated with this was a tapering cylindrical brick-built chimney stack, now reduced to roof height, set on a square-section, stone-built base. (Textile Mills of Lancashire: The Legacy)

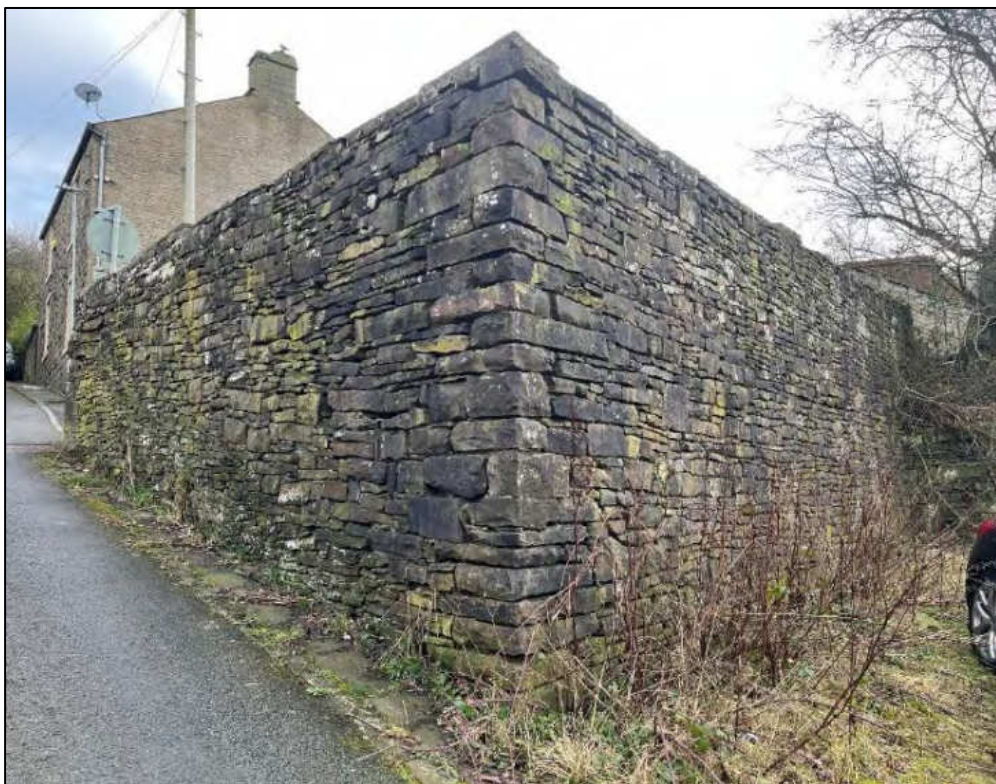
Image

A five-sided, stone-walled enclosure with doorway on east side; clearly identified on the 1849 OS Towns Map as 'Pound'. Stray animals were formerly driven into this enclosure and released only on the payment of a fine. This is a rare, if not unique, survival of a pound in an urban setting in Rossendale.

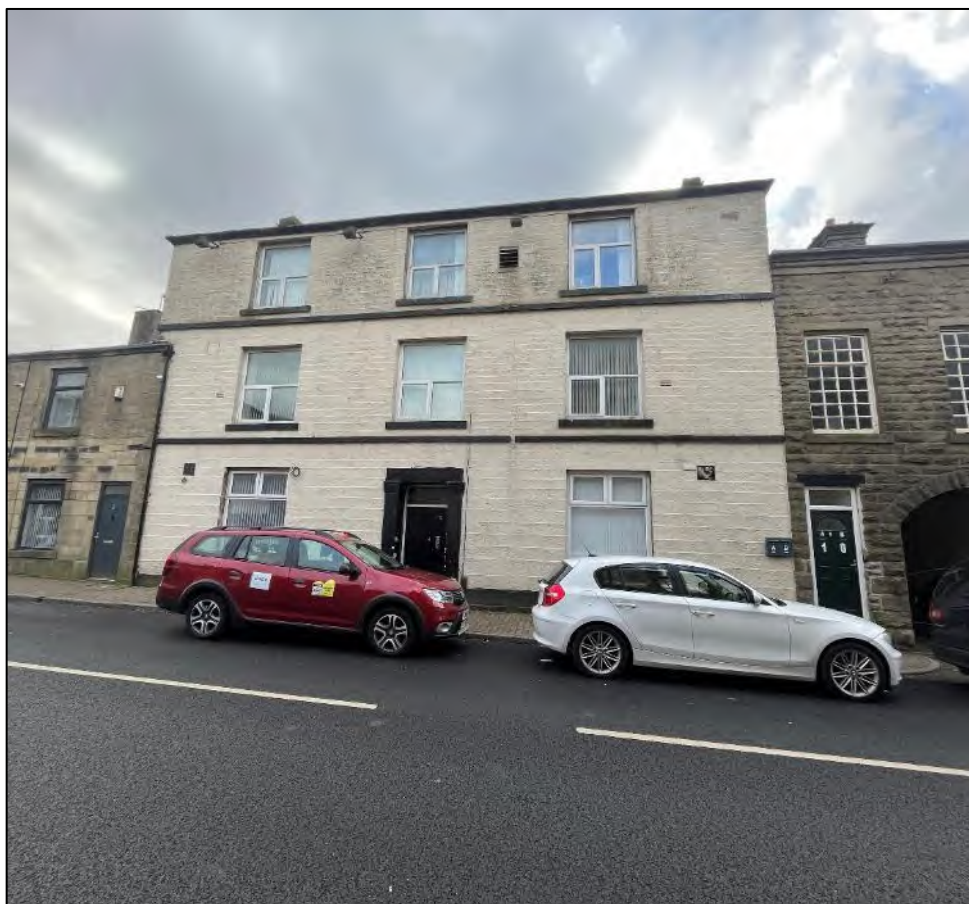
Image

Early 19th century public house, formerly known as the 'Grey Mare'. Watershot walls with a stone band at first floor level. Sash windows. One of the remaining early buildings from the old part of town. The Grey Mare had associations with the Free Masons (The Lodge of Amity and Rossendale Forest No.283). From 29th December 1887 until 1921 the Lodge met at the "Grey Mare Hotel", Regent Street, Haslingden.

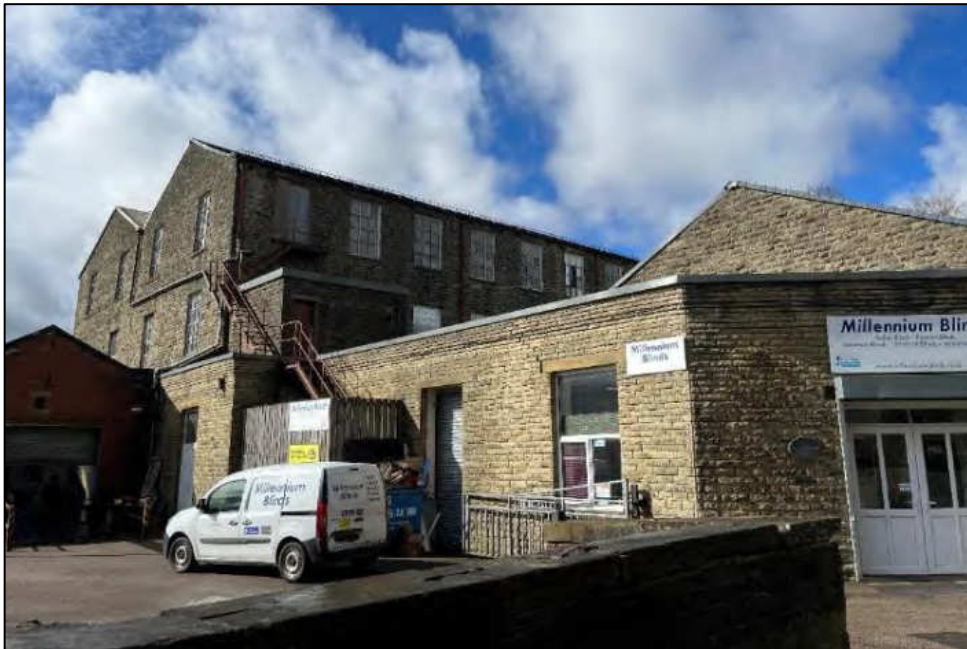
Image

The three-storey spinning mill is at the northern side of the site, and has a two bay gabled roof. Upper floors are lit by four windows in the gable ends and 11 on the return walls. An integral boiler house is at ground level at the west end, and seems to have originally had three round headed doors, or loading slots, though one has been widened. The central arch has a datestone reading 'Spring Vale Mill, 1847'. A stone staircase is adjacent to the boiler house along with the engine room. Above the engine room is a sprinkler tower, with a cast iron water tank on the north gable roof. This appears to have been added in c 1900. On 11 bay weaving shed, with a complete northern light roof extends from the south wall of the mill. An additional roof against the wall covered the second motion shaft. There are blocked ground floor windows in the spinning department, which indicate that the shed was a later extension. There is a brick built addition adjacent to Swinell Brook, with its roof aligned to that of the earlier shed. To the north is a single storey block with a flat roof which was used as a canteen and warehouse in the 1950s. Adjoining this is a much larger warehouse, which possibly dates from the 1960s, this structure covers an old weft cellar. Most of the mill is constructed from parpoint and random masonry, with slate roofs. Yorkshire points are used for the canteen and warehouse (Rothwell, 2009).

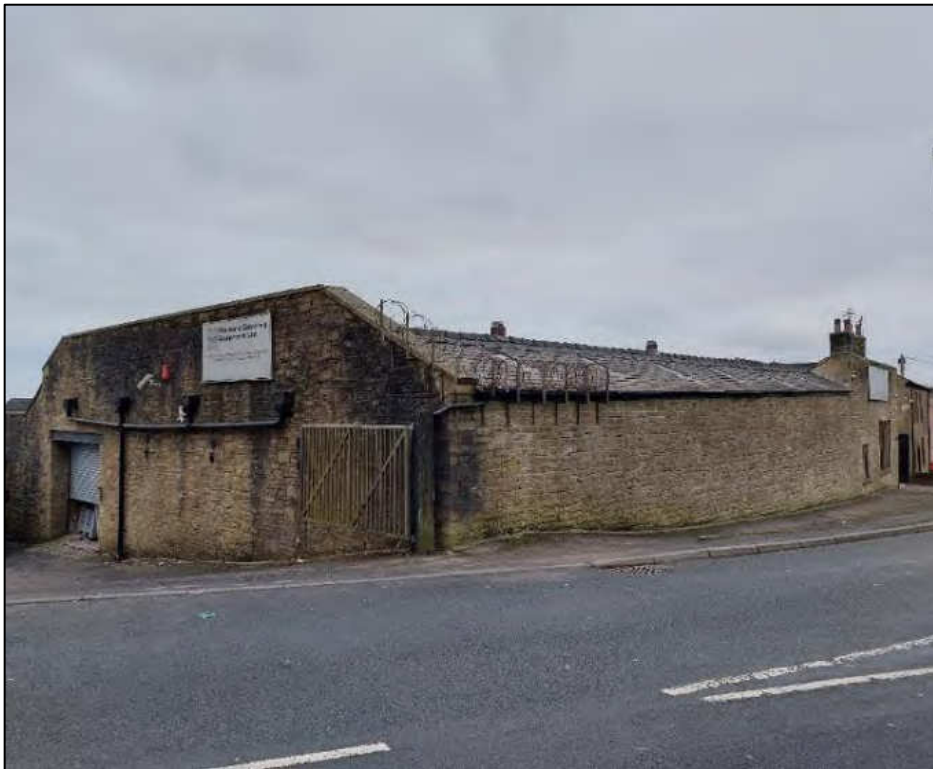
Image

The original weaving shed is on the south side of the site, at a lower level to the later extensions. Four bays are intact. Internally, cast iron columns, with recessed bolting faces, and the flagstone floor remain. Only the outer walls of the rear part survive. The additions made by Haworth and the Scapa Manufacturing Company face Rakefoot, and principally consist of a four bay weaving shed fronted by later offices. The northern light roof is supported by cast iron columns and steel girders. Ventilators are placed at intervals along the roof. Fountain House, which is older than the mill, was used as offices, winding room and warehouse by the Scapa Manufacturing Company. The lean-to opening onto King Street was a boiler house. The mill buildings are constructed of random stone, with a dressed masonry frontage (Rothwell, 2009).

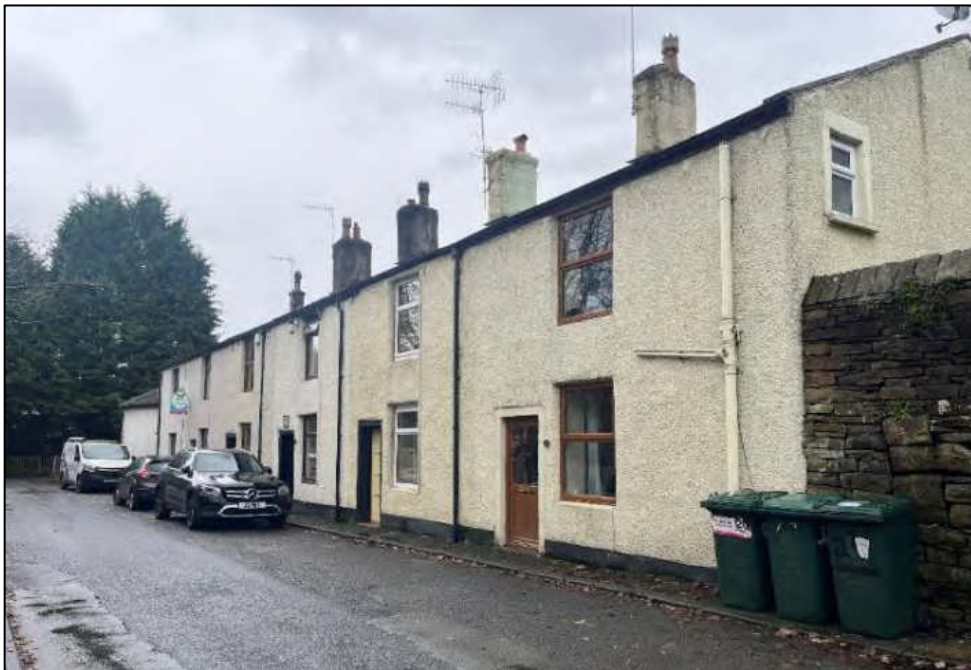
Image

All the cottages appear to have original chimneys, which are also rendered, however, all joinery appears to be modern. No.25 adjoins a tall dry stone wall that turns into a small lane leading to a building that appears to have been part of the Sion Primitive Methodist chapel shown on historic mapping. One of only two surviving rows of workers' houses to survive in the village.

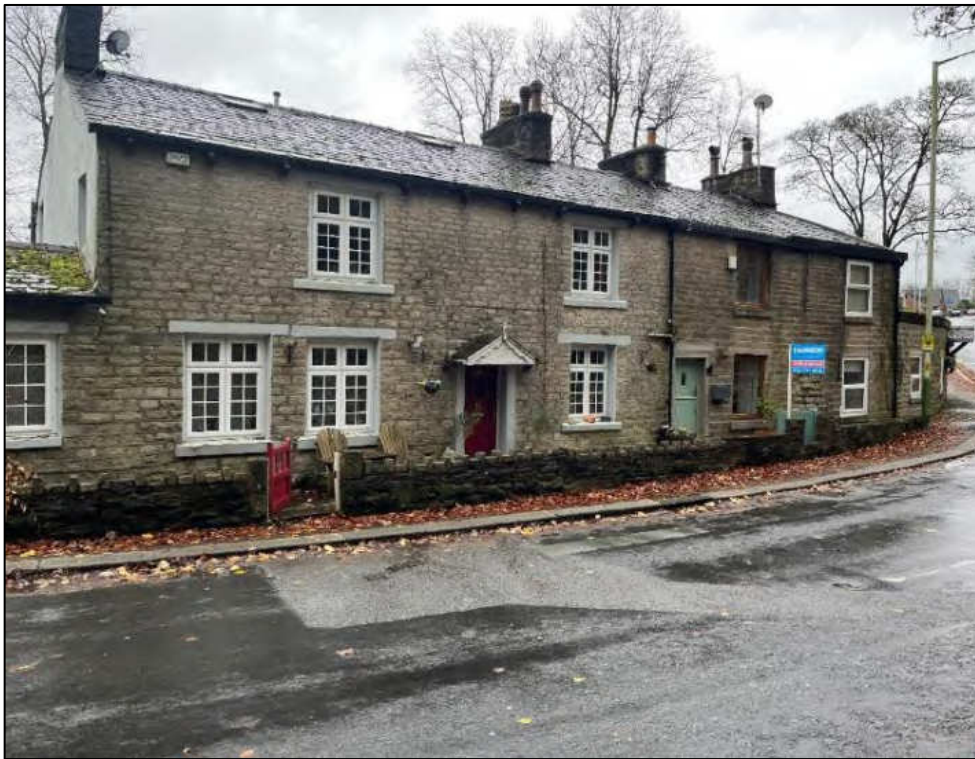
Image

Block of early 19th century stone cottages, two storeys at front, three storeys at rear. Originally front and rear were separate houses. Largely retains original external features and fenestration, with the exception of a loss of original entrance and chimney stack.

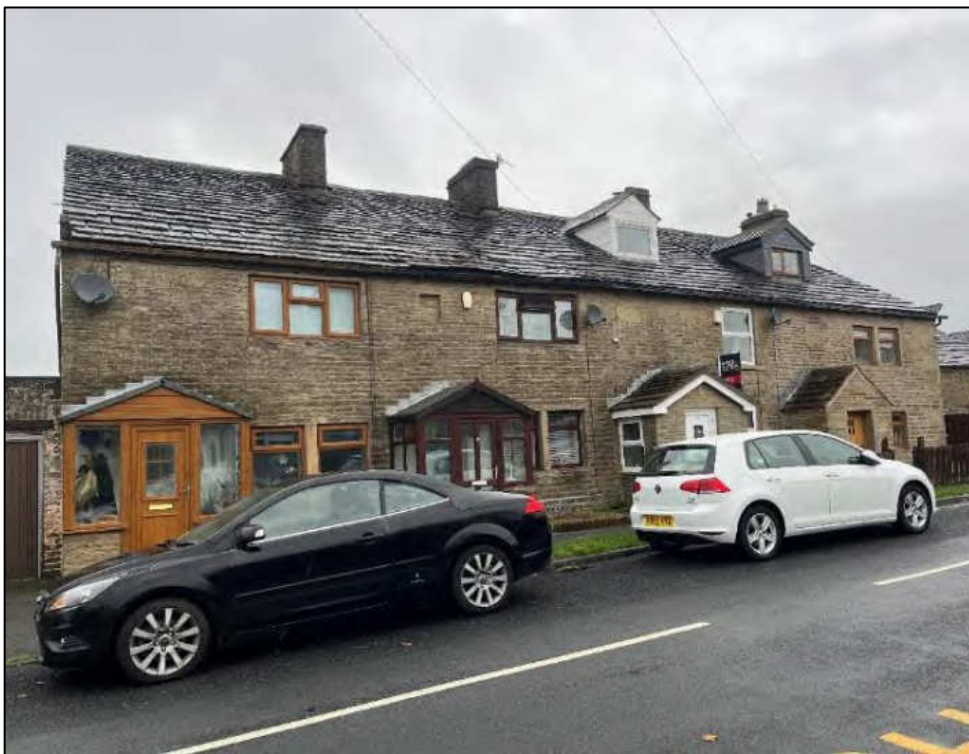
Image

Row of 18th century cottages (No.5 is dated 1774) now altered. Stone two-storey cottages with slate roof and gabled porches. Retains many of the original repetitive features with some modern alterations.

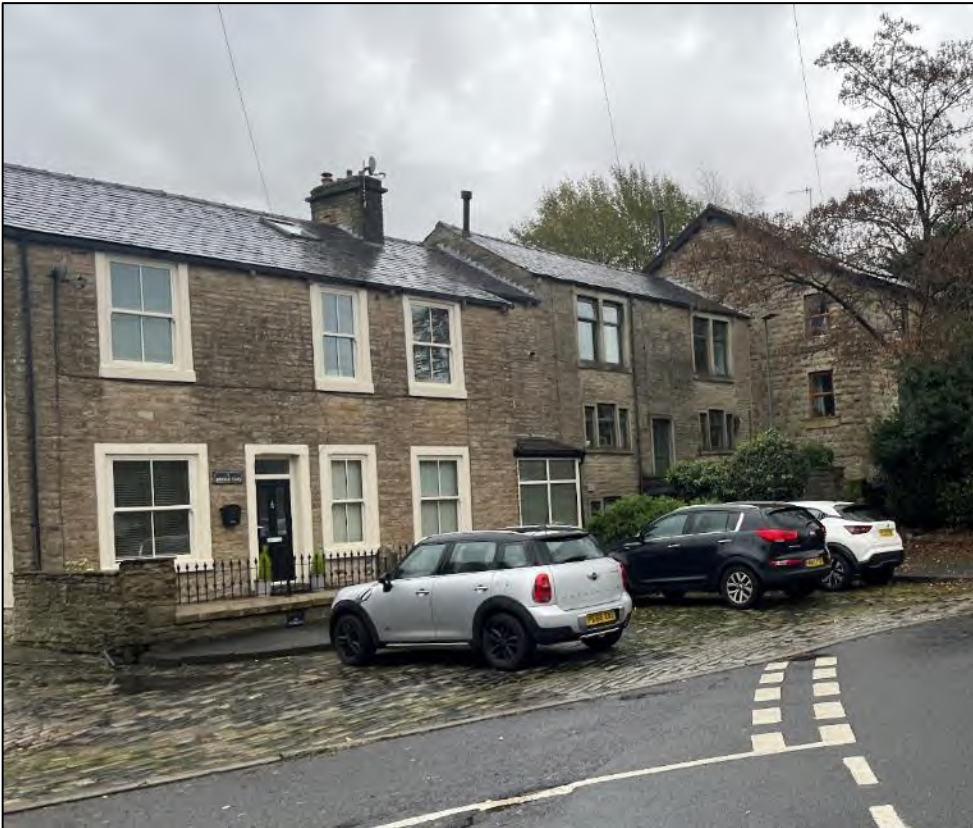
Image

A row of stone built cottages, some two-storey, some three-storey. Different in design, with some set back more than the others. Many original features retained including fenestration and dwarf boundary walls and gateposts.

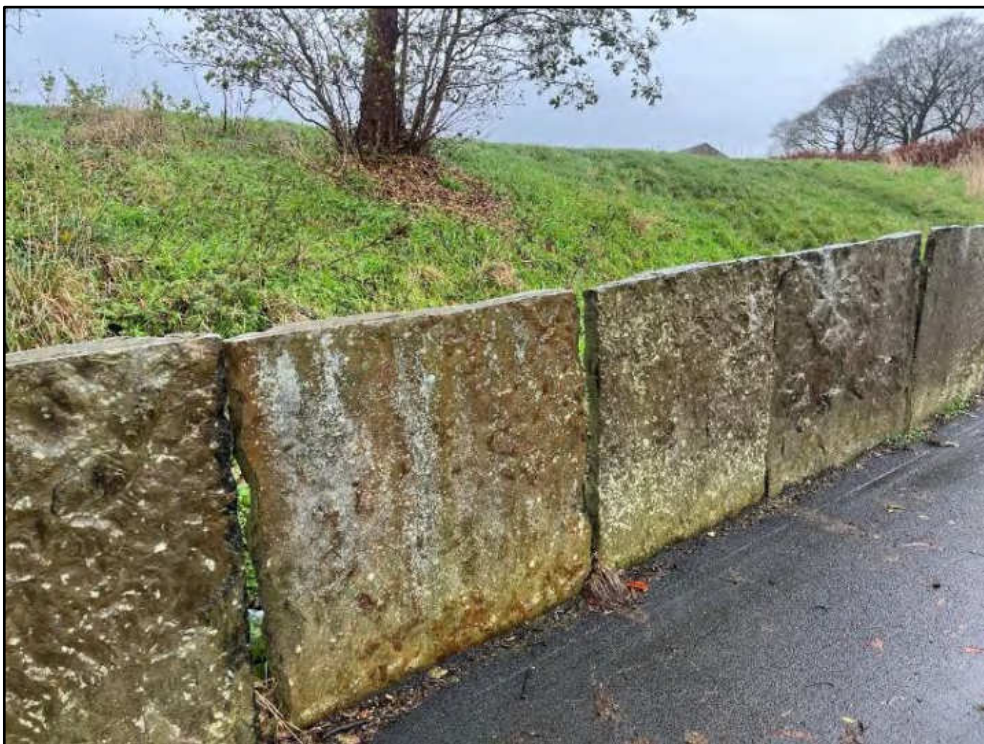
Image

Two small remaining stretches of flagstone walling (outside Albion Mill and on boundary of Sports Centre playing field). There was formerly much more of this type of walling on Helmshore Road.

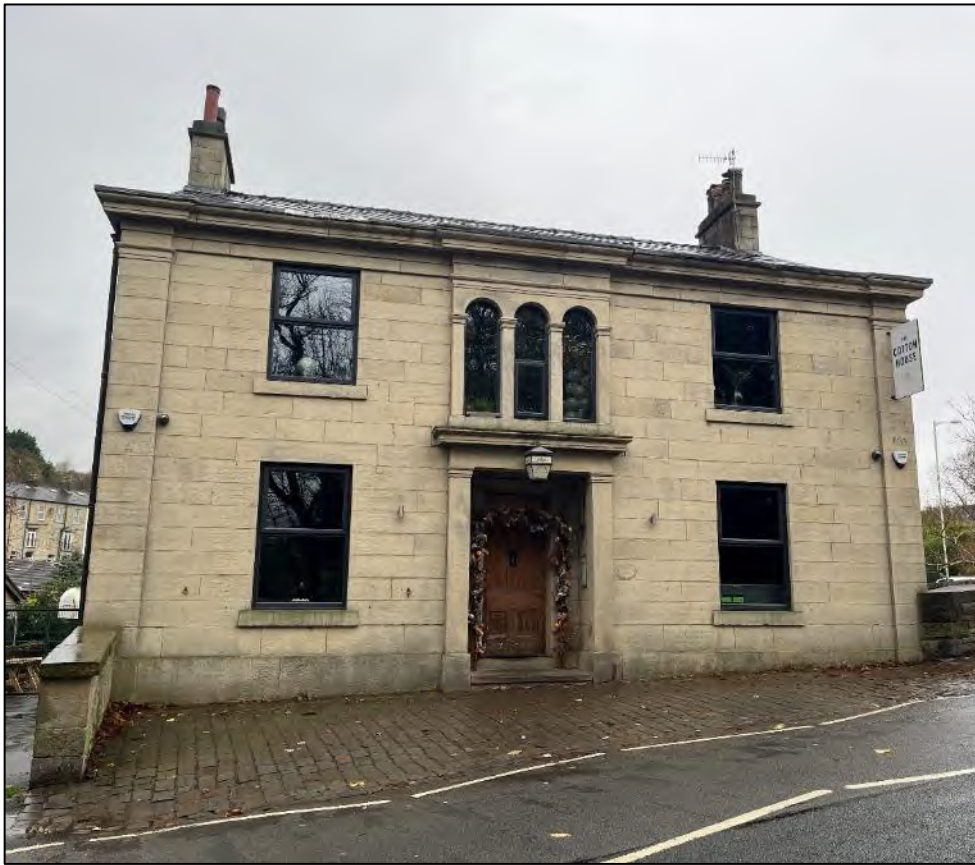
Image

Built in the late 1840s, detached two-storey building, constructed from stone, double fronted with symmetrical fenestration. The front of the building has good stonework and is well built with an imposing entrance topped by a triple arched window. Fronted with stone setts.

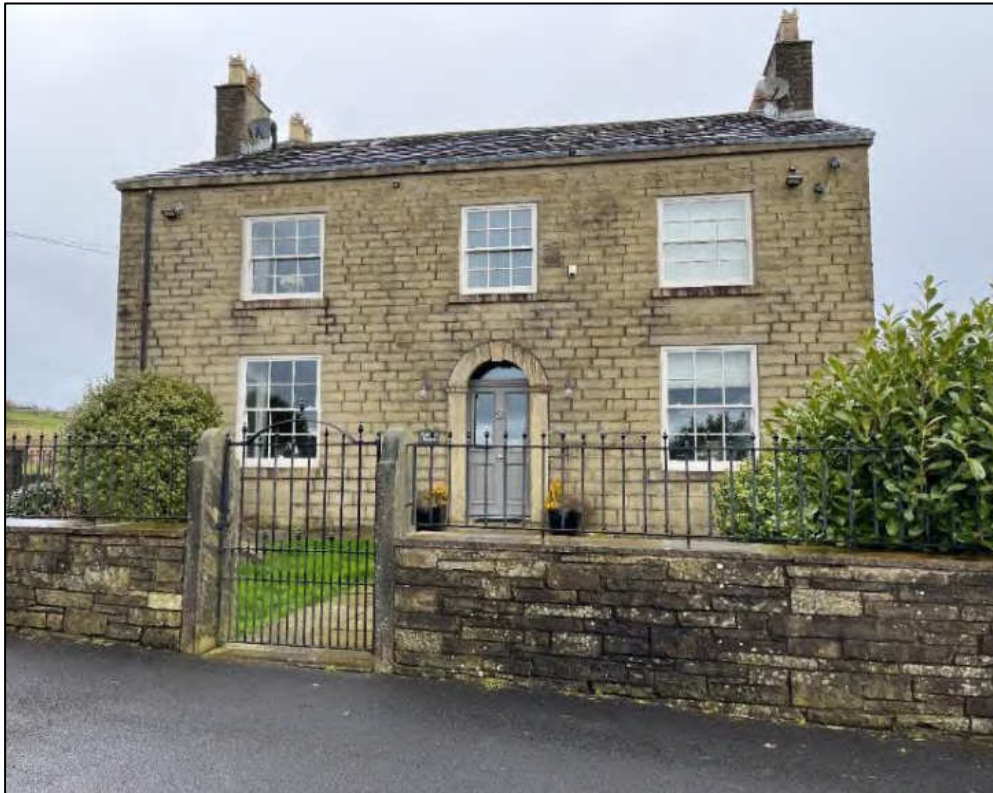
Image

Substantial early 19th century farmhouse. The front is well-proportioned with an arched doorway. The quality of the stonework, etc. possibly reflected the wealth of the Duckworth family who built the house.

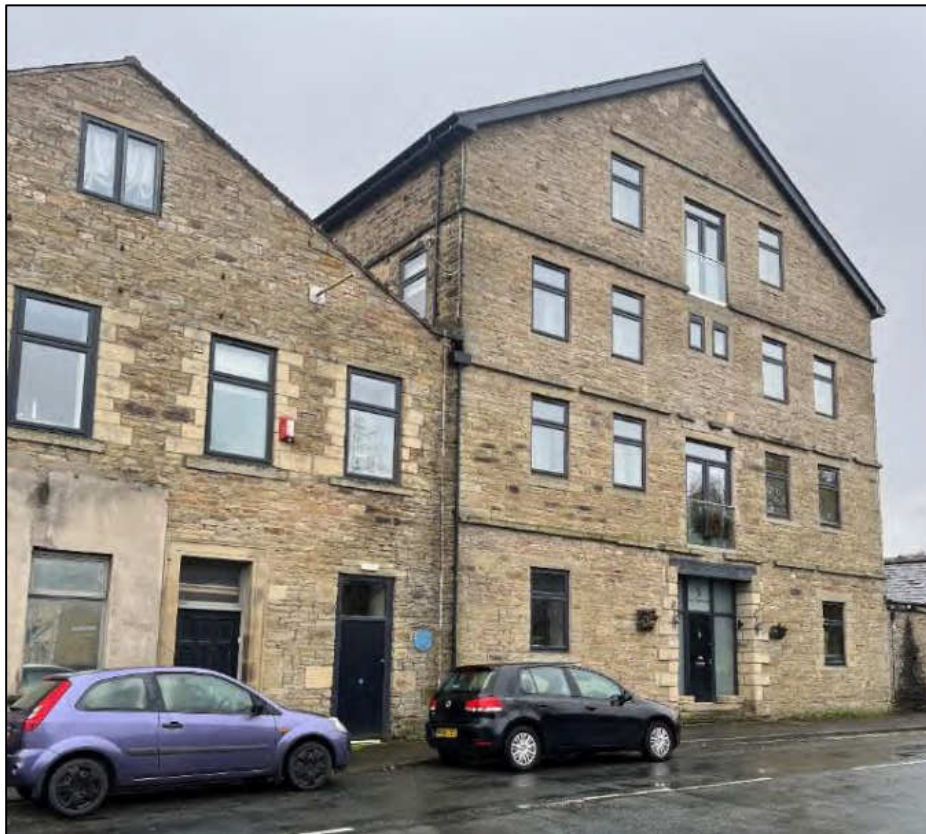
Image

The main surviving building is the spinning mill. Facing Holcombe Road is its gable end, three storeys in height, with an attic. Details include quoins and string courses. A central loading door is sited at street level, with loading slots above. The north wall is 14 windows long and remains of the third floor windows can be seen just below the roof line. At the western end is an integral engine room, with a round headed window. To the north side of the main factory is a single storey, random stone building constructed to a trapezoidal plan, which was used as a teasing room and then as a weaving shed in the nineteenth century. South of the preparation building is a smaller two block, with its gable to the road. An octagonal, stone chimney was set on the hillside above the mill, but has been demolished (Rothwell, 2009).

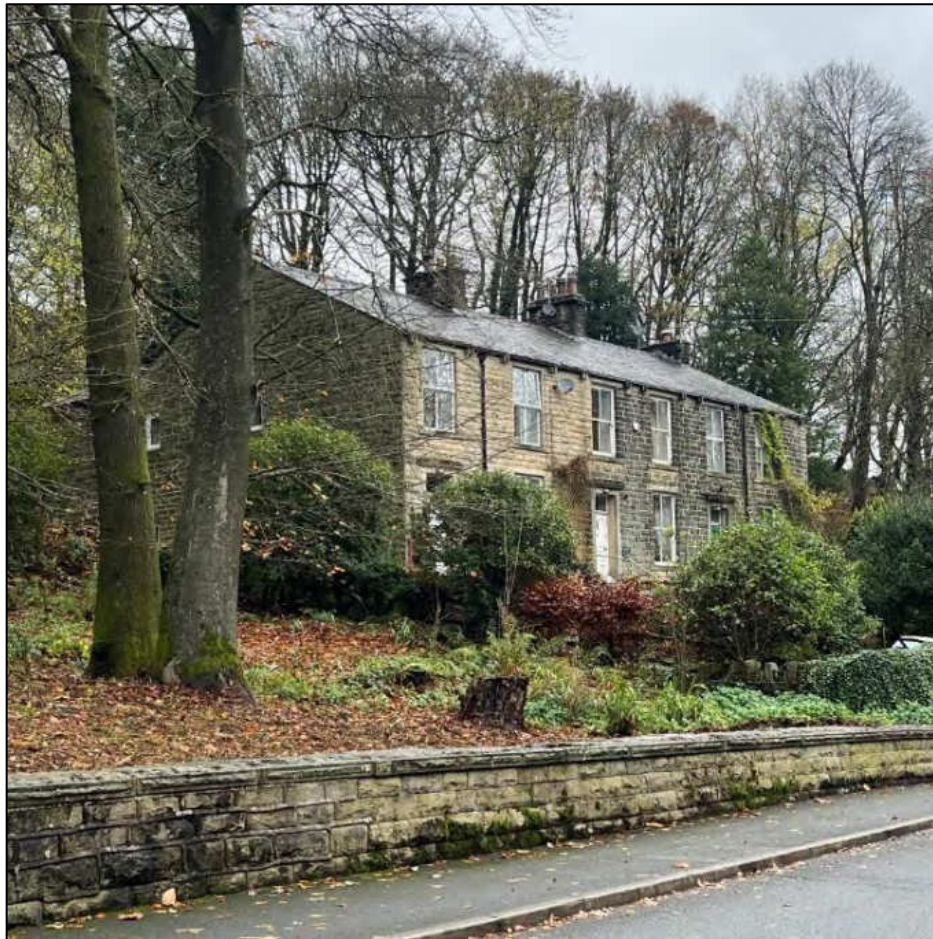
Image

Row of 3 stone houses, built by the firm of Joseph Porritt and Sons. The houses were intended for managers and senior employees of the firm. The houses are two storey with a slate roof and have two-over-two sash windows with stone cills and lintels. The row is on a slight slope and has stepped access to the front doors.

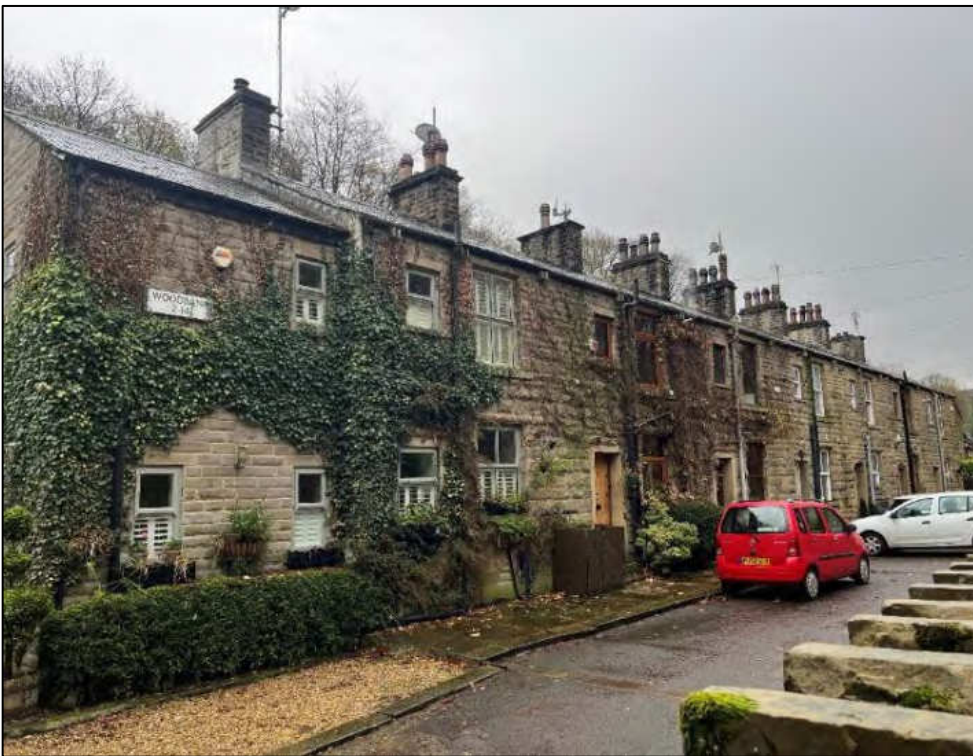
Terrace row of stone built cottages (mill workers). The dwellings have a door with a stone surround and window at ground floor level and have two windows at first floor level with one smaller in size than the other. The windows have stone lintels and cills. The row has a slate roof and chimney stacks on the ridgeline.

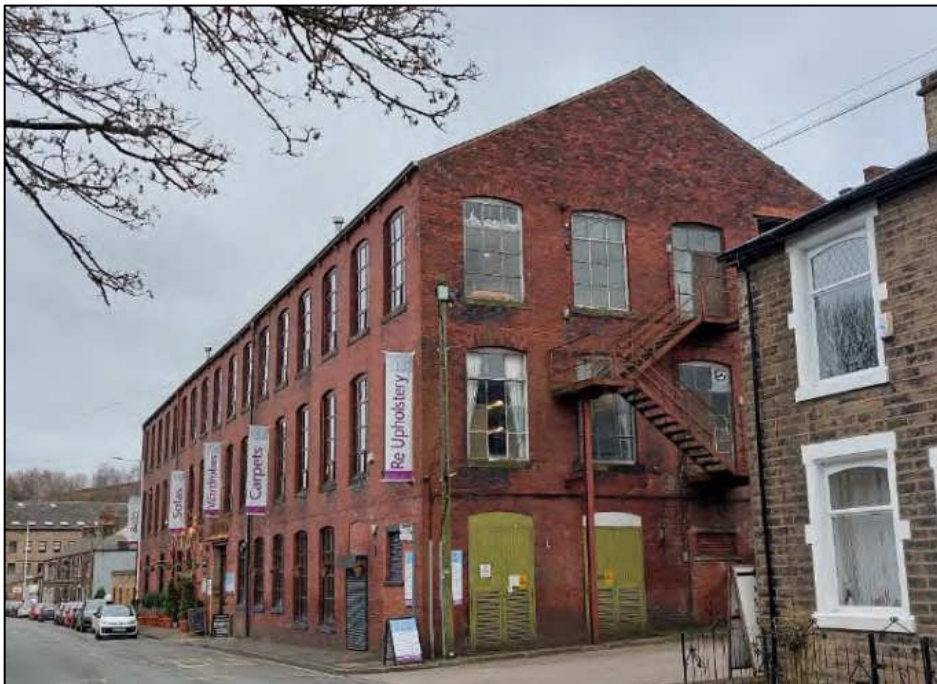
Image

There is a three storey addition from 1914 on Park Street, constructed of brick with a three bay roof. Loading slots open to the inner yard. Beyond the extension some older buildings have been demolished and replaced with a car park. There is a modern boiler house at the top of the street, with a circular brick chimney on a square stone base behind it.

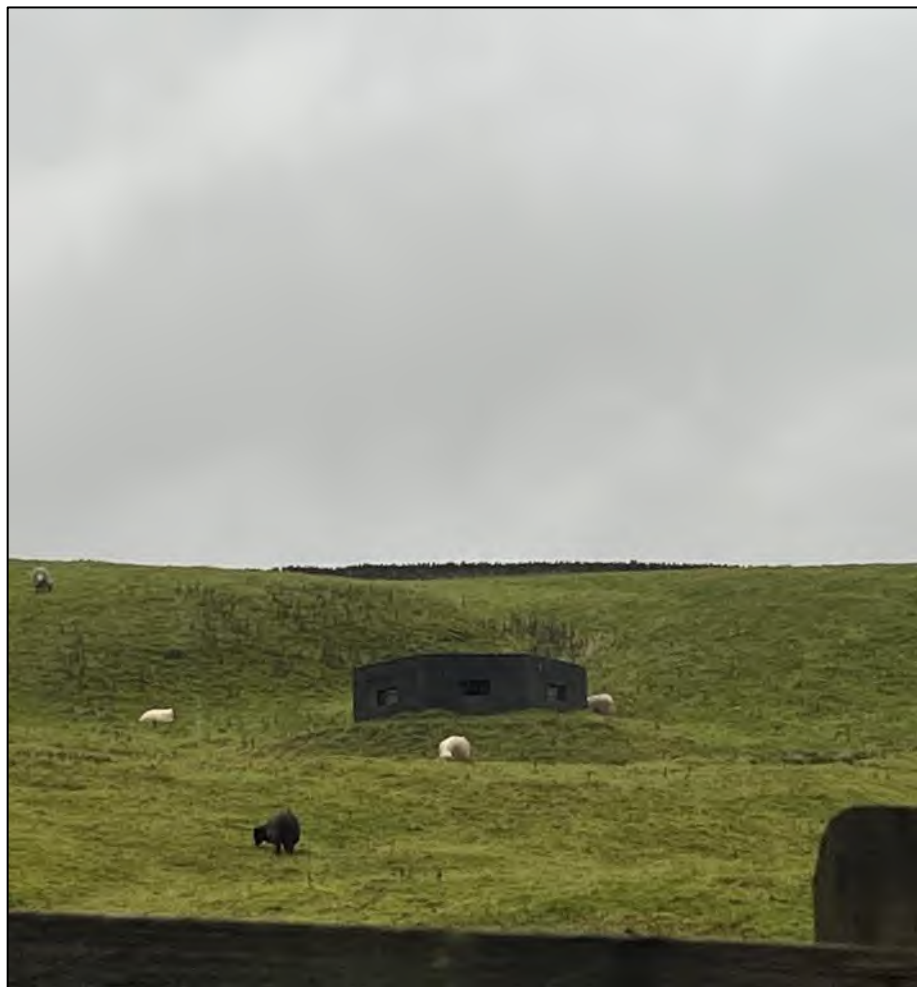
Six-sided concrete pillbox built c.1940 as part of system of defence for Helmshore in World War 2.

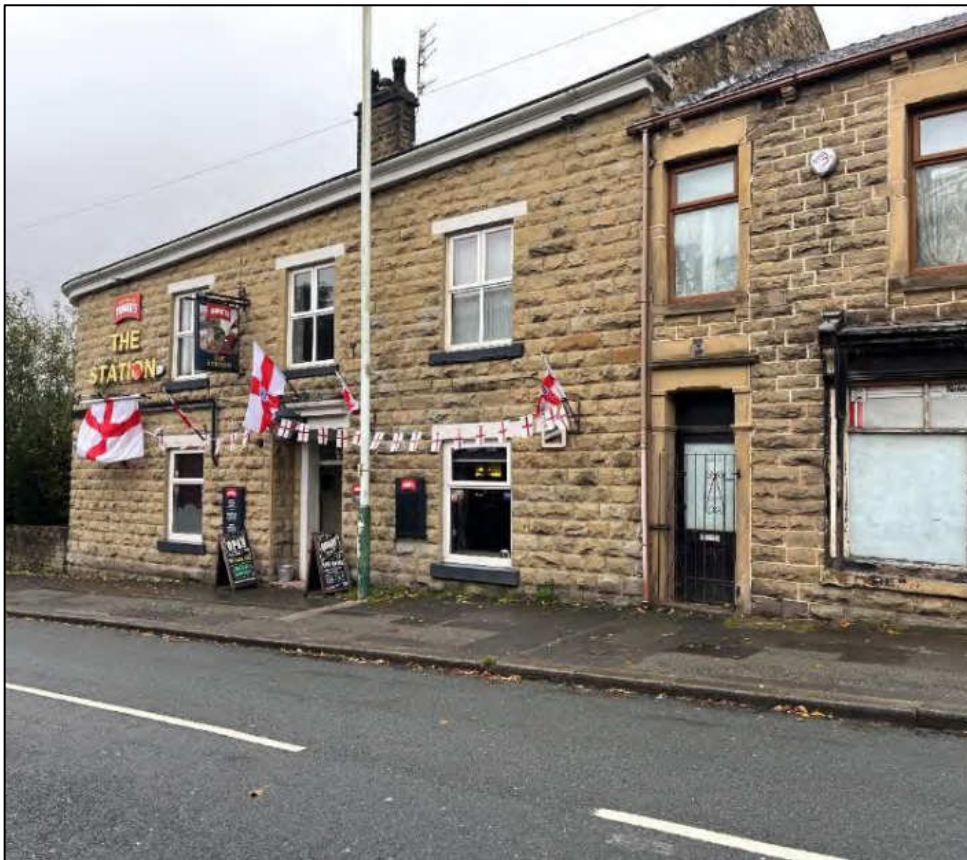
An example of a building built of rock-faced sand stone. It is two storey and has an elegant curved corner at its lower end, the roofline slopes to follow the gradient of the road. The current name relates to it being next to the former route of the Clifton, Accrington, & Colne line of the Lancashire and Yorkshire railway and Helmshore station, which have been completely removed.

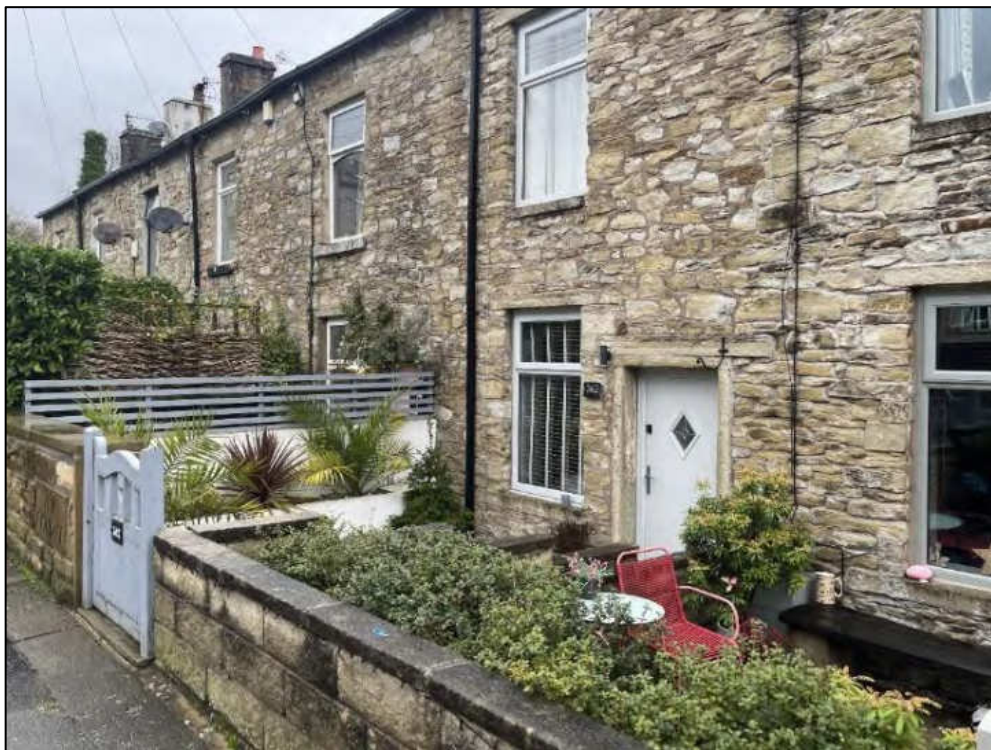
Asset Ref.	Asset Name	Address	Asset Type
NDHA_87	Tanpits Row	352 - 374, Holcombe Road, Helmshore	Building

Row of mill-workers' houses (possibly formerly back-to-back) built in the 1820s. One of only two surviving rows of houses built in the village by W. and R. Turner. The Tanpits area got its name as it was an area where leather was tanned; the workers cottages may have been associated to the Tan Pits Mill (Woolen), identified on 1849 OS Map, across the road slightly north of the cottages.

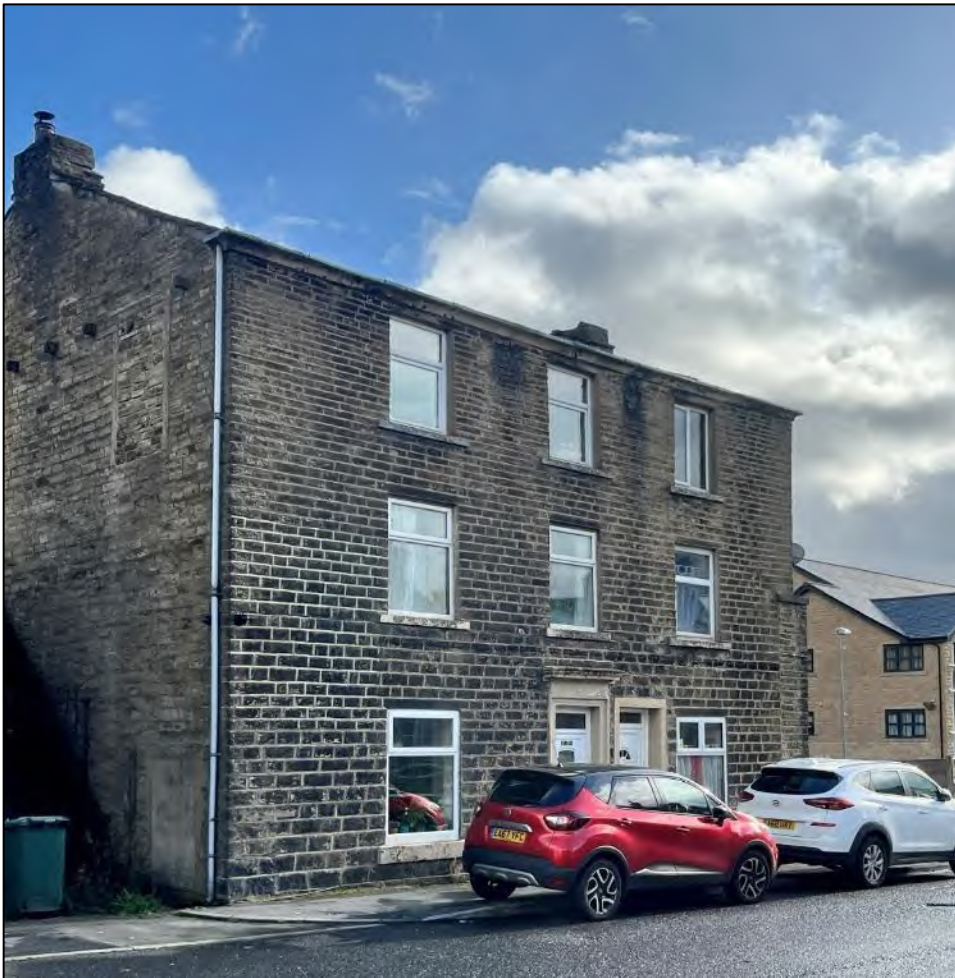
Asset Ref.	Asset Name	Address	Asset Type
NDHA_88	123 - 125 Burnley Road	Burnley Road, Rawtenstall	Building

Three storey 'workshop' with accommodation on ground and part of second floor, now two separate houses. Has rare surviving outside staircase to top storey as well as taking in door with 'cat's head' pulley or hoist.

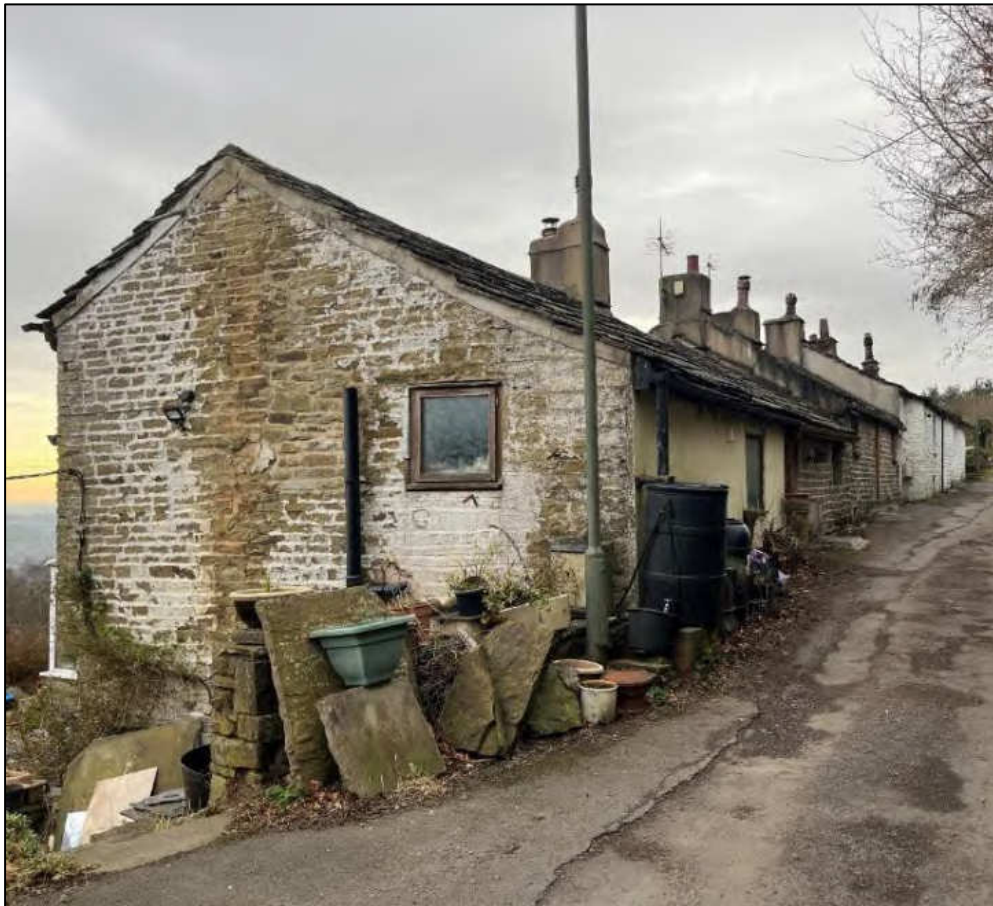
Two separate rows with a group impact as an early 19th century weaving colony. The individual buildings have lost some integrity, but show evidence of weaving windows and taking in doors. Historic mapping indicates that the hamlet of weavers cottages were known as 'Top of Bank'.

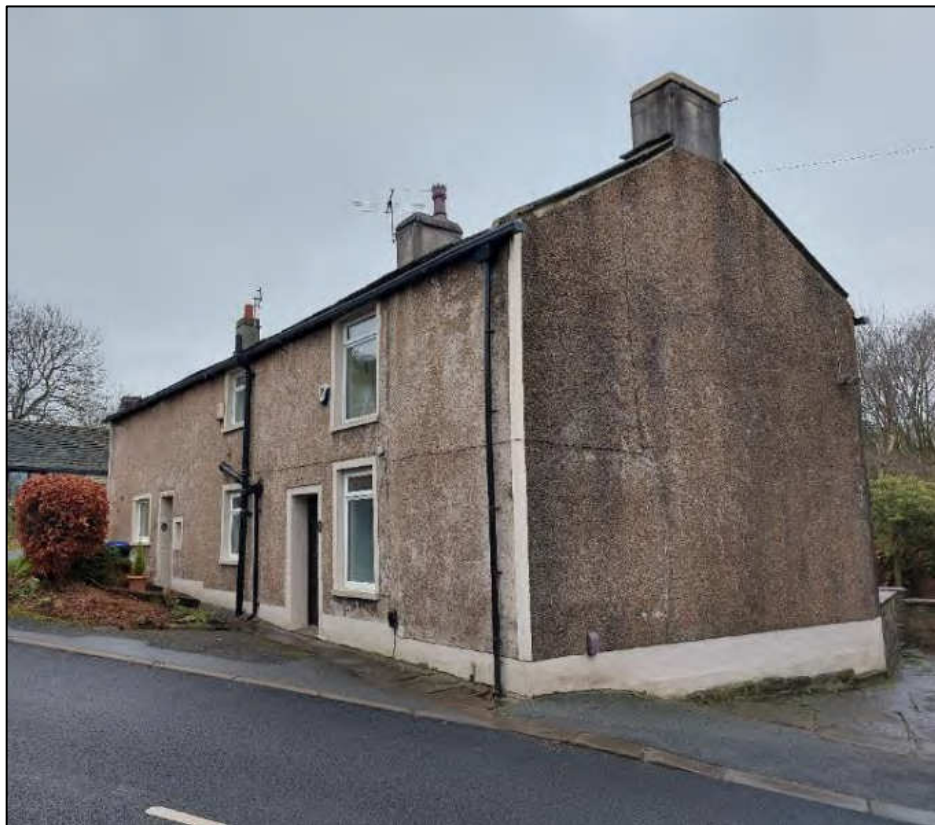
Houses c.1650, later altered. Externally only original proportions remain but internally many original features survive, e.g. flagstone walls and beams. Surveyed by Sarah Pearson as part of Rural Houses in Lancashire survey, 1980 (records with D.O.E).

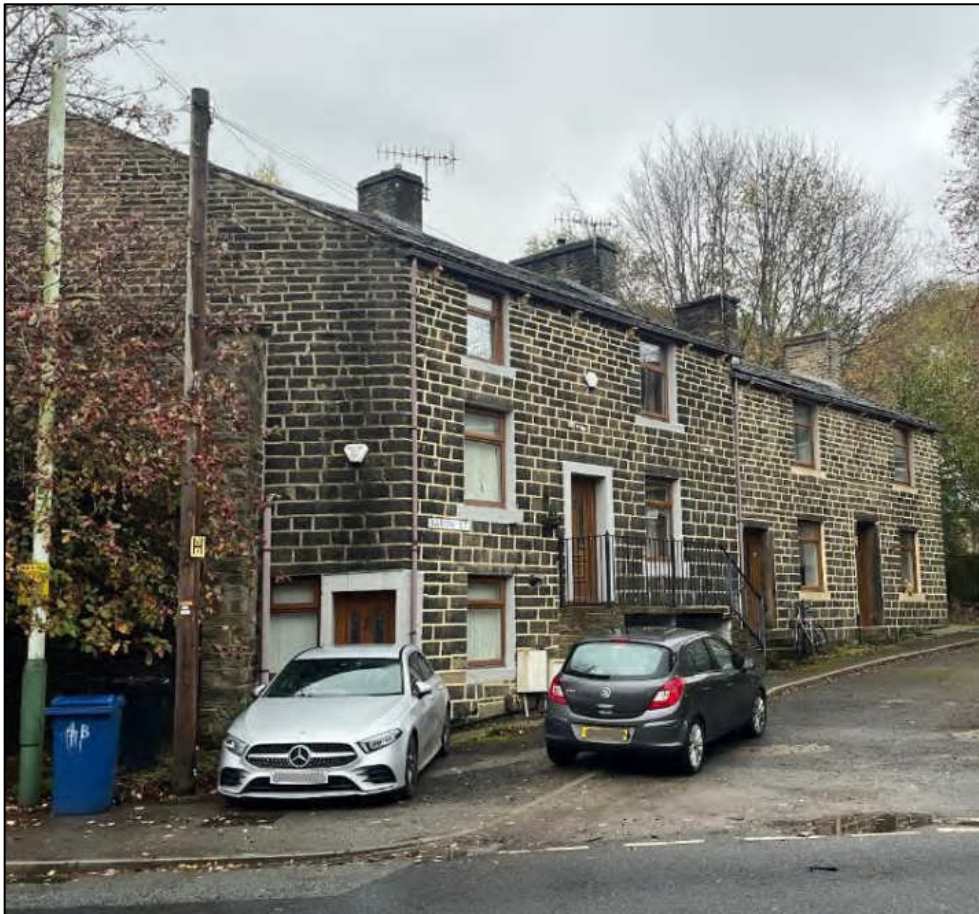
Group of four terraced houses on different levels providing a picturesque focal point. Constructed from stone, the cottages are on sloping ground so No.4 is 3 storey, No.6 is 2.5 storey with a basement floor and elevated entrance, and 8-10 are 2 storey. Some houses have triple mullioned windows to rear. Typical of the industrial housing which was provided for mill workers in this period.

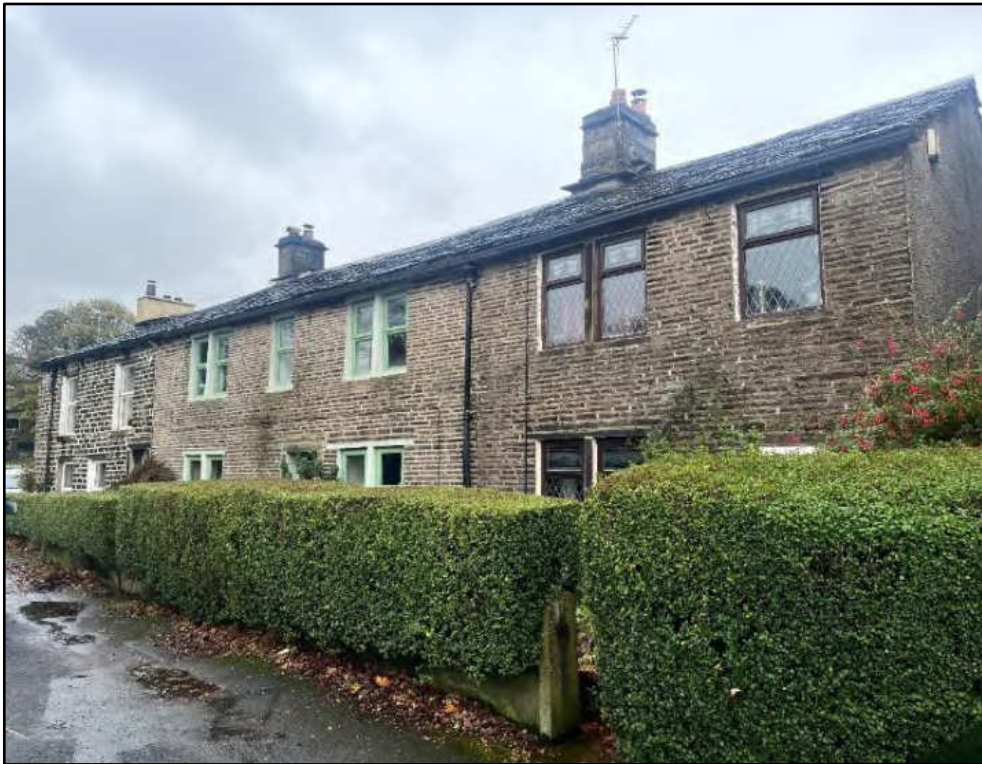
Image

A row of small independently designed 2 storey stone houses joined together into a terrace which gives it great character. Many historic features remain, particularly possible Victorian era stained glass and some window frames. Possibly dating to the 18th century although No. 445 is possibly later as the stonework is different. The shallow pitched stone slated roofs are subdivided by chunky axial stacks.

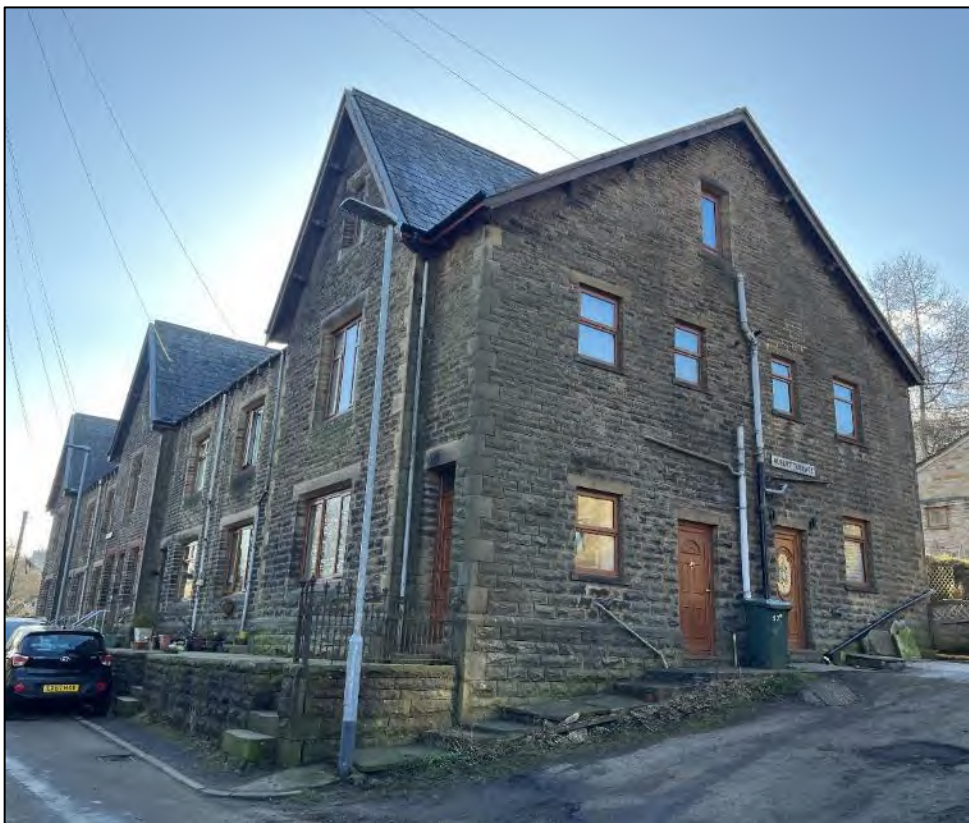
Gable fronted quality terraces in a 'Ruskinian' style with high gables and some tall chimneys. Many original features such as a raised footpath. Most of these, originally back-to-back, houses have now been knocked through and provide spacious living accommodation.

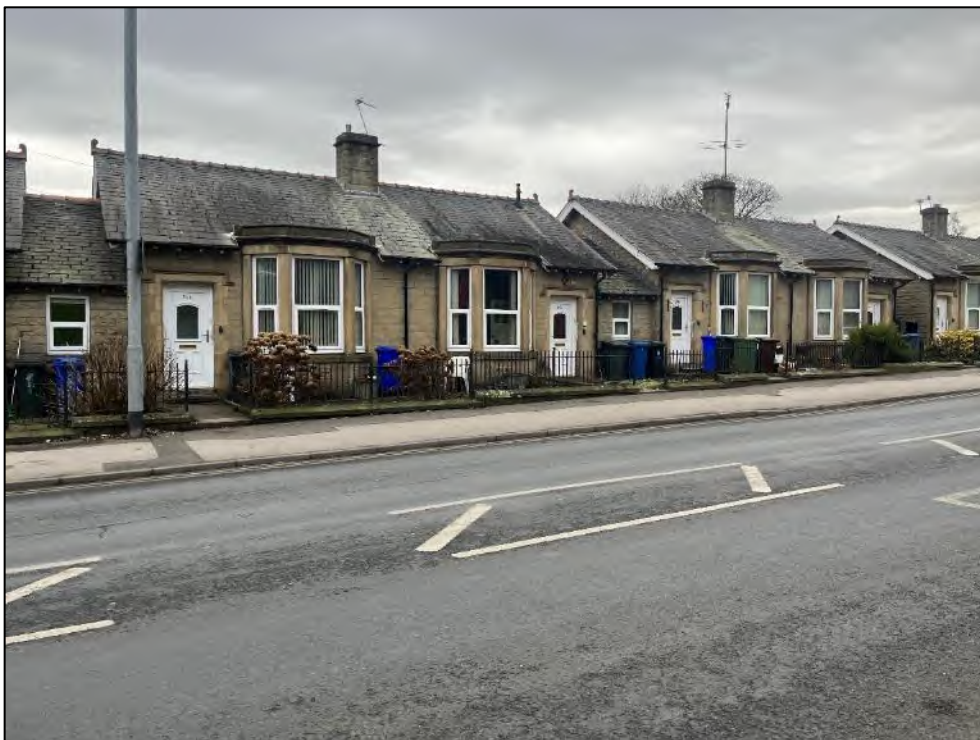
Eight houses built in 1901 in four groups of two, single storey fronts, two storey backs. Large stone mullioned bay windows create attractive rhythm across frontage. Constructed from stone with a slate roof and have a central chimney stack on the ridgeline. Largely retains significant features, but has modern windows and doors.
