Draft Rosendale Local List of Non-Designated Heritage Assets

December 2024

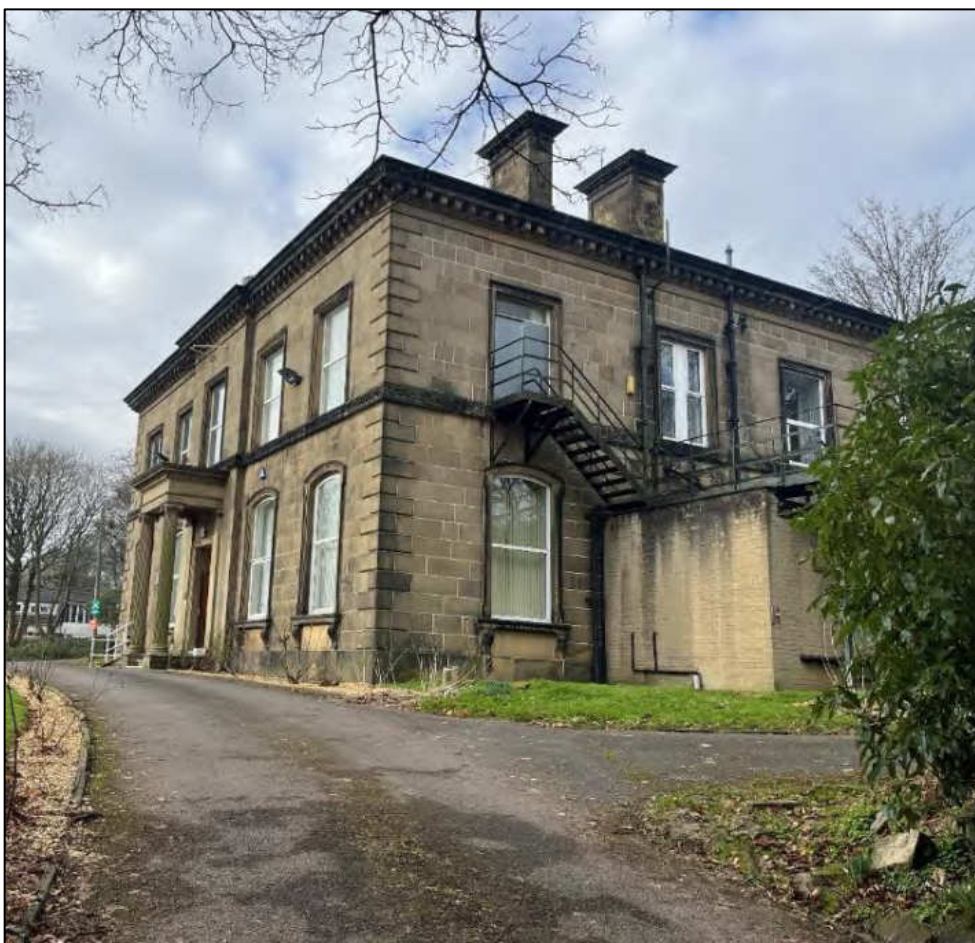
A two-storey building built in c.1860 from stone in a classical style with decorative stone details, such as quoins, bands and porch with Ionic columns, and now a masonic lodge. The stonework is excellent and design is plain and elegant. Set in its own grounds.

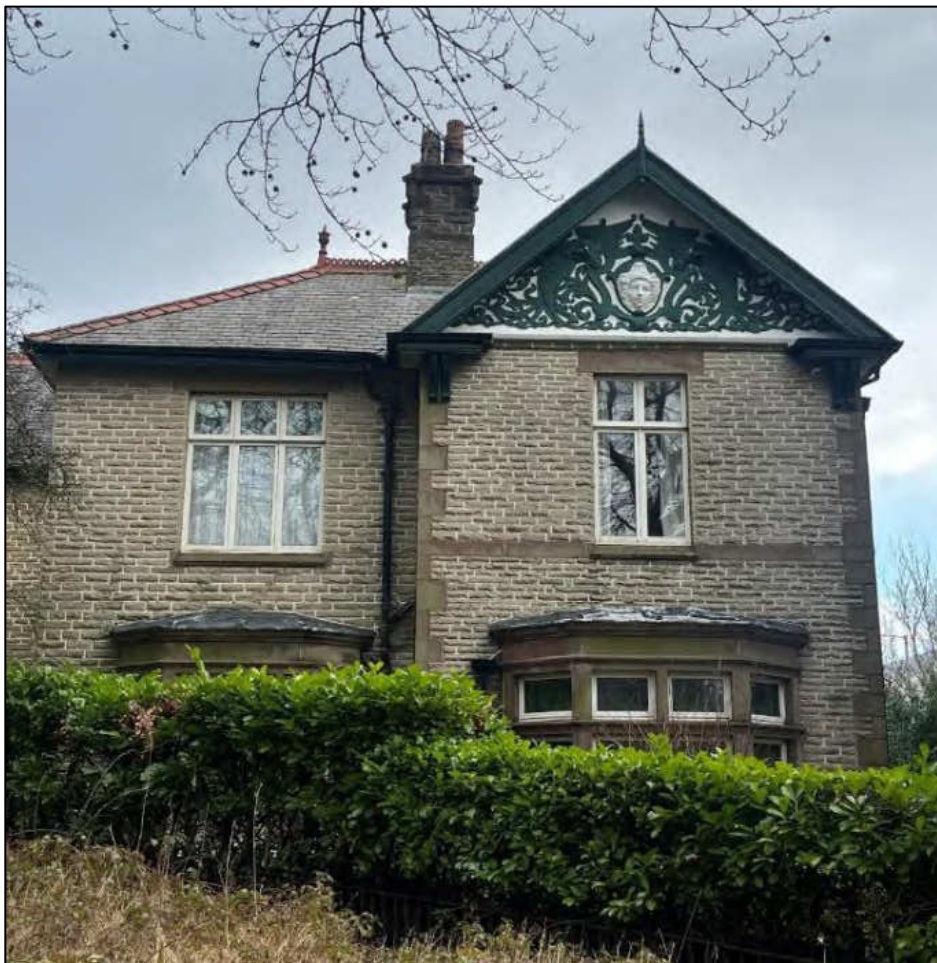
Detached large house (built 1903), two storey with partially gabled front. It is constructed from sandstone with a slate roof and red decorative ridge tiles. The dwelling has elaborately decorated gables and carved red Cheshire sandstone detailing.

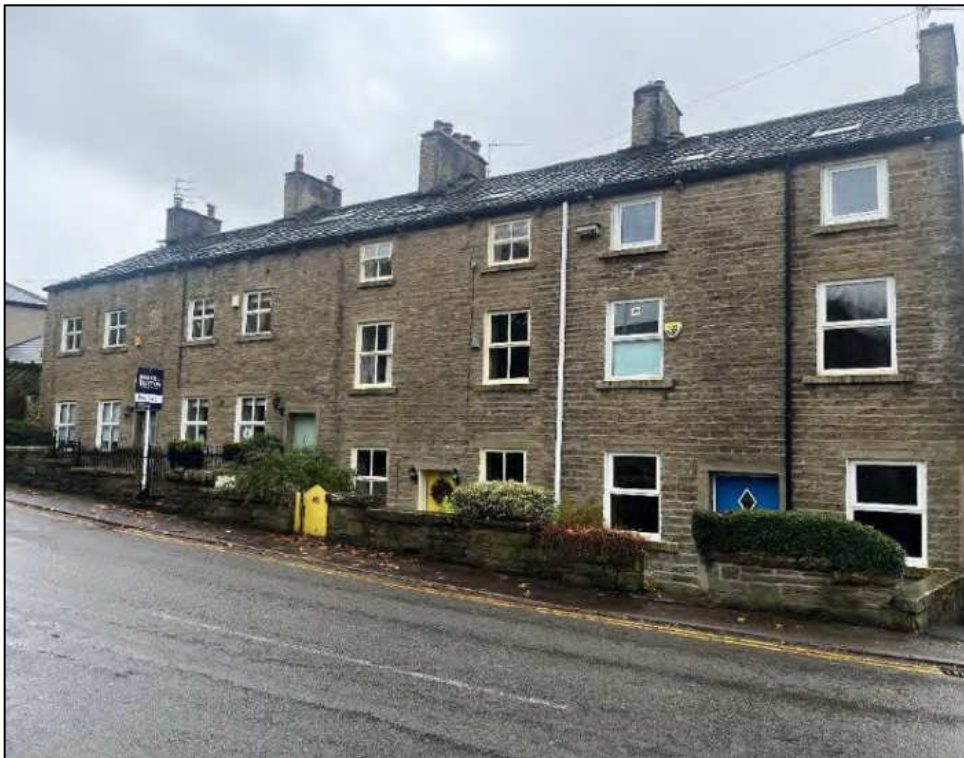
Attempt at economic housing of growing population in mid industrial Revolution (c.1840). Large block of back-to-back houses, three storeys, sympathetically restored in 1977. Purpose built as joint living and loom shop accommodation (note the “takin’ in door” on the gable) possibly about 1830. Good example of pre- factory attempt to house workers by local entrepreneur, possibly from the Ashworth family of Cross.

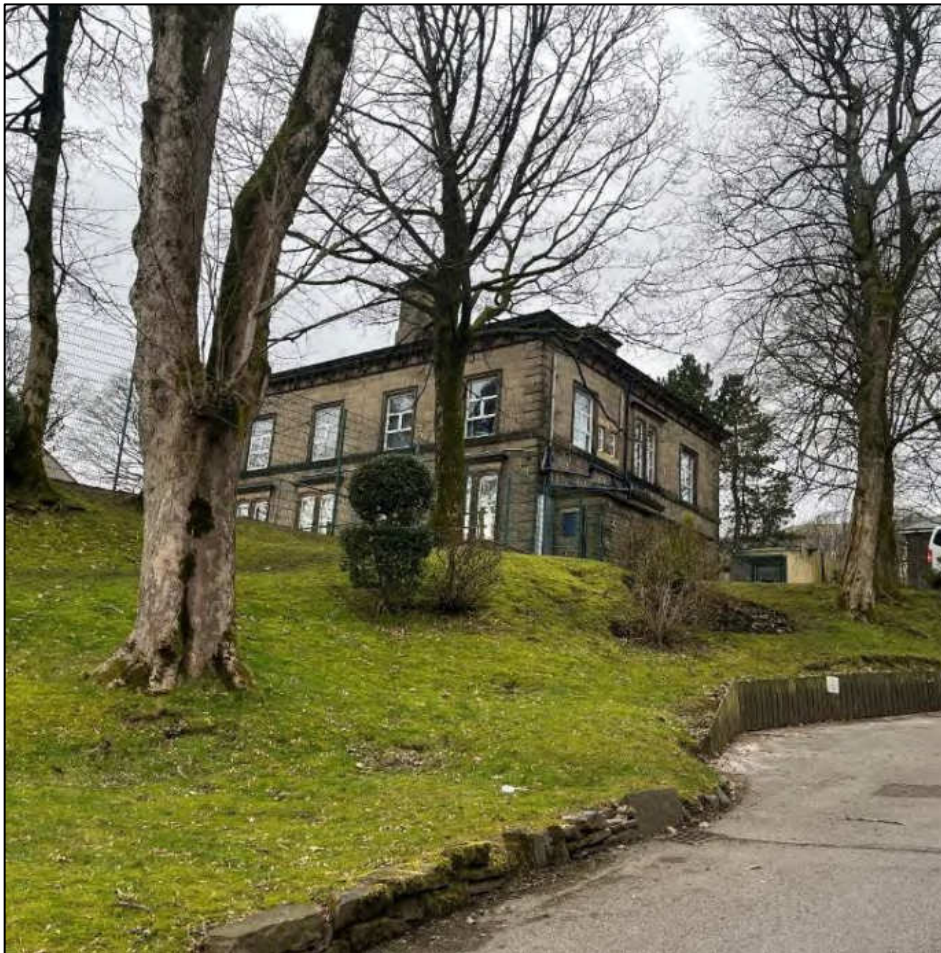
Main building constructed from stone, with decorative stone dressings. Plain in plan, it is decorated with rich carving under the eaves and swags of fruit and flowers, all different, under the windows.

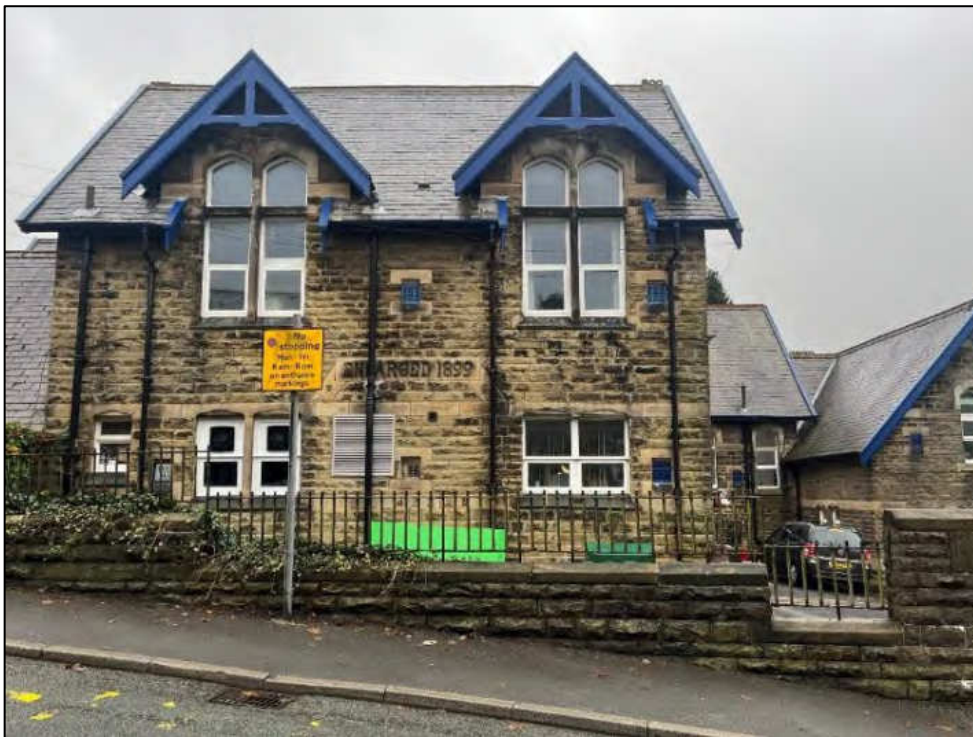
Asset Ref.	Asset Name	Address	Asset Type
NDHA_99	Belmont School	Peel Street, Cloughfold	Building

Belmont School is a late 19th century two storey building which was constructed in three stages. It is built from local sandstone laid in roughly equal courses, with ashlar stone string courses and other detailing. The overall style is Gothic, with steeply pitched slate roofs, decorative bargeboards, and pointed windows. Windows often sit in pairs separated by a stone mullion, the larger windows also have a transom. The school is set behind a coursed stone dwarf wall with railings.

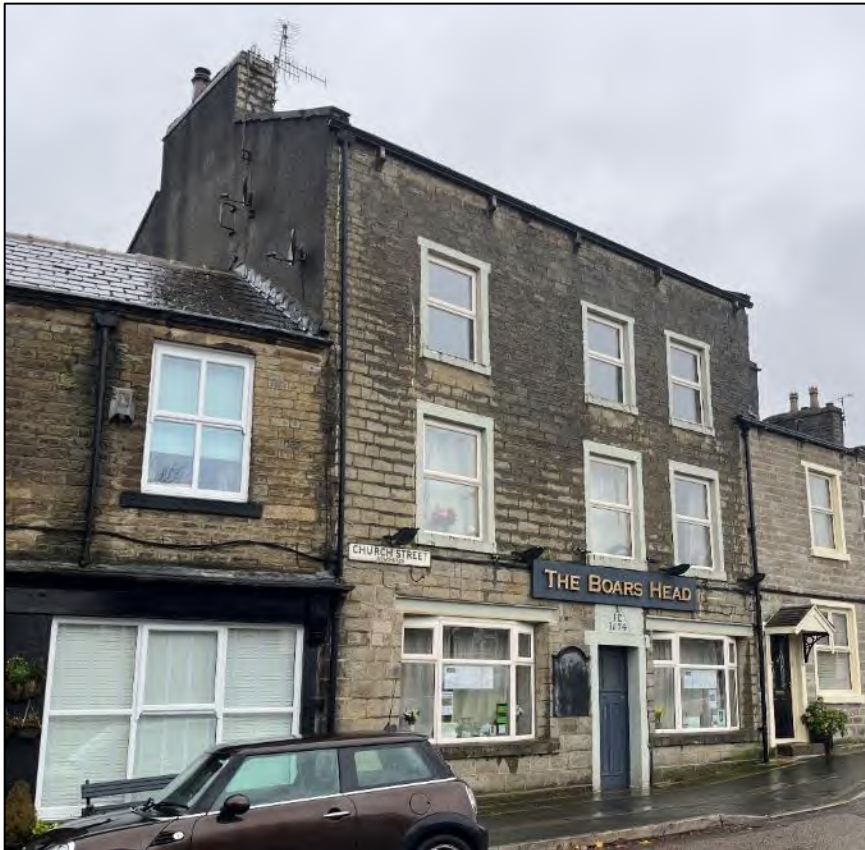
Important to character of street. Much remains still of the late 1790s building and the 19th/early 20th century sash windows survive. The oldest portion being at the rear, where there were still whittle walls inside and may still be there. Remains of the earlier building may survive in the arched cellars, where there is a mullioned window, and a curious example of a 'witch post' carving exists on the end of a beam in the back ground floor room. Down the cellar there is a sealed up entrance from a past era, which is said to have been a secret passage which led to St Nicholas church (Newchurch Village Community Association).

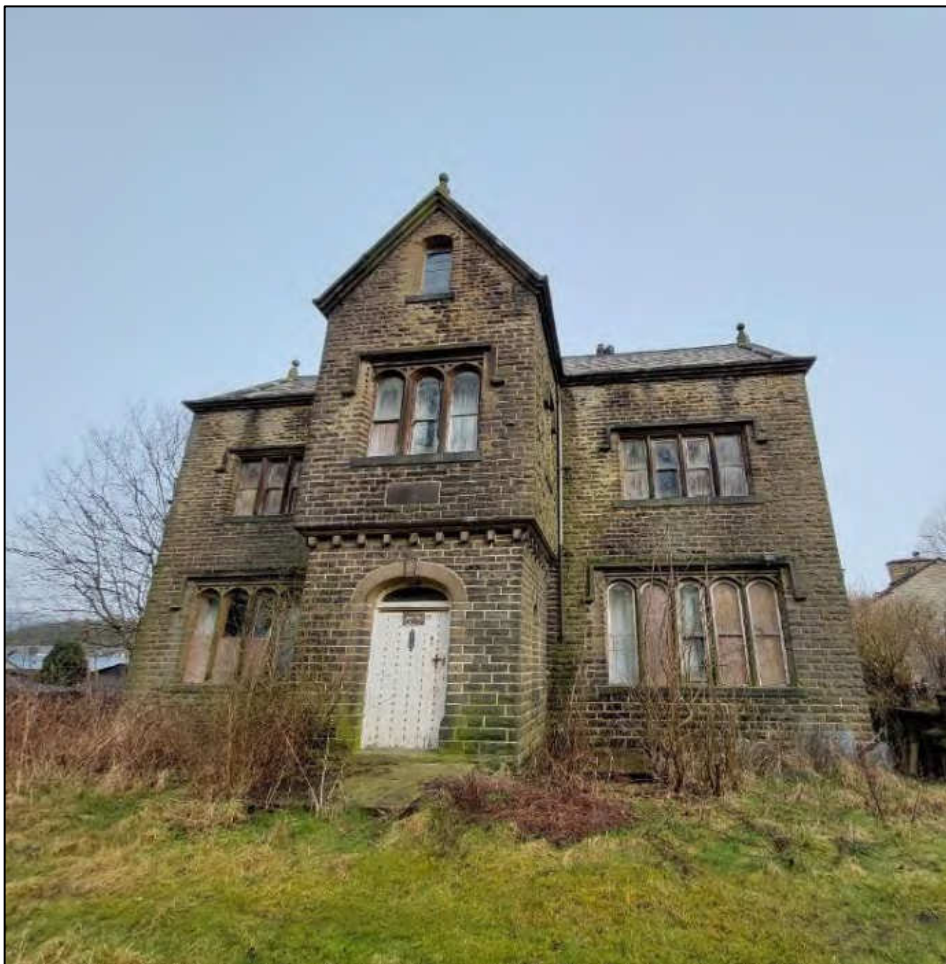
Cherry Tree House is a large, symmetrical, stripped Gothic villa built of local stone in two parts, the front two and the back three storeys, with a valley roof. It has tall mullioned windows with curved heads and a central porch, facing south away from the road, and is rarely seen.

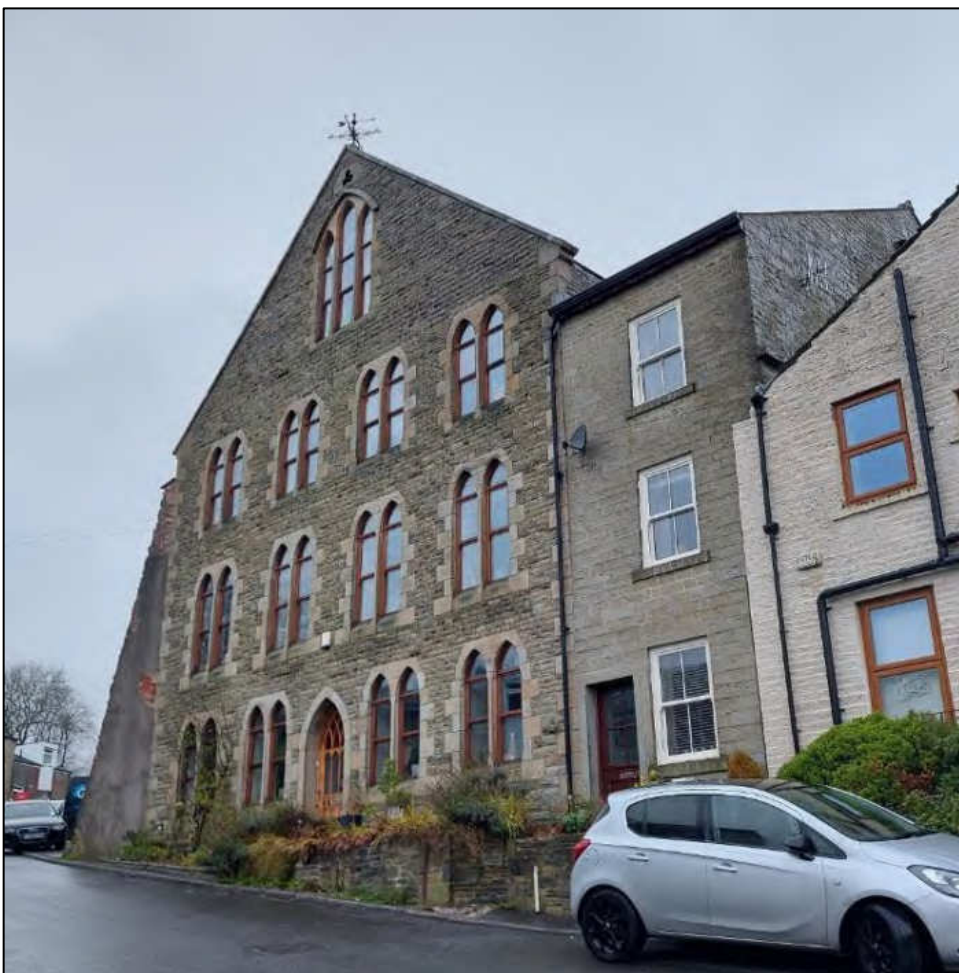
A tight group of houses and chapel / Sunday school. Houses vary, some two, some three storeys, reached by stone steps where door levels are above road. Some houses have triplet mullioned windows to rear. A very striking group with the huge chimneys being a retained feature.

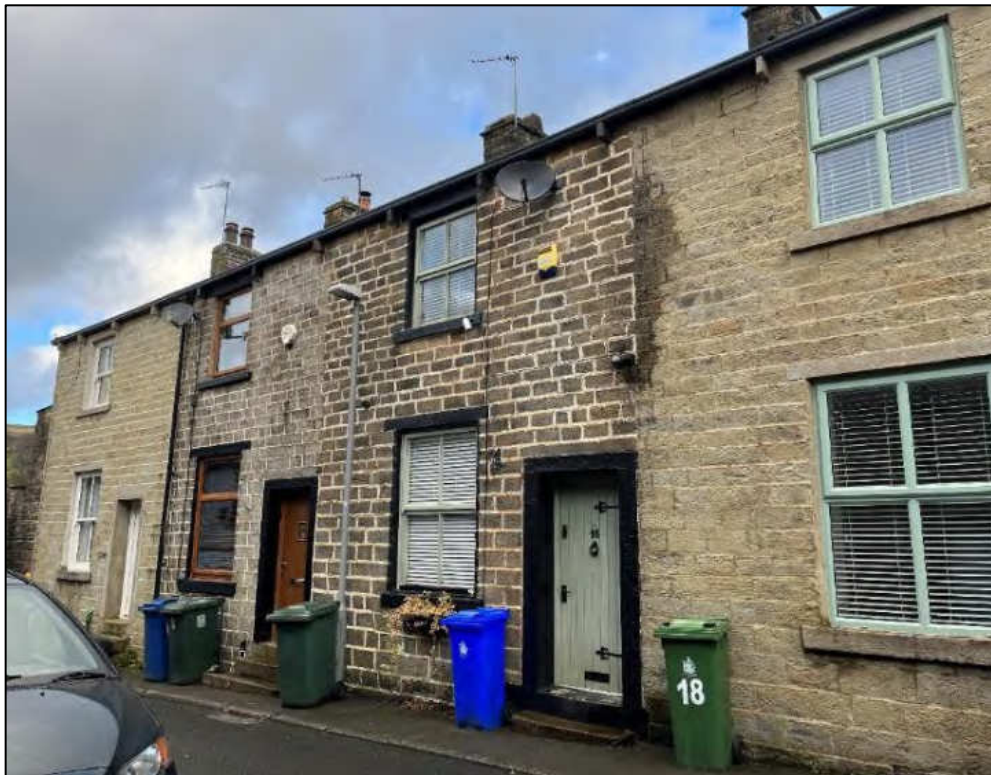
Row of stone terrace cottages (even numbers 12-26), possibly mill worker houses. Two-storey and constructed from coursed stone, they have a small doorway with a stone surround and a window at ground floor level and a singular window at first floor level, all with stone headers and cills.

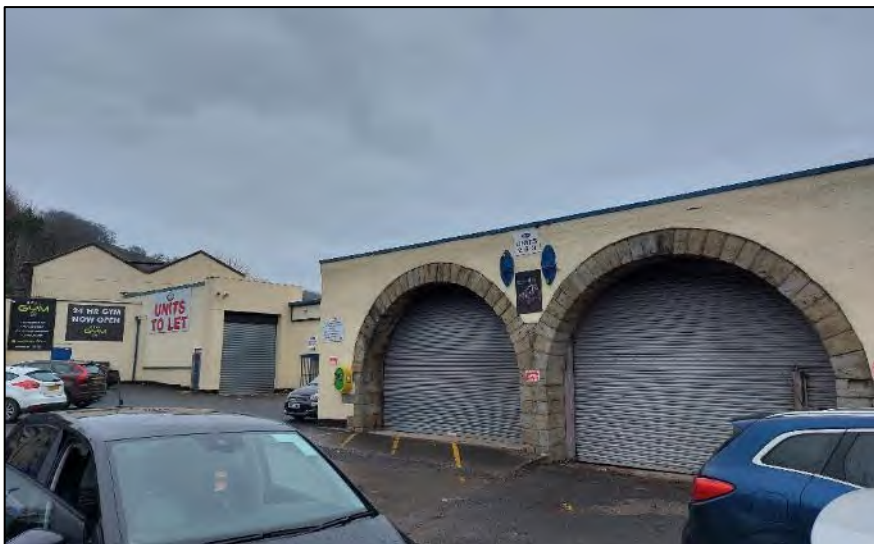
Asset Ref.	Asset Name	Address	Asset Type
NDHA_104	Dale Mills	Burnley Road East, Piercy, Newchurch	Building

The 1891 OS map shows the former Edge Holme Mill labelled as 'Dale Mills' and Old Shoddy Mill is labelled as 'Edgeside Mill (Disused)'. The 1930 published OS map shows that the main part of the complex along Burnley Road had been enlarged to fill in all the gaps that were there. The smaller of the two blocks that were on the Old Shoddy site has also been greatly enlarged. All the site is now labelled as 'Dale Mills (cotton)'.

On the OS map surveyed in 1939 little seems to have changed with the general layout of the complex, however, the larger eastern building on the former Old Shoddy Mill site seems to have become linked to Whitewell Works across the brook, which is now labelled 'Glove Mill', indicating that building had perhaps become separate to the rest of the complex.

The 1891 OS map shows the former Edge Holme Mill labelled as 'Dale Mills' and Old Shoddy Mill is labelled as 'Edgeside Mill (Disused)'. The 1930 published OS map shows that the main part of the complex along Burnley Road had been enlarged to fill in all the gaps that were there. The smaller of the two blocks that were on the Old Shoddy site has also been greatly enlarged. All the site is now labelled as 'Dale Mills (cotton)'.

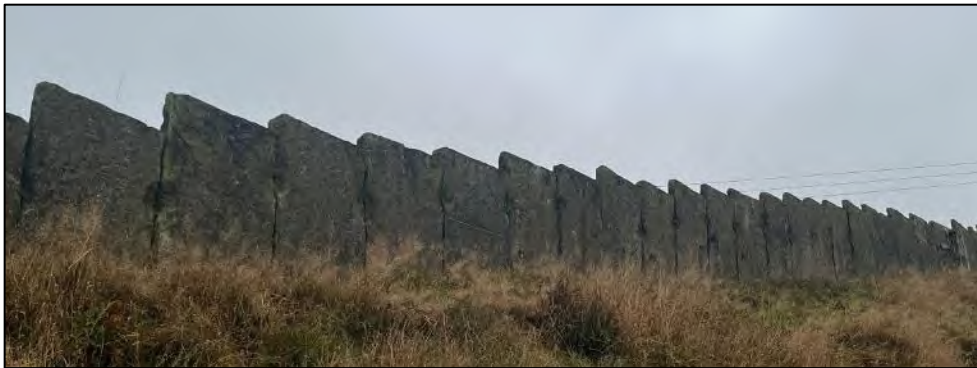
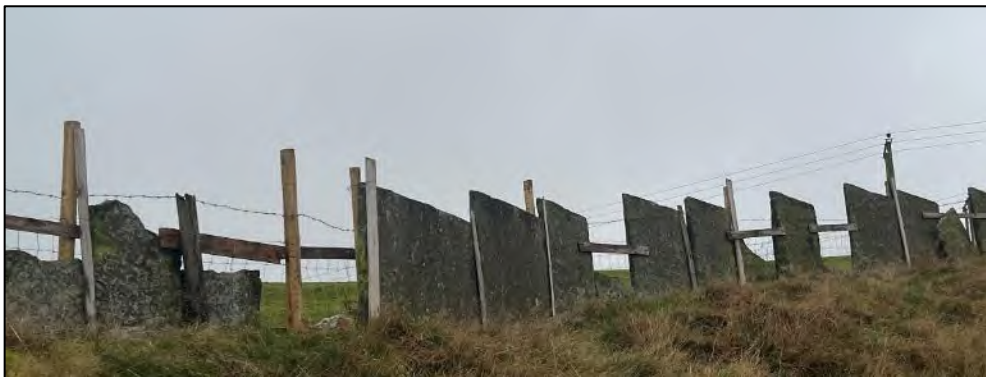
Flagstone walling made up of vertical rectangular sections of stone, the flagstones are stepped up the hill along Hill End Lane. Some of the flagstones are missing or broken in areas and are held together with wood.

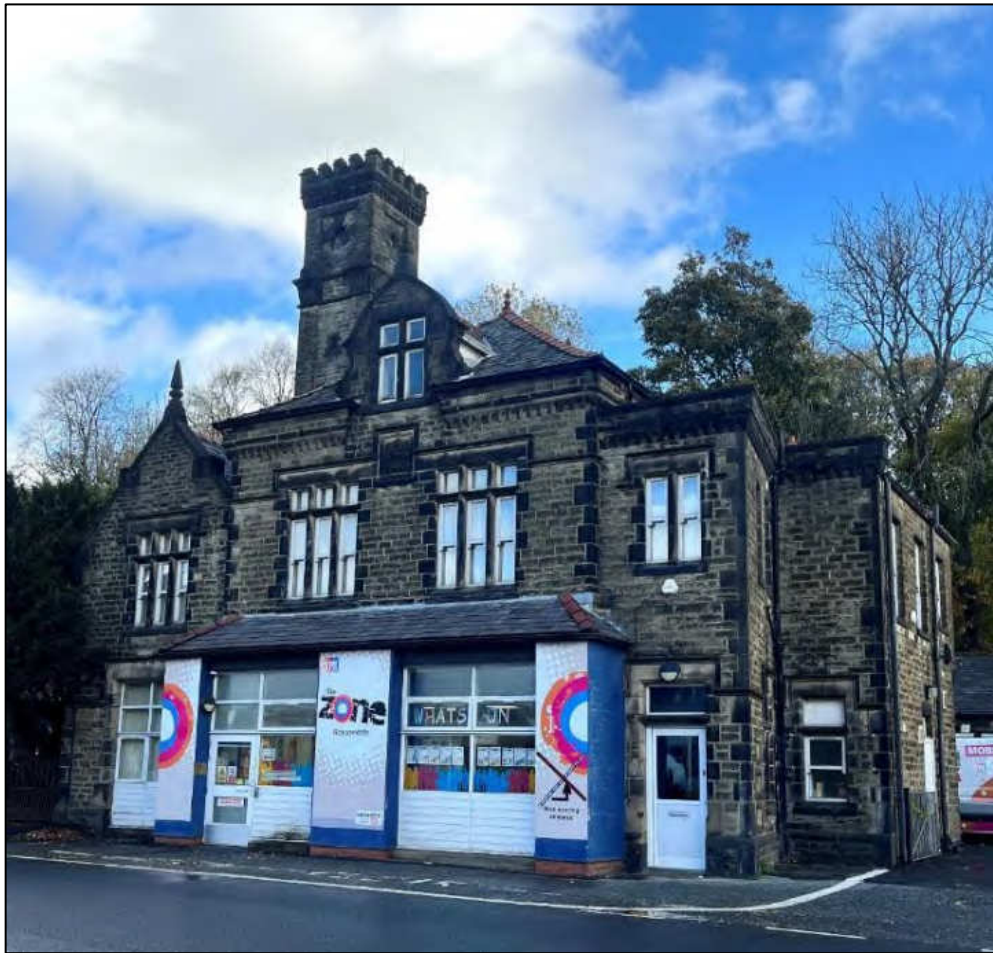
Asset Ref.	Asset Name	Address	Asset Type
NDHA_107	Former Fire Station, Burnley Road	Burnley Road, Rawtenstall	Building

Description
 Eclectic building. Gabled main block is important as is the tower with battlements and circular window. Decorative details include pilasters with flared reeded tops, an upper stage with bullseye openings and deeply undercut Lombard frieze and crenellations [Pesvner]

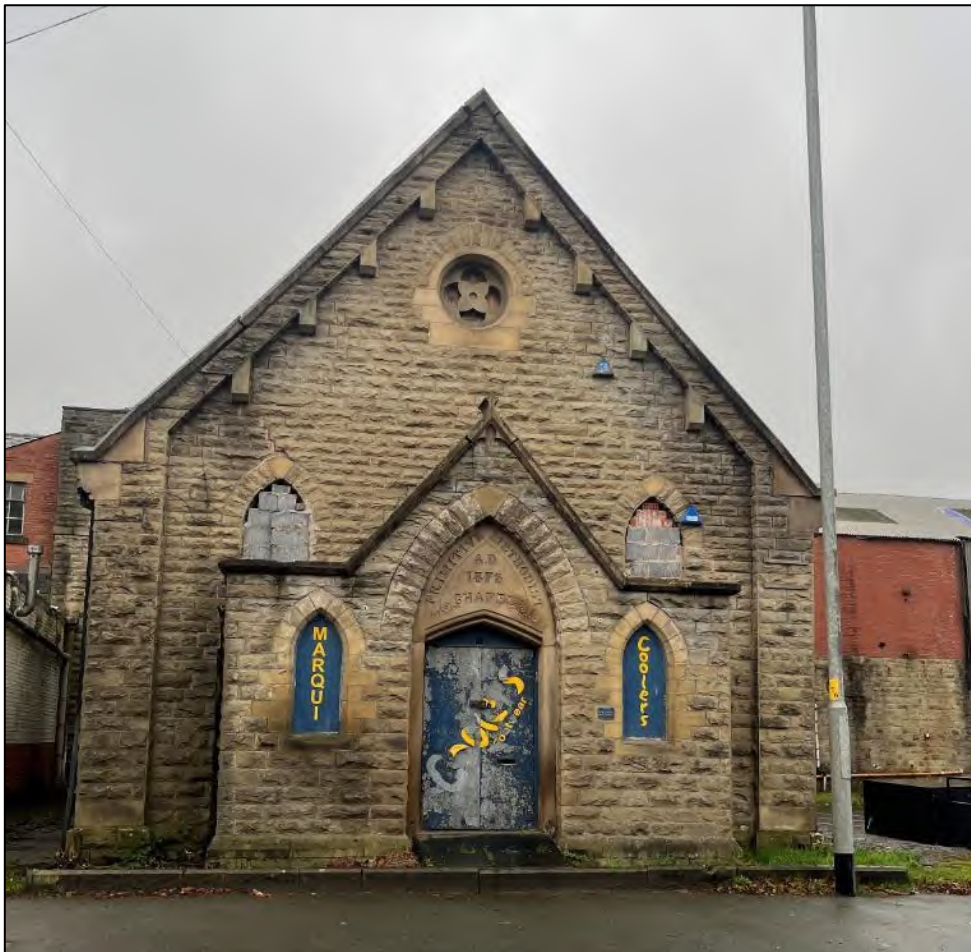
Description
 Small former chapel dated 1873 with gothic style windows and porch. Original on outside providing an important visual break amongst surrounding factories.

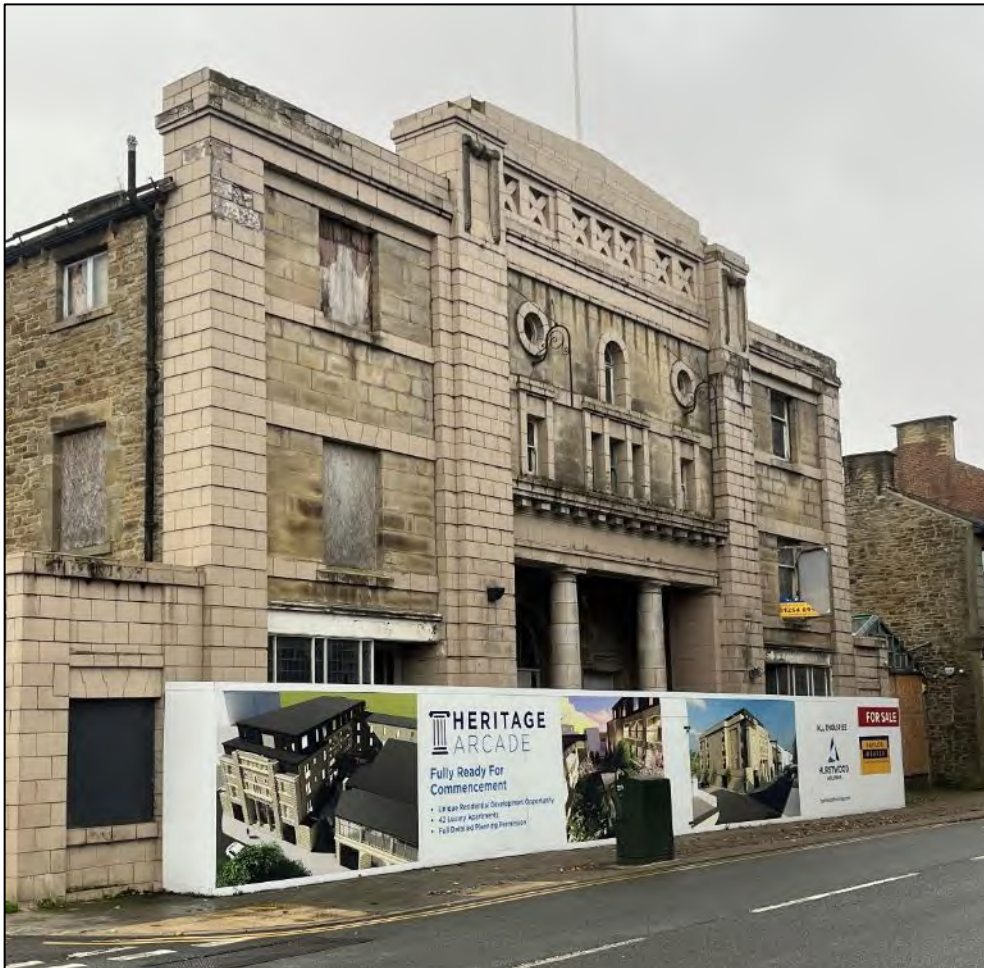
Image

Built 1920 in typical 'Picture Palace' style. Pillared entrance with set back doorways has defied modernisation. Some original stained glass windows remain.

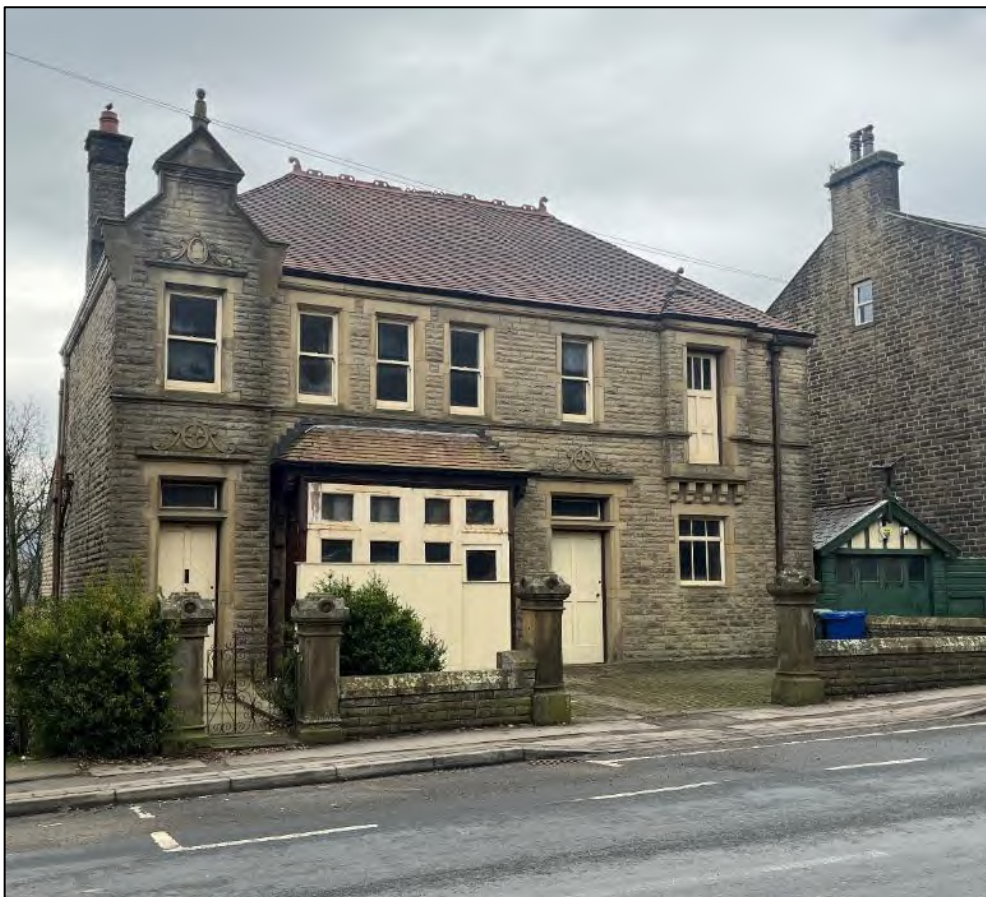
Stable block, possibly built for the adjacent Oak Bank villa. Somewhat elaborate for a stable block with details such as hook finials and decorative ridge tiles, carved stone cart wheel and scrolls, a narrow projecting left bay with a decorative Dutch gable and a projecting FF hay door with pitched roof and hook finial. stone dressing throughout and surrounds for all apertures. Clay tiled hipped roof.

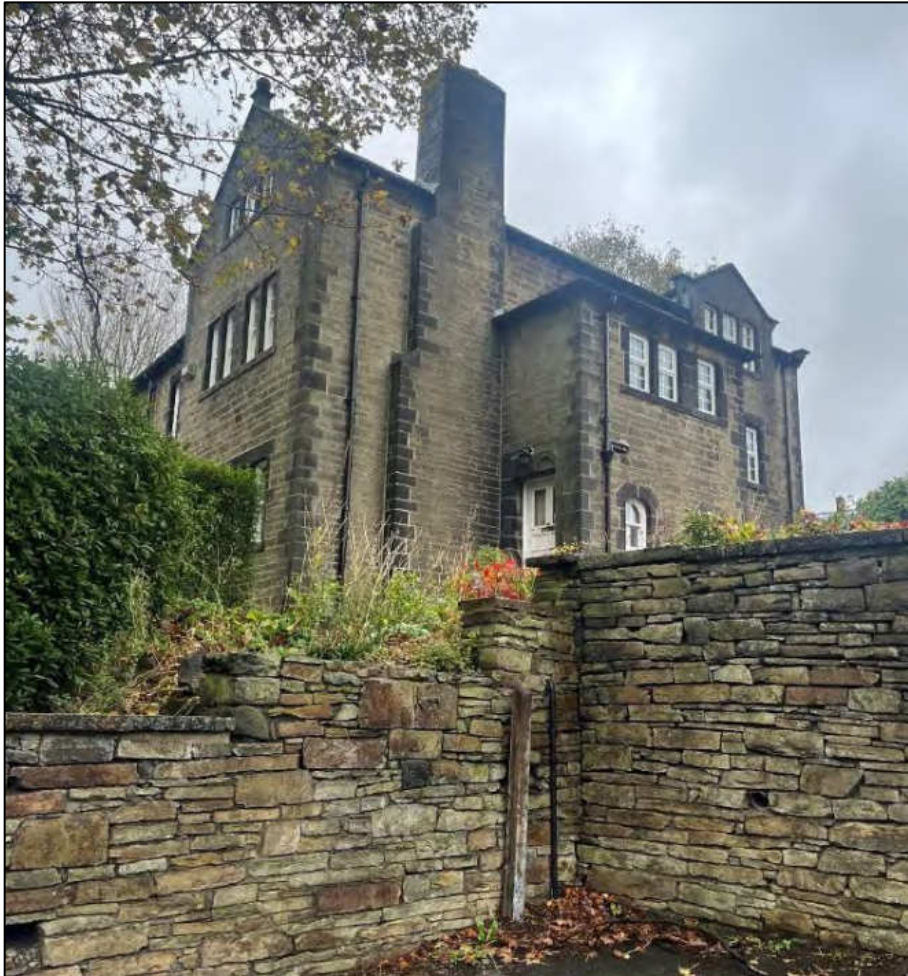
Large stone house with mock Tudor and mullioned bay windows, built c.1906. The design pays detailed attention to the local vernacular style, whilst being true to the Arts and Crafts period.

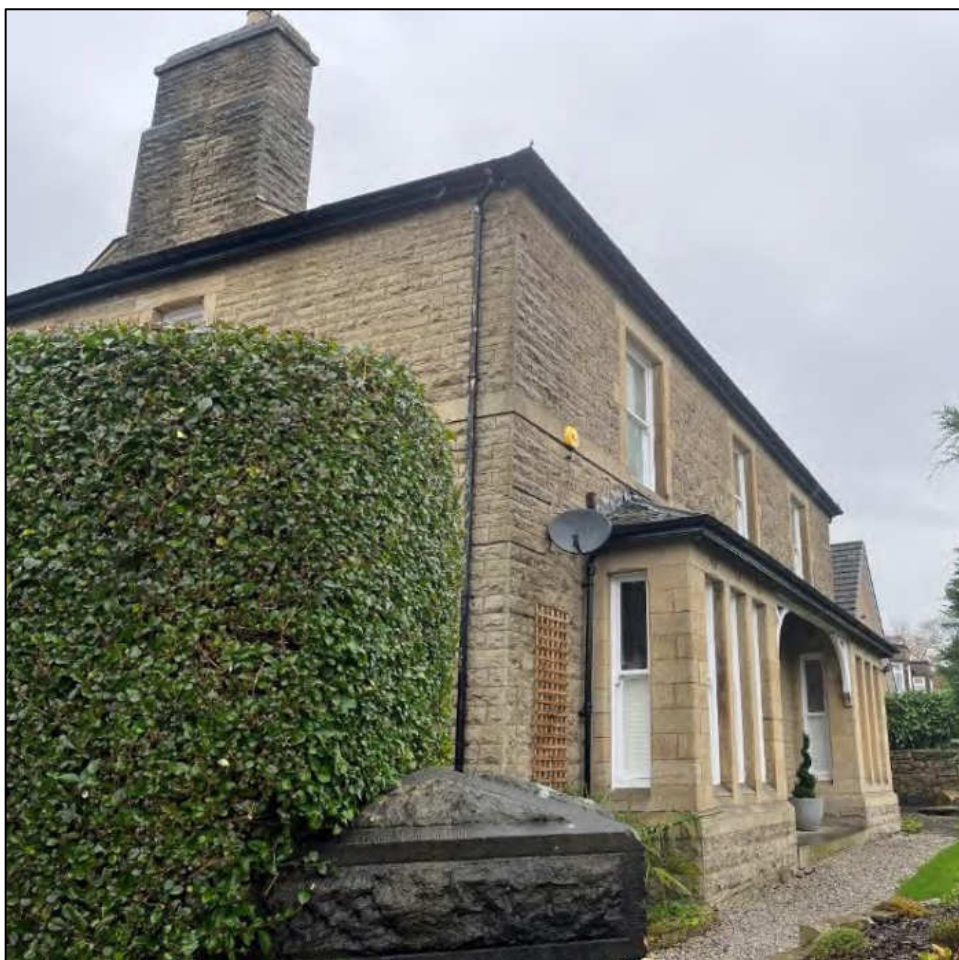
Substantial and well-built Victorian detached house with good quality stonework. Built in 1864 as vicarage for St. Thomas's church, Musbury. Exterior seems little altered.

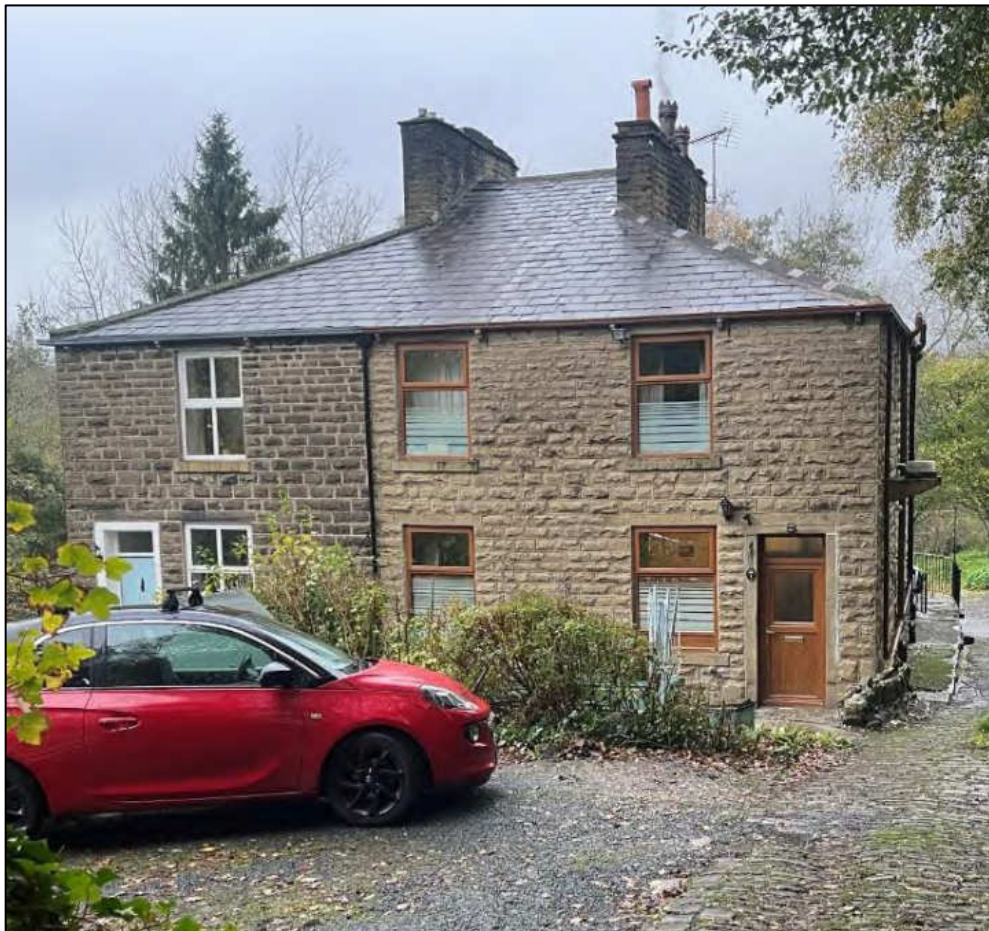
Conglomerate of houses, two storey on front, three on back, c.1840. Basically square in format with a house in each corner. Stone supports for old rainwater tank.

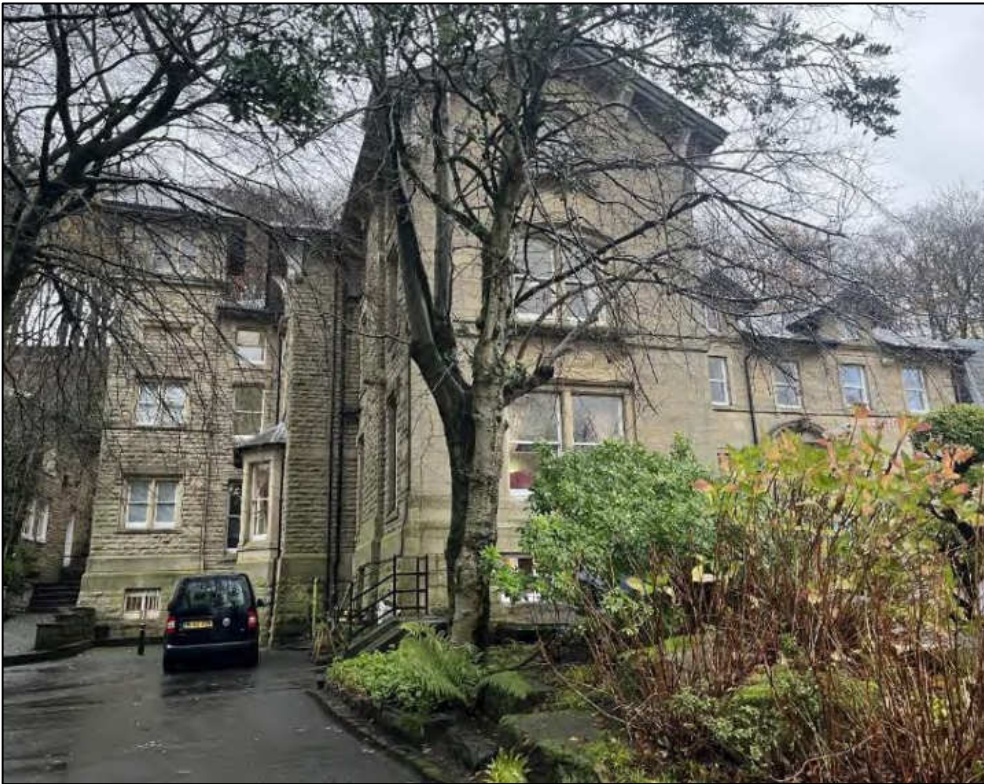
In two distinct parts. The earlier, with Georgian details, already Listed. To the west a large Victorian addition complete with observation tower.

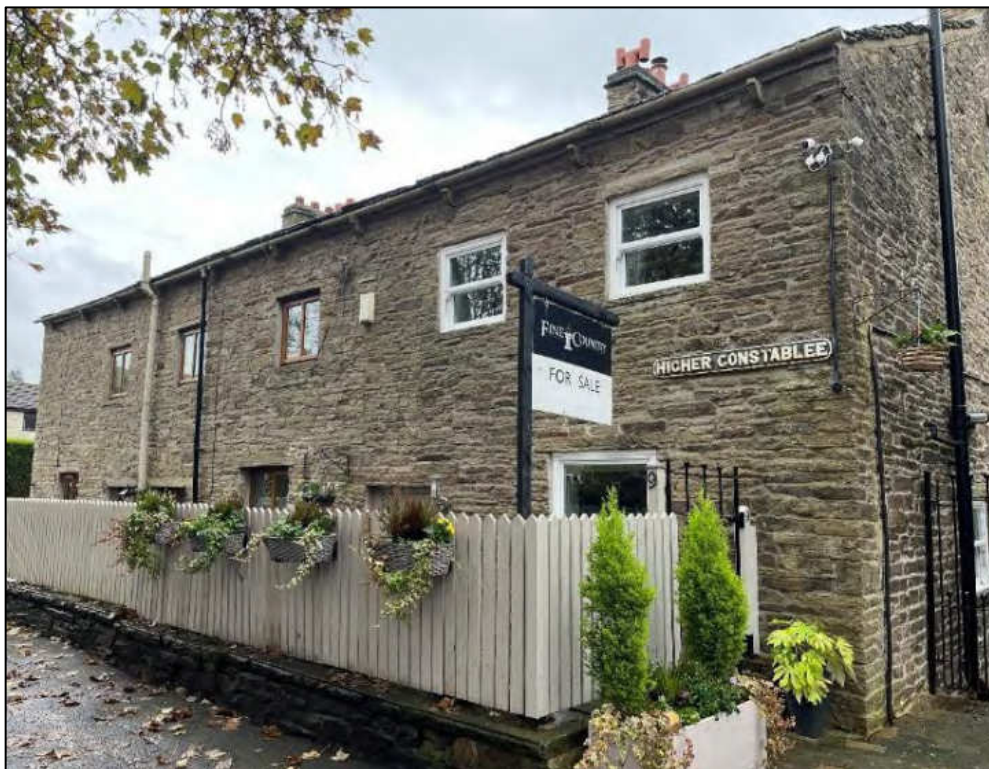
Nos.2 and 4 are Listed and are pre-1700. Terraced row to south of lane dates to mid-1700s and surrounding houses have features (e.g. two storey porch) which indicate early origins.

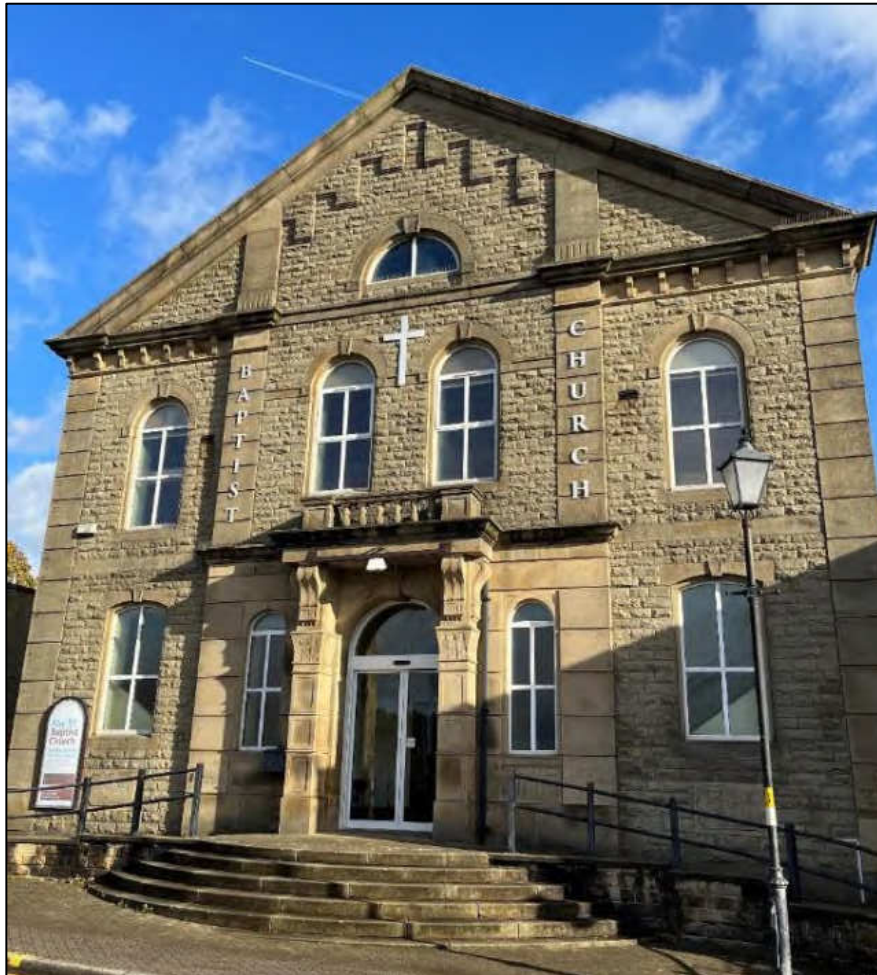
Despite its date (1901), this is a throw-back style to the late 19th century watered down Italianate chapel style. Ground floor is converted for community use, but the chapel upstairs retains the original gallery.

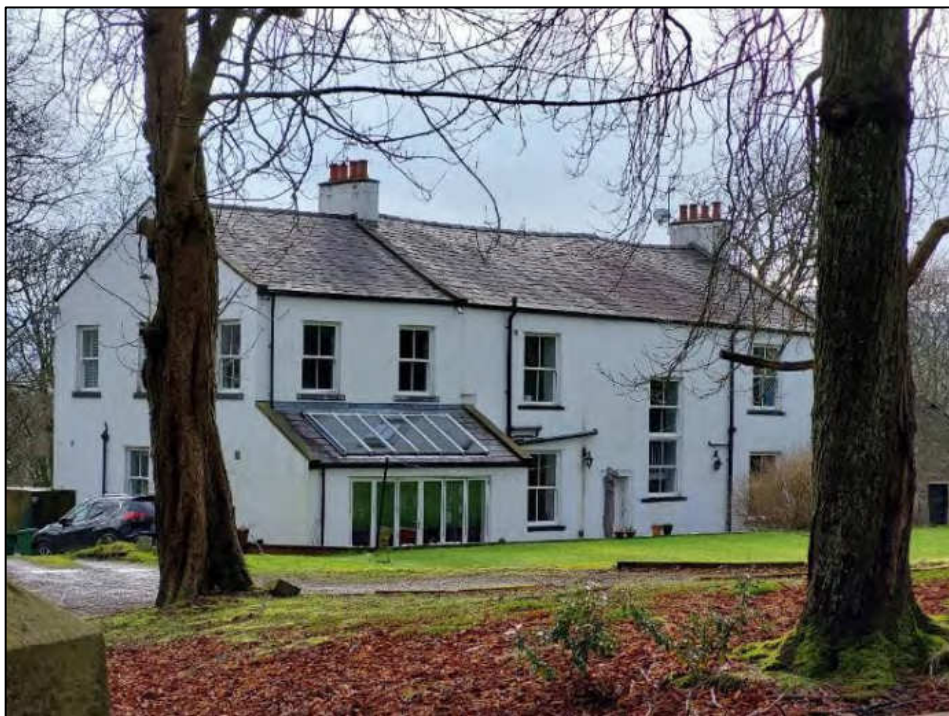
Rendered house with balcony to first floor level, c.1830-1840. Set back from road in own grounds. Two storey with slate roof and two chimneys on the ridge line. The windows have stone cills and are two-over-two, there is a large eight-light window to the rear.

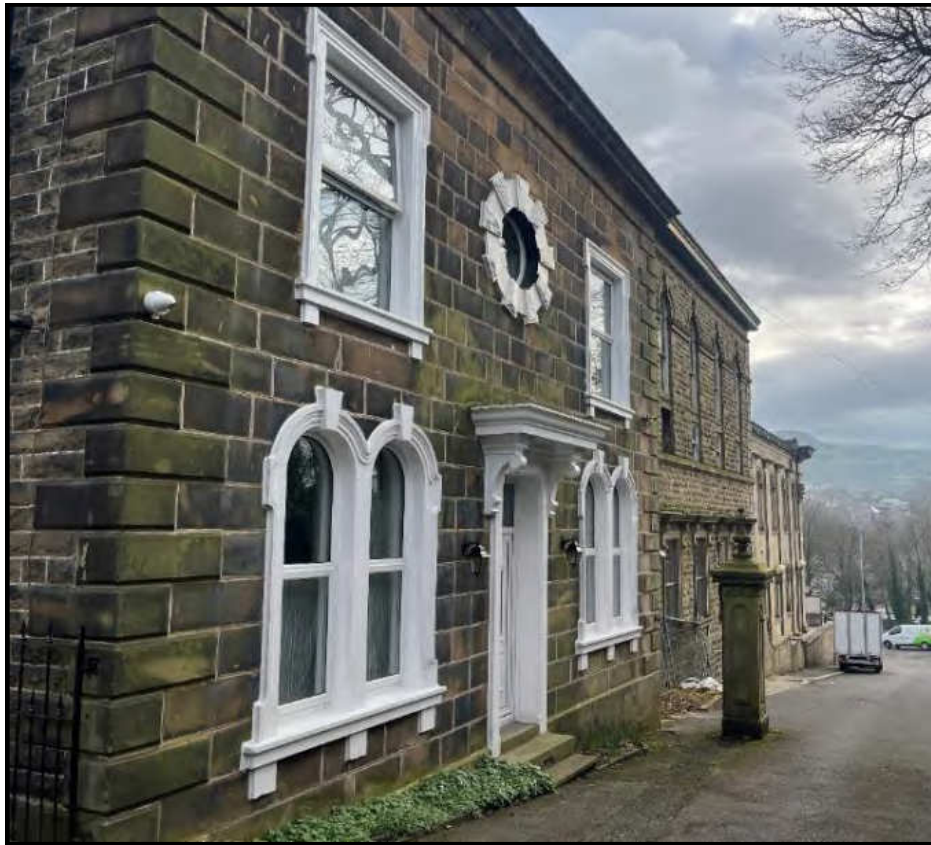
Gatehouse - Two-storey building, constructed from stone with decorative stone details including, quoin's two-light rounded arched windows with keystones to ground floor and a central decorative round window.

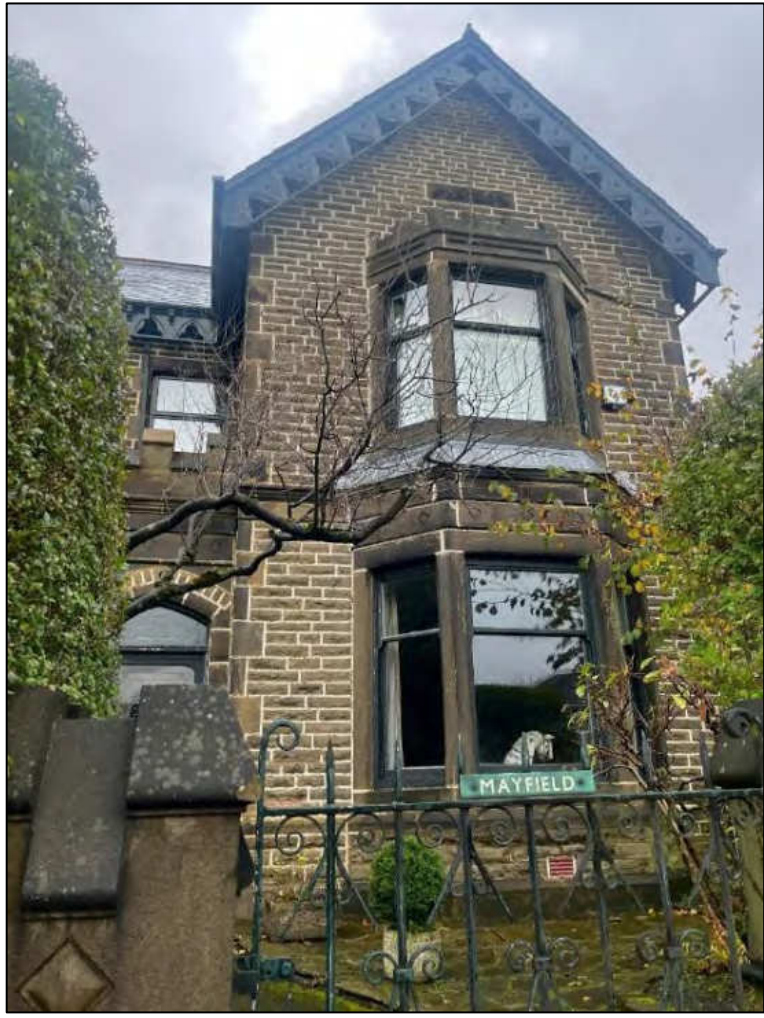
Description
 Victorian Villa built in 1895 and retains many original features.

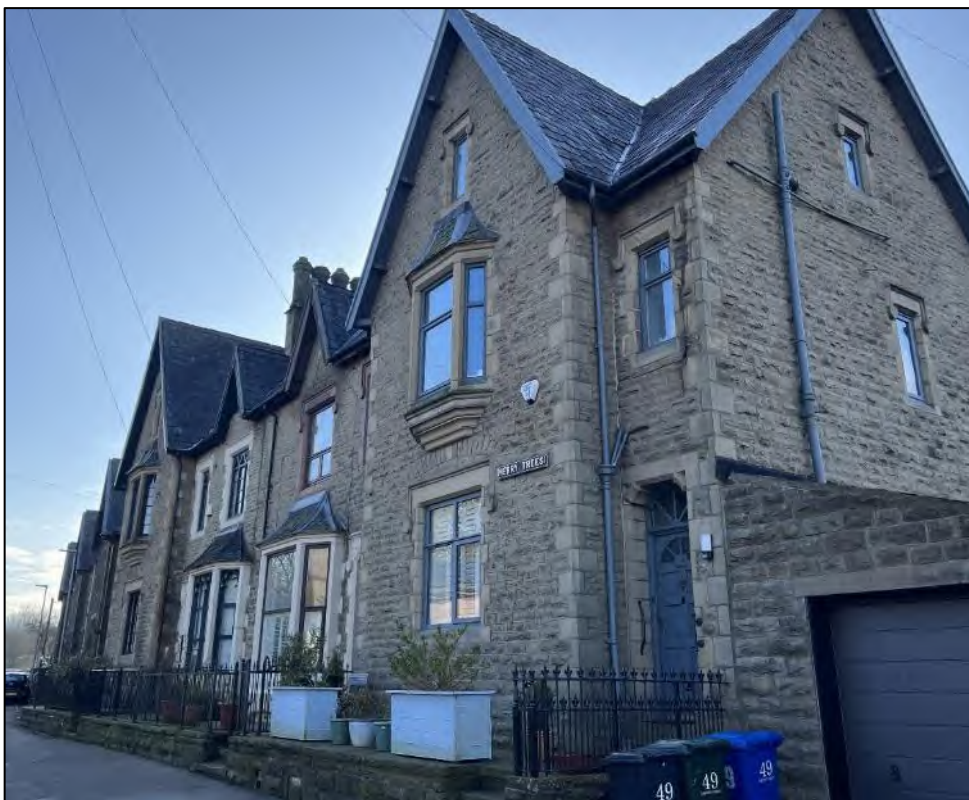
Asset Ref.	Asset Name	Address	Asset Type
NDHA_121	Merry Trees	Fall Barn Road, Rawtenstall	Building

A group of four houses built c. 1850- 60. The two end houses have tall, steep gables, a Williams trademark (see Wesley Villa) and the middle two small gables. All have tall, stone 'Tudor' style chimneys and drip moulds to the inset windows. However, the ground floor windows of the two middle houses are shallow bays, and the first floor windows of the end houses shallow 'oriels', all with elegant French chateau type canopies. The left middle and end houses retain their original elaborate cusped window frames. All four are set on a high plinth accessed by stone steps above the narrow road. The quality of the stone work is remarkable.
