Draft Rosendale Local List of Non-Designated Heritage Assets

December 2024

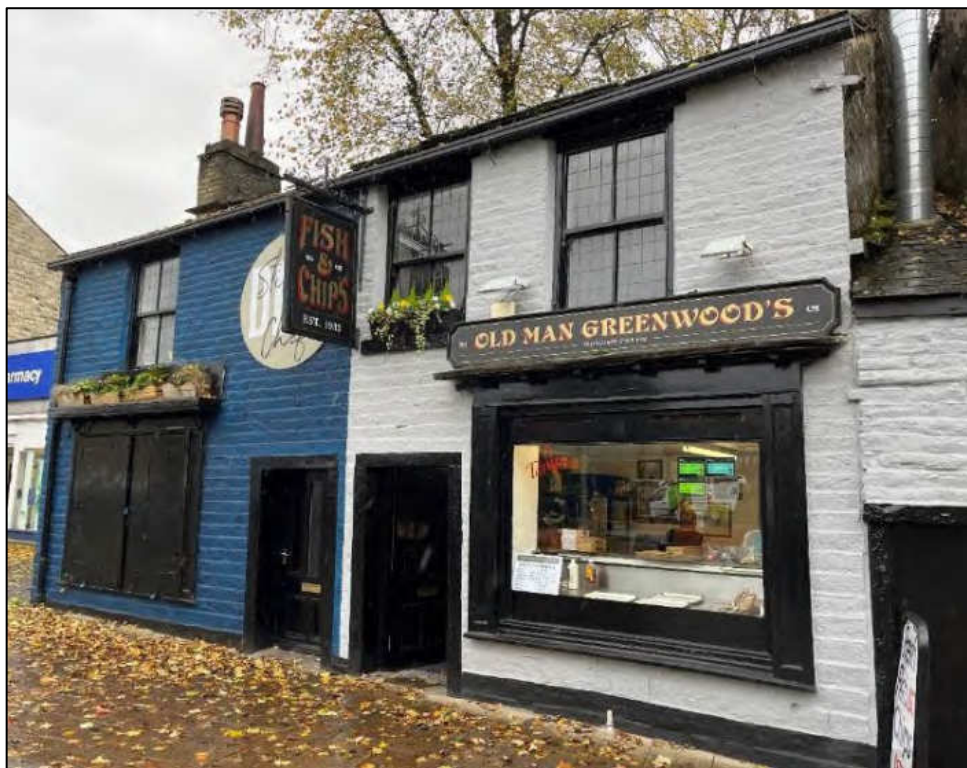
7 and 7A Bank Street are a pair of two-storey shops, proportions are typical of scale of town in late 18th century. They are constructed from water-shot sandstone which has been painted. Each has a timber shop window and door at ground floor level, the door openings are small with stone surrounds. At first floor level are two-over-two sliding sash windows, the pair have gable end chimneys. There is evidence of a taking-in door at first floor level on the east gable end.

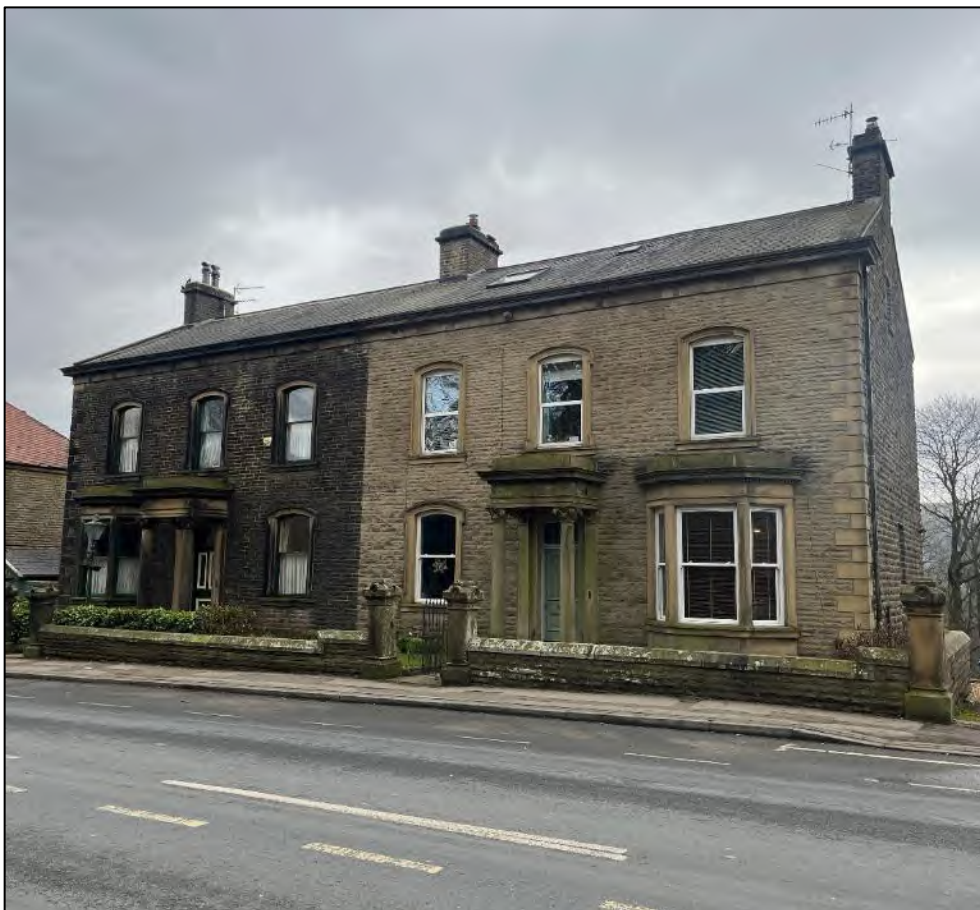
Adjoining pair of double fronted villas built c.1890. Central door with Corinthian columns supporting large entablatures. Bay windows flank the outsides to ground floor; moulded jambs and lintels on first floor.

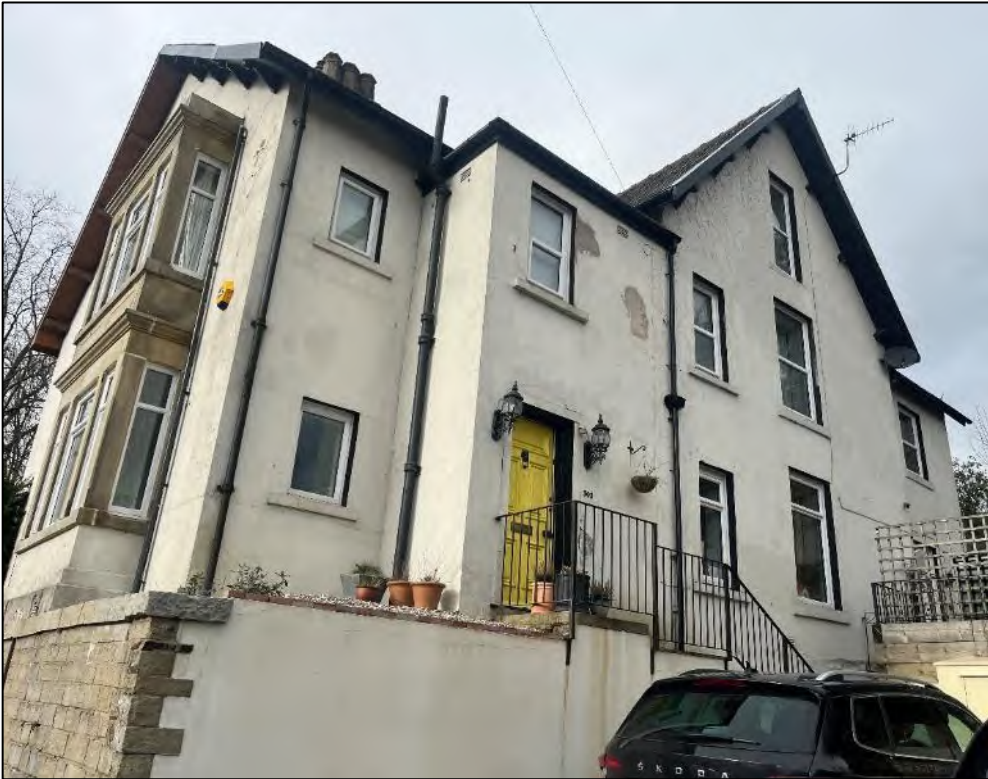
Description
Former manse to Haslingden Road chapel, dated 1853. Rendered large detached house with prominent stone square bay windows to front.

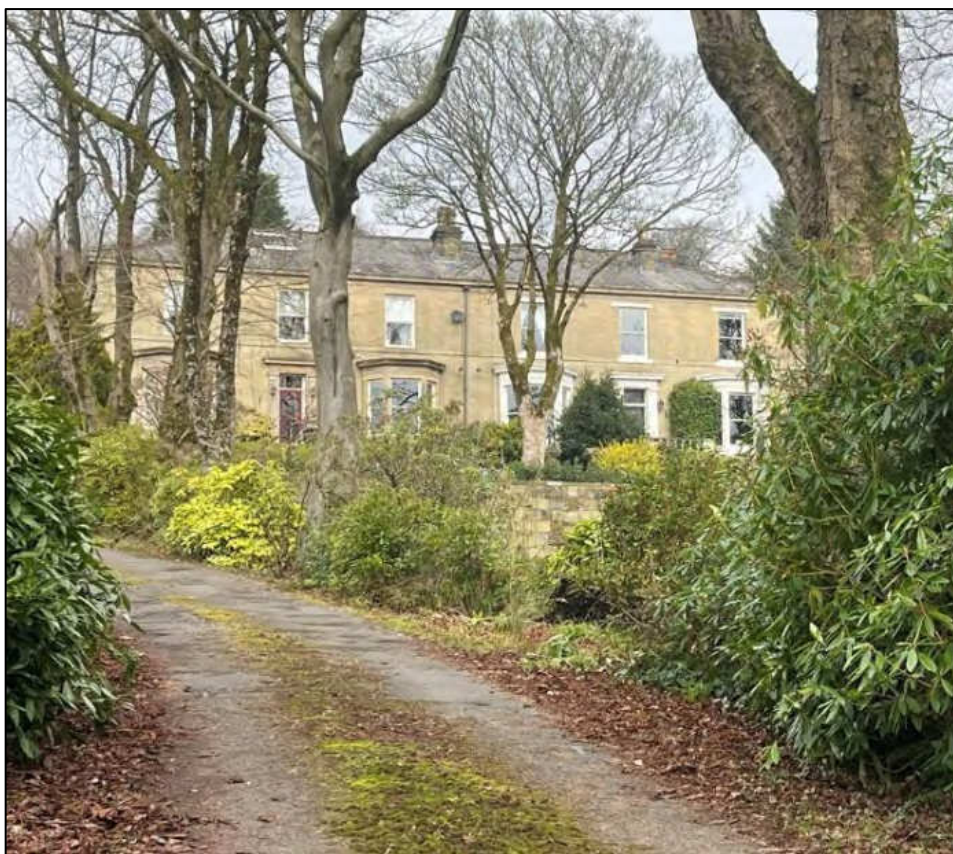
Dated 1865. Pair of Victorian semi-detached houses. Accessed via a long drive, through original gated entrance with low rock-faced sandstone walls, curved cast iron railings and matching cast iron gates, all with finial and Fleur-de-Lys motifs. The gates are attached to the original stone gateposts. The houses are two-storeys, with decorative stone details including quoins and bays to the ground floor. Central stone steps up to the property at the front, which overlooks substantial grounds. The rear of the property is simpler in design with the exception of two tall arched windows, with leaded and stained glass.

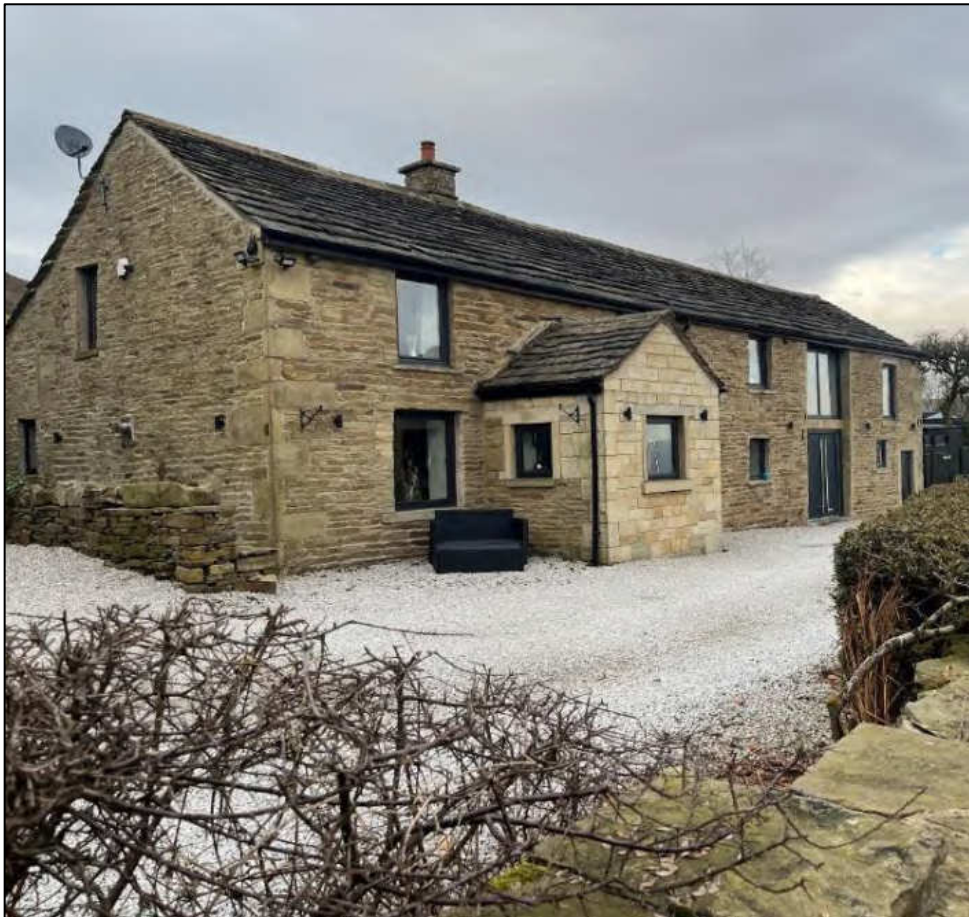
Plain and simple typical Rossendale farm, c.1750. Sympathetically restored with character retained c.1975. Two-storeys, constructed from stone, with quoins and a porch. Would have formerly also been an adjoining barn, now converted, with some features remaining, including the arched cart entrance, rear entrance and 'lean to' aisles at rear.

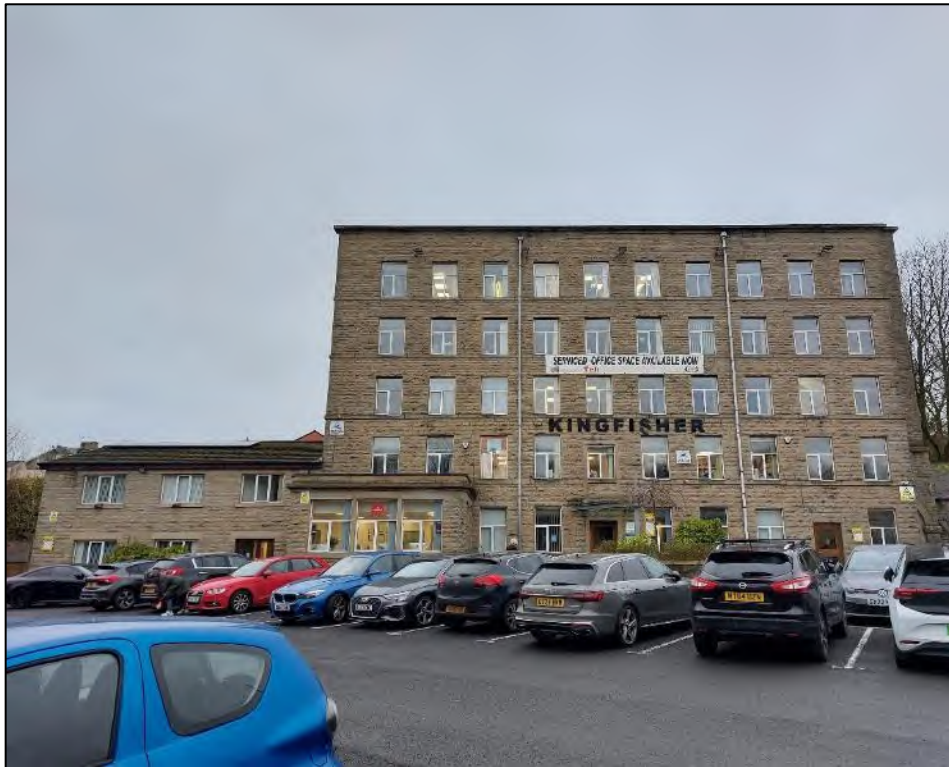
Platt or Star Mill is a five storey building constructed from coursed stone with a string course between each floor, it has a single storey addition on its principal elevation and a two storey addition on its south east elevation. The building is 10 bays wide with a regular fenestration pattern. The building formerly had a chimney adjacent to the south east gable and a single storey range to the front.

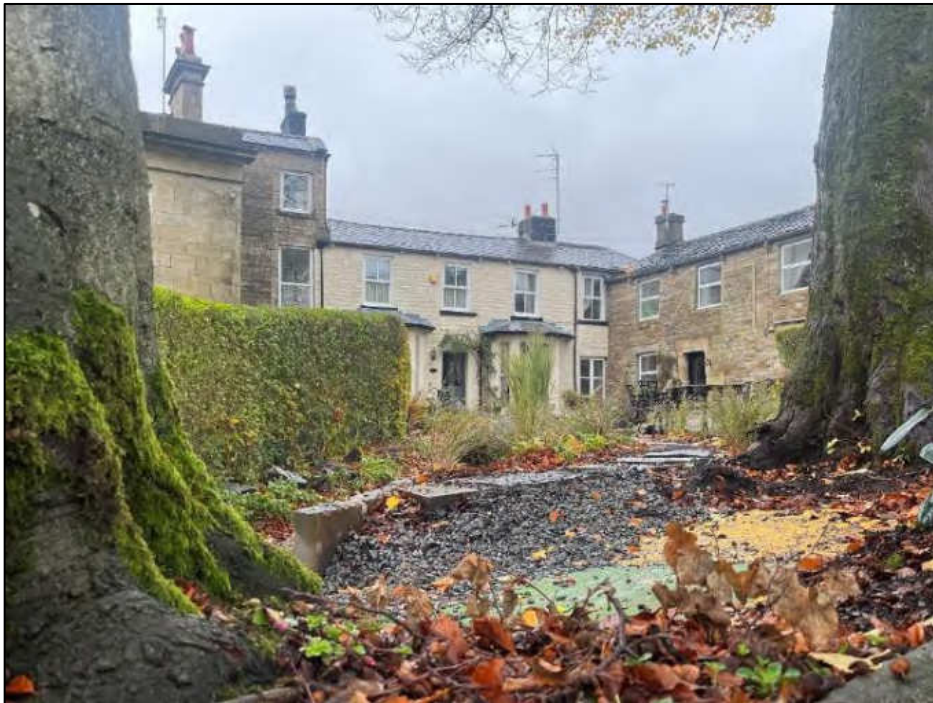
The buildings are 17th-19th century, two storeys high and built from local sandstone, and some retain historic details, such as stone corner quoins. Where they can be seen, the roofs are stone slated.

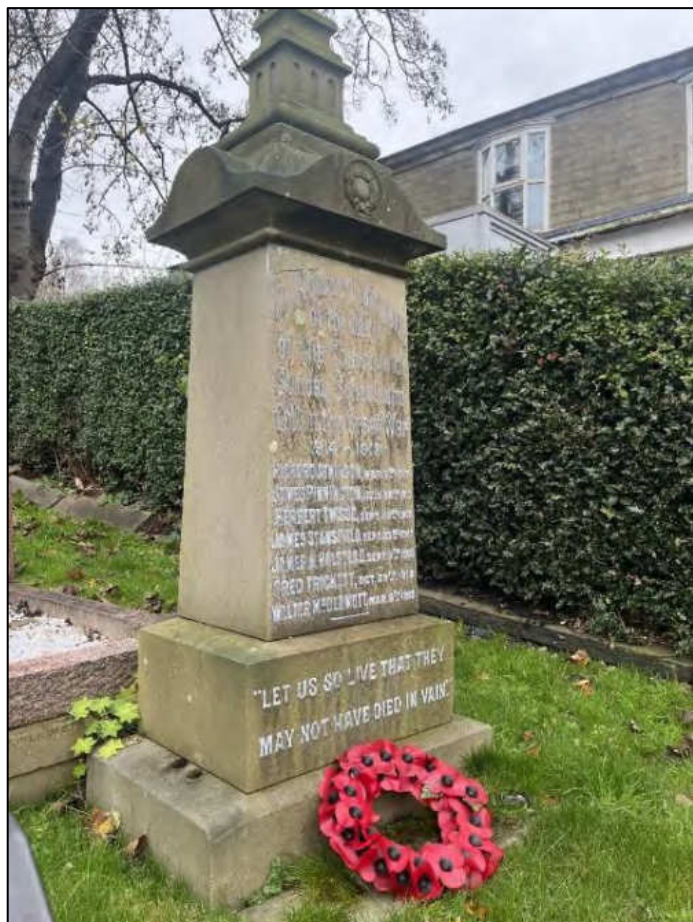
Rawtenstall Unitarian Church war memorial is a free standing pillar with ornate cap set on a square plinth and base. The front face carries the dedication and names on the pillar and plinth. This is executed on raised lead lettering in an ornate font and topped by an engraved wreath. The memorial is dedicated to those who fought in the First World War (1914-1918).

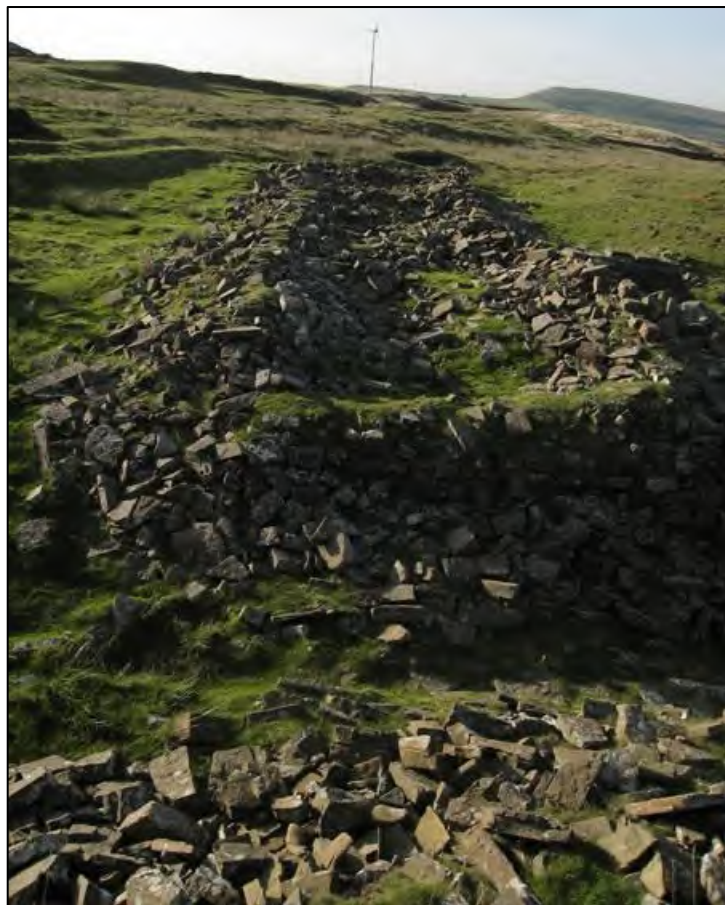
The site is made up of identifiable ruins including a saw shed, loco shed, scrubbing mill and four cottages. The Scrubbing Mill was positioned at the junction of a series of mineral tramways.

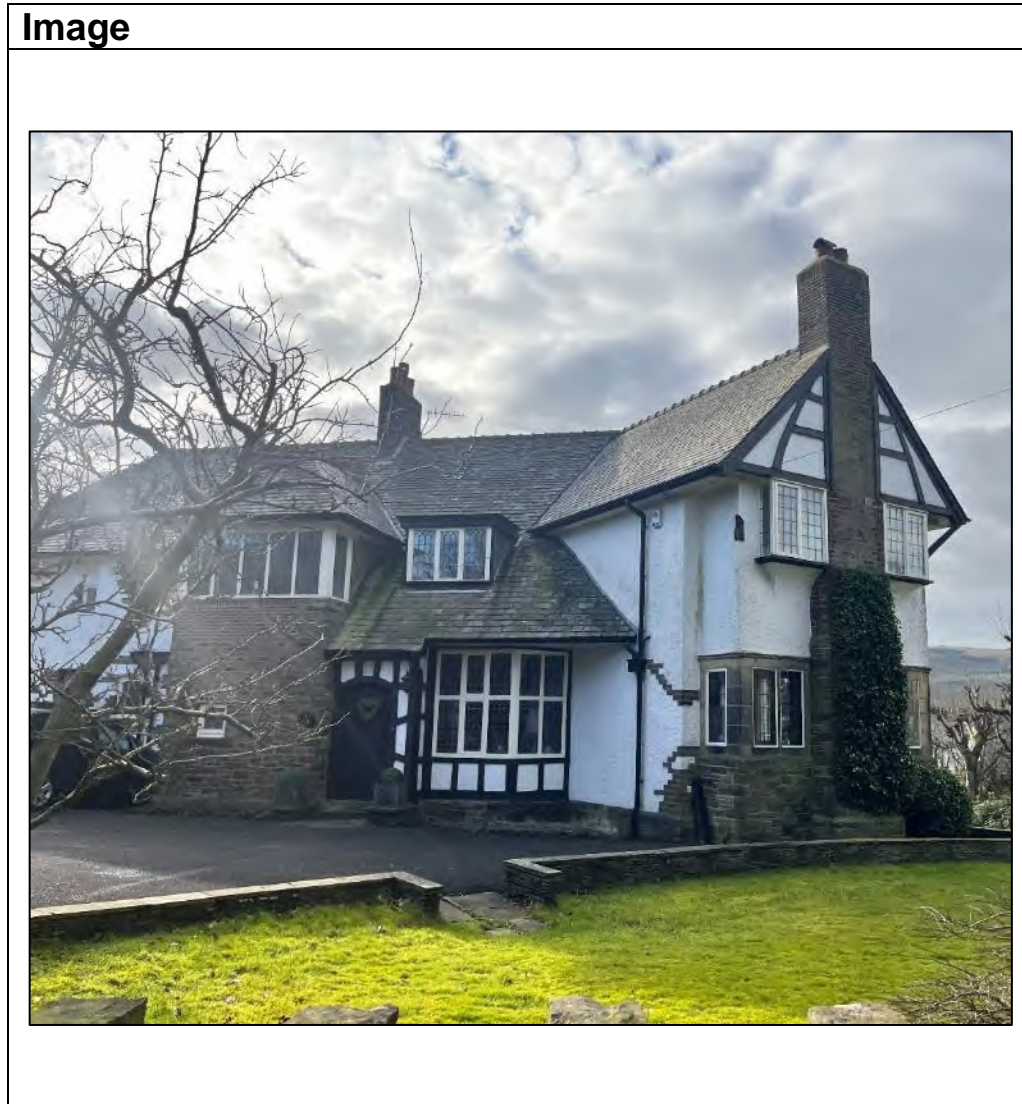
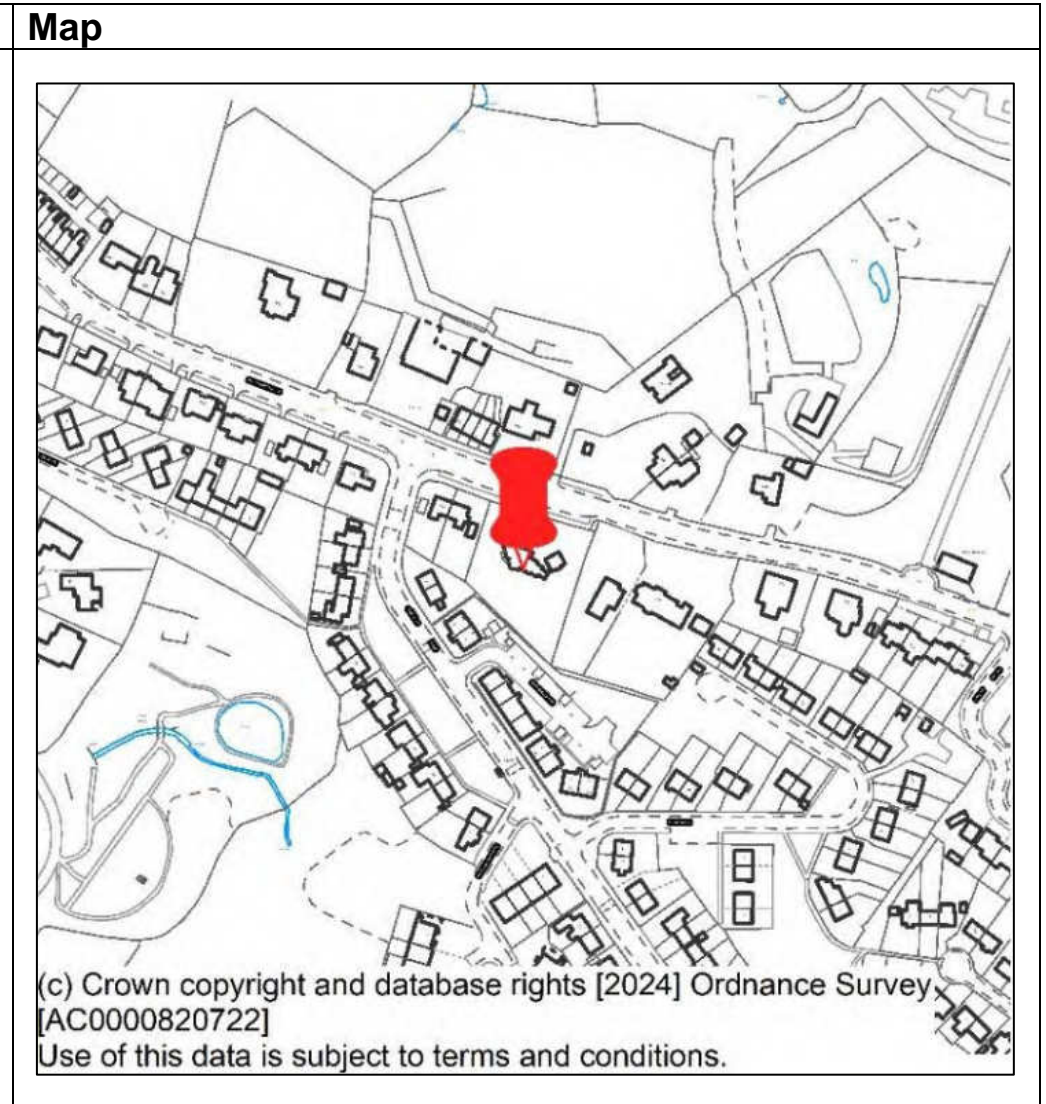
Description
 Superb example of the style applauded by the '1930s Society' built in c.1927.

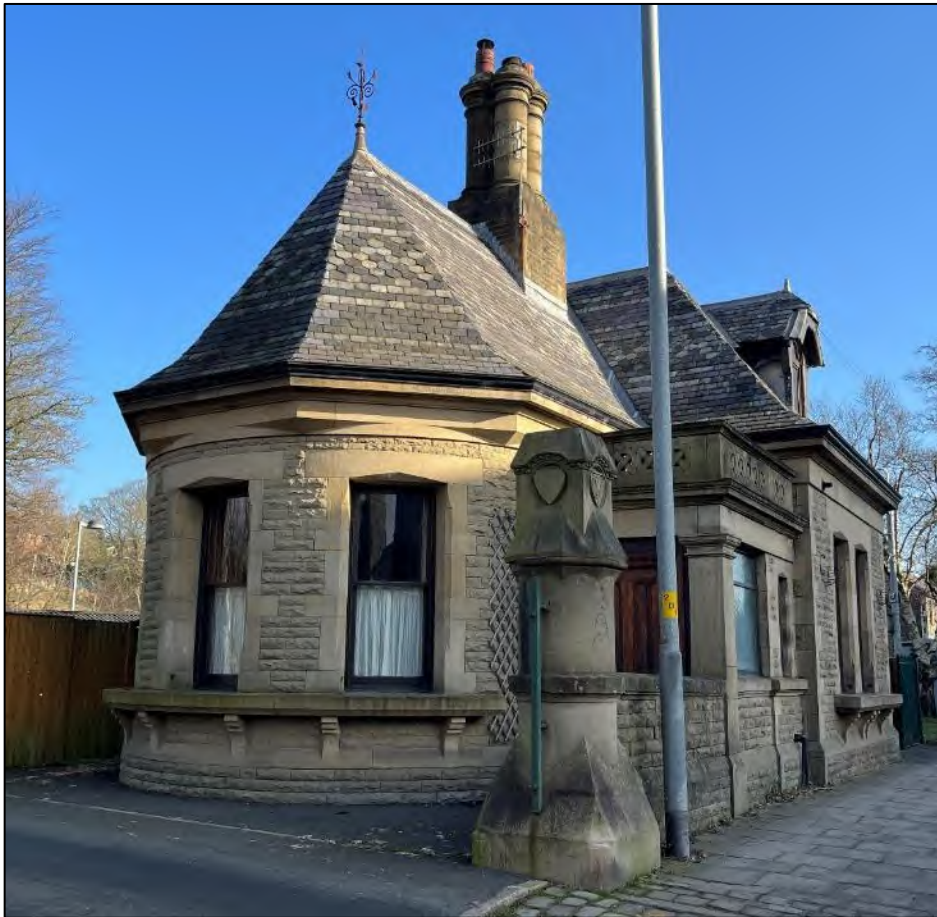
Stone built gatehouse with large semi-circular end topped by a steep roof with decorative slates and metal work. Round end has large bay window with sash frames. Two large gateposts, one with coat-of-arms. Gatehouse and posts are in Rawtenstall conservation area. They are the only remaining structures of the demolished house Greenbank.

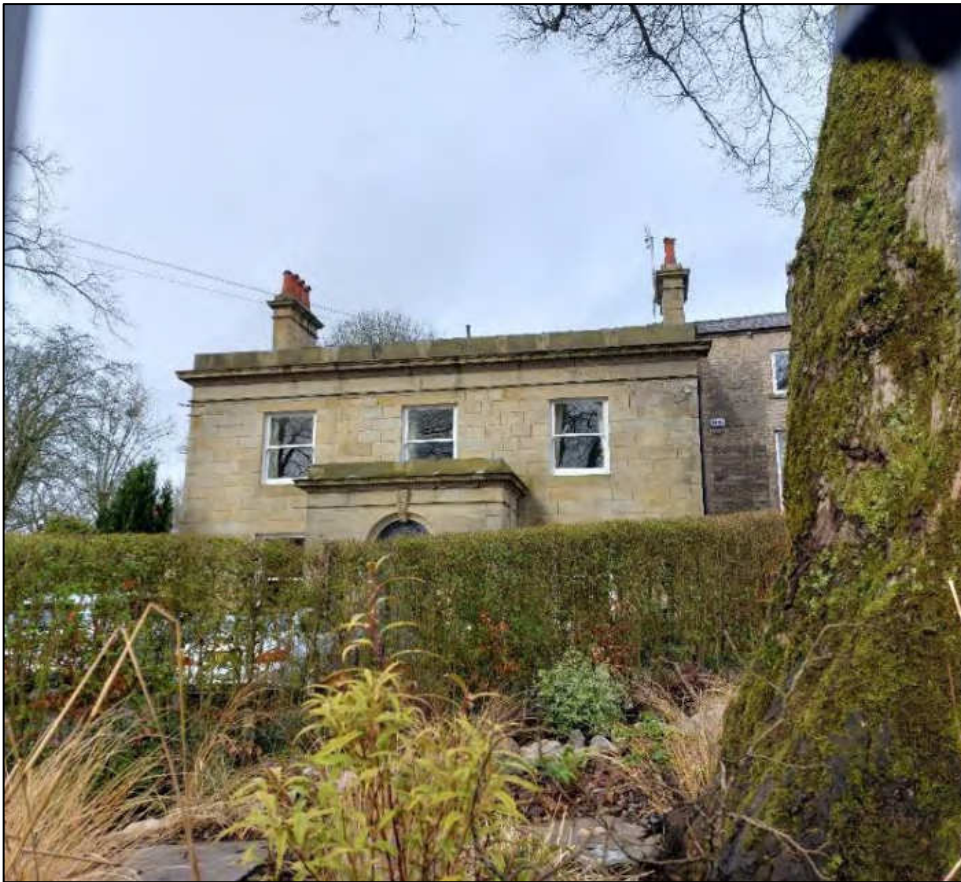
Cubic symmetrical fronted house with stone-flanked porch, c.1860. Stonework throughout is very high quality. Outside very little altered.

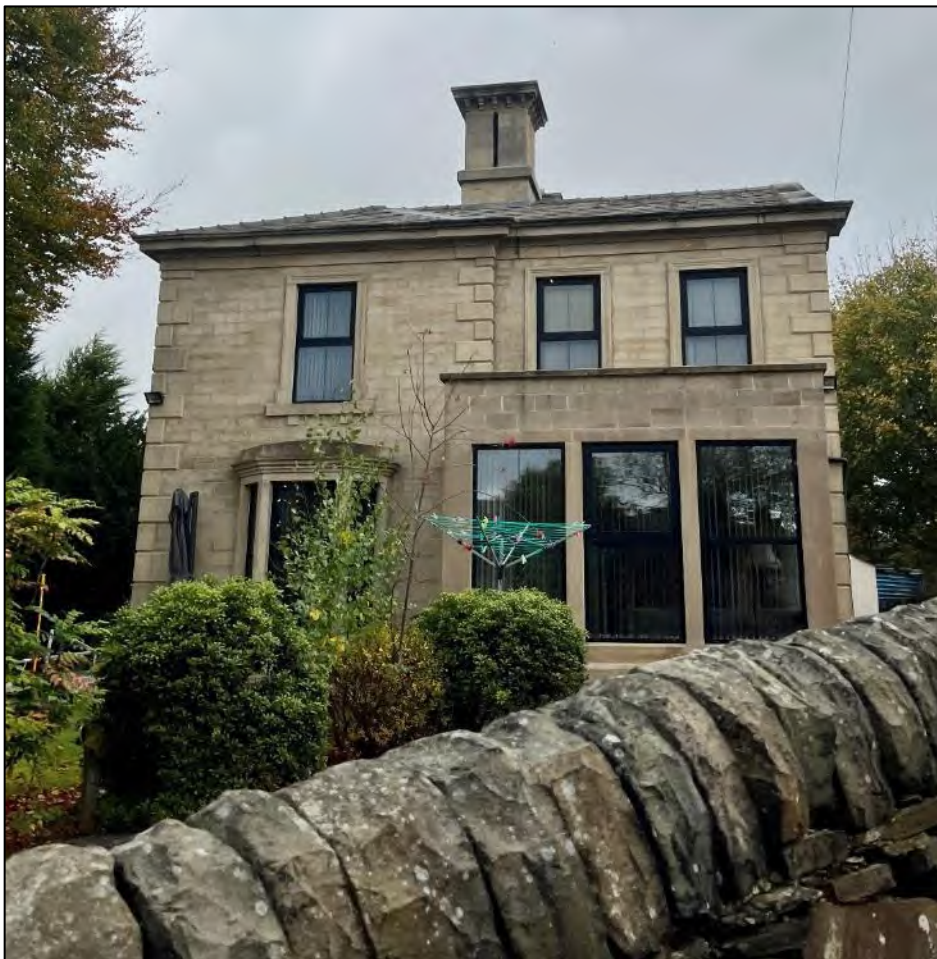
Large symmetrical Victorian house of quality construction with large ashlar blocks all round. Plain but imposing. Has large gateposts to two driveways.

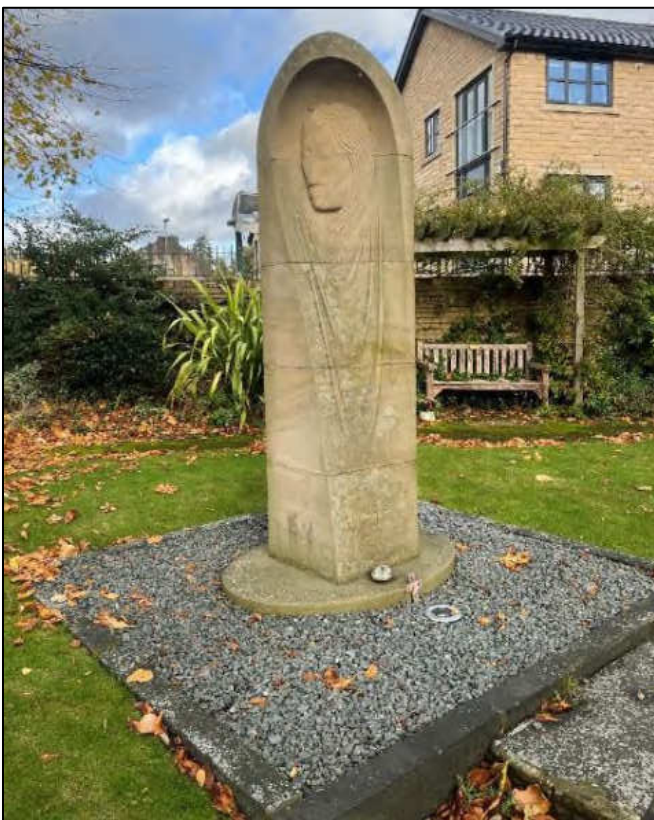
St James the Less war memorial is an upright stone column on a circular plinth set within the grounds of the Church of St James the Less. "The front face of the memorial is a Marian figure standing on an oval plinth, with the dedication: Mary, Mother of Peace, Pray For Us. The figure has a semi abstract face, hooded above a flowing cloak, with hands held in prayer. The cross at the base of the figure echoes the three crosses on the plinth. The side face has a bas-relief image of a mother and baby in arms looking out over headstones. The names and ages of our dead parishioners are inscribed alphabetically beneath. The contrasting sharp edges and sweeping lines create an evocative shape, one which is even more memorable and moving when illuminated at night." (Imperial War Museums).

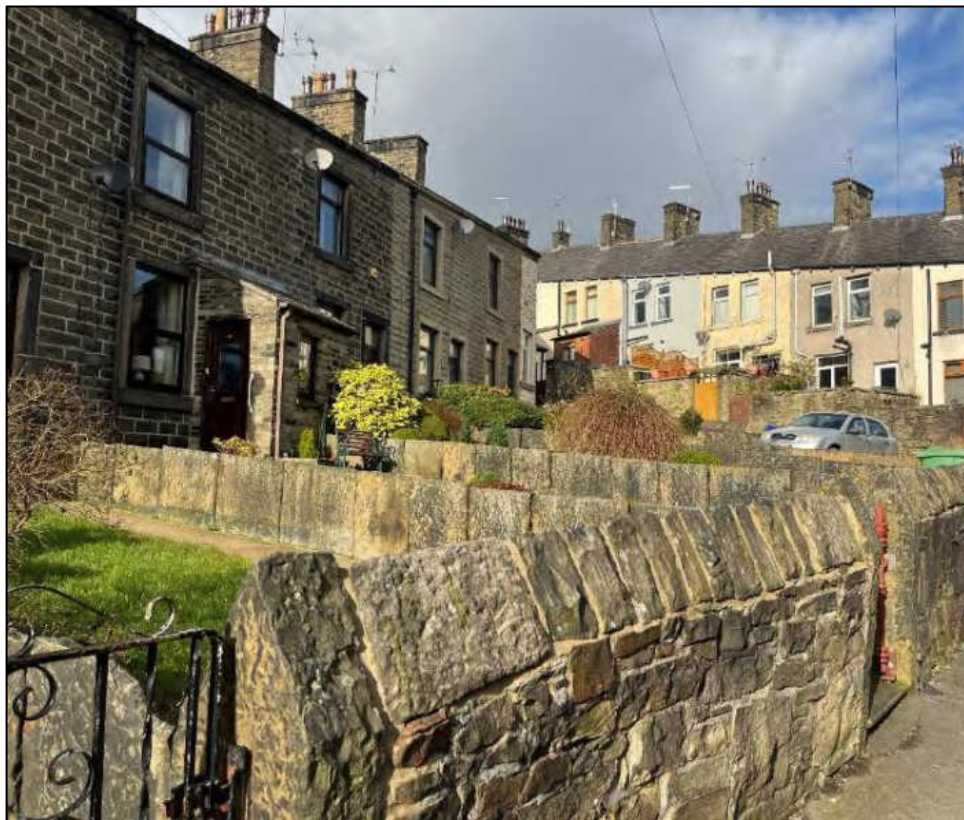
A complete row of terraced houses with gardens divided by upright flagstones. Visually dramatic and unusual; a unique detail of the town centre.

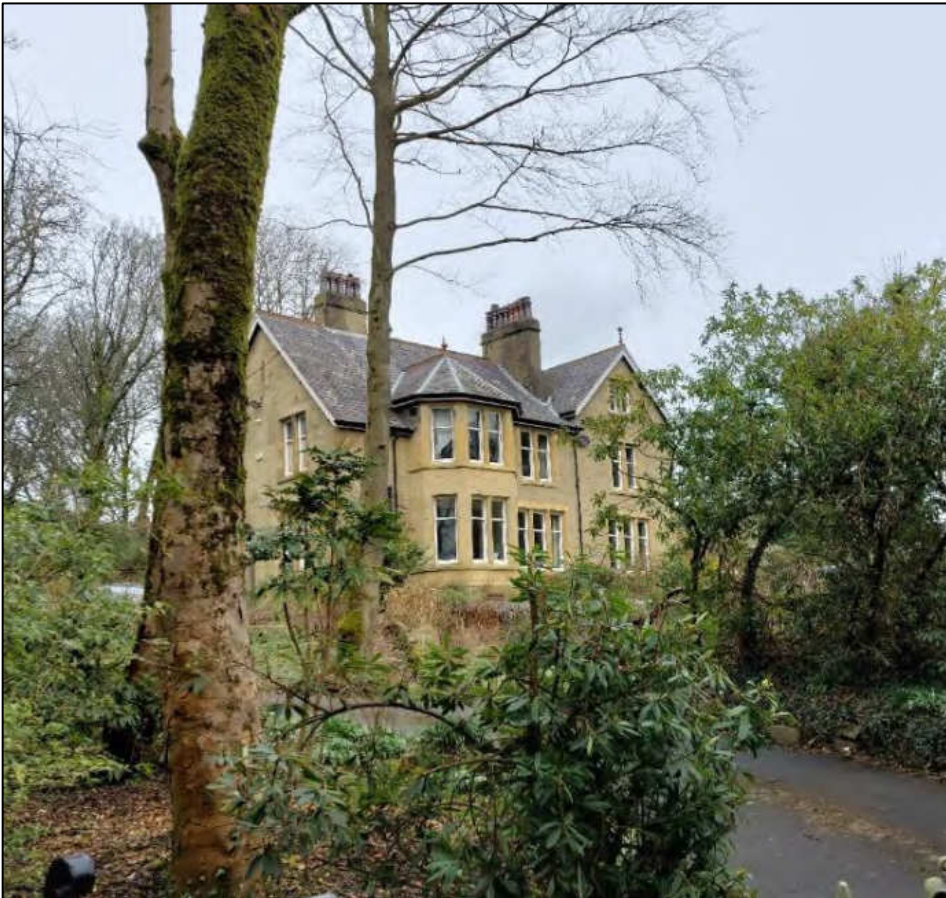
Image

Purpose built 1886 as vicarage to St. Mary's church and as such contains a wealth of church furniture type fittings e.g. woodwork and stained glass leaded lights. Still very original and excellent example of late Victorian style.

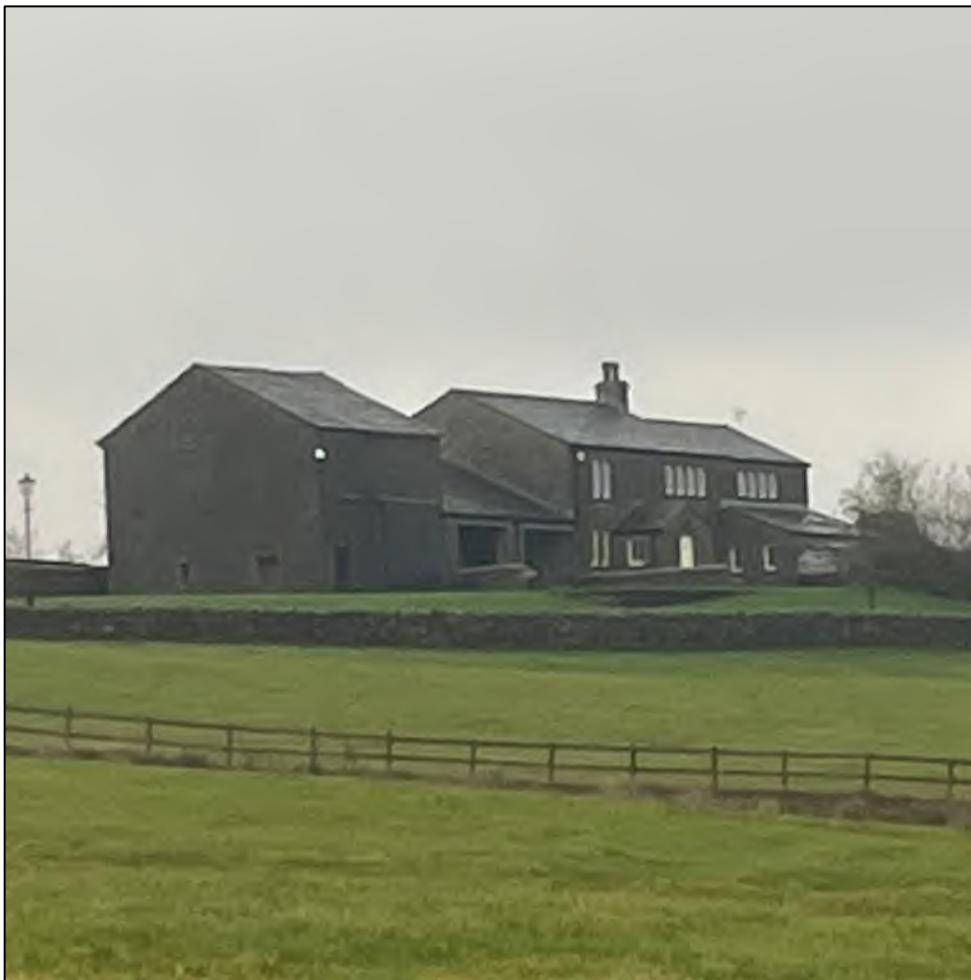
Ta Top Farm is a laithe type house and barn on old route over hill from Water / Lumb valley. The farmstead included a late 18th century farmhouse, a late 19th century cottage, a small barn, and other outbuildings as well as the remains of two other demolished cottages.

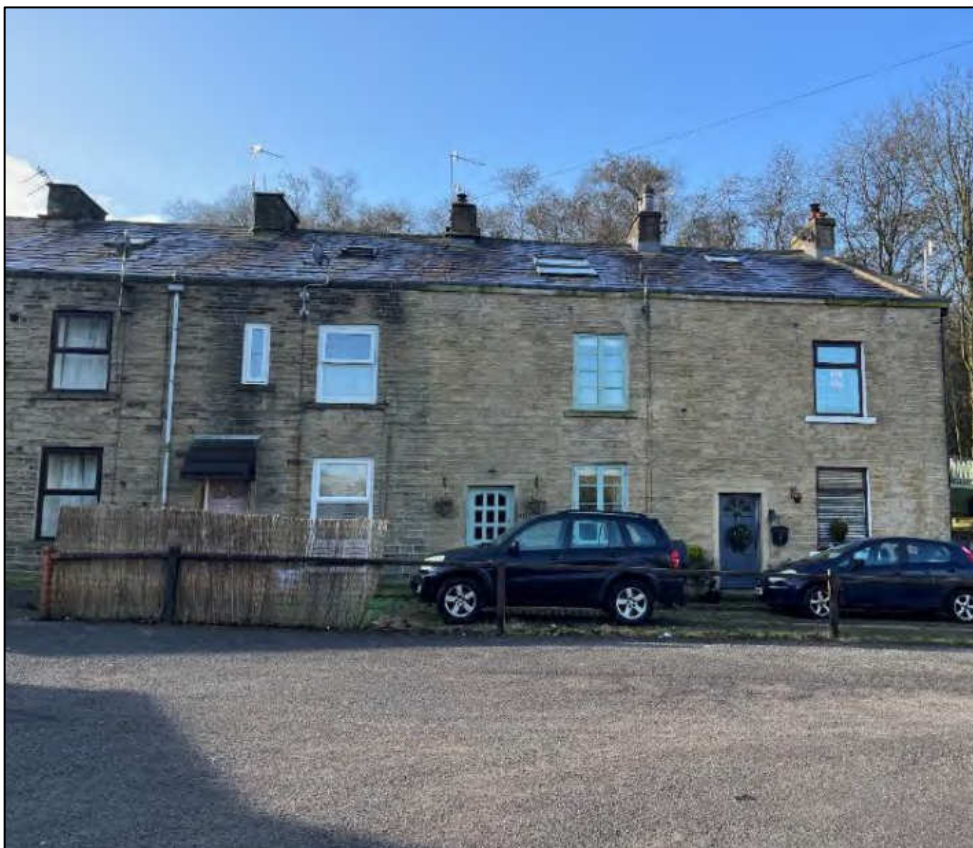
From the front, a row of unremarkable terraced houses, but has triplet stepped mullioned windows to rear, indicating early use as loom shops. Front is in a contrasting plainer style to this. End house is slightly different to the row with the gable being its main façade. Important period piece.

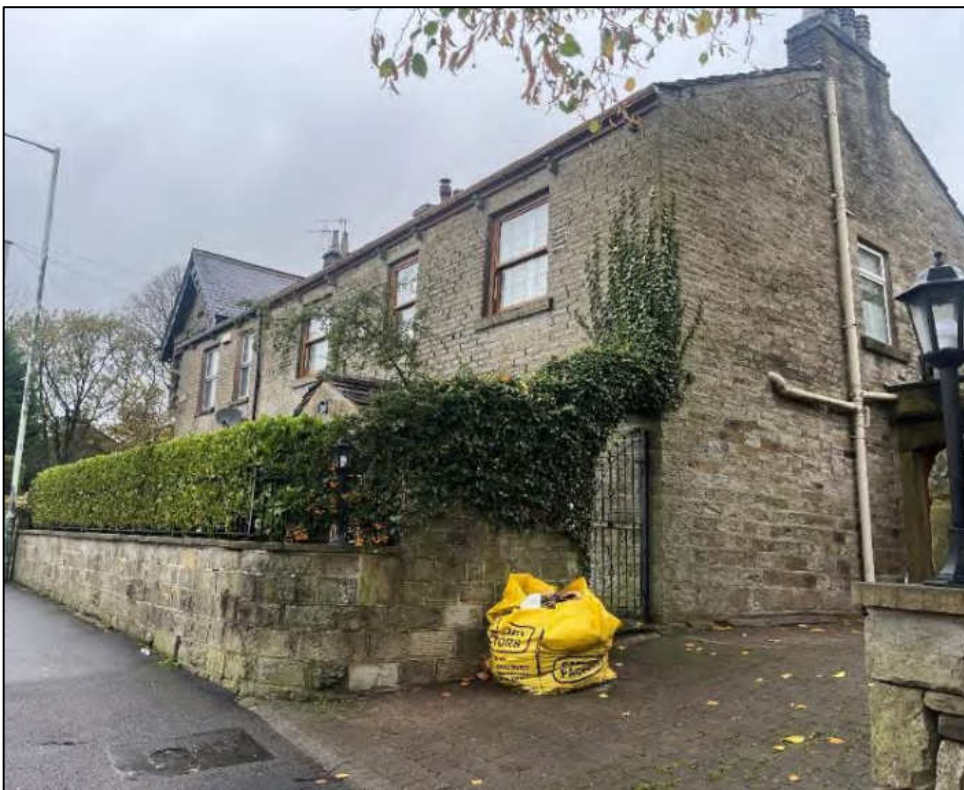
From footprint (404 as main house and 402 as service end) and remaining details (mullioned windows and stair gable at rear) seems to originate from the mid-1700s, modified at an early period for handloom weaving (“takin’ in” door on gable). The Cross was further modified to turn it back into a dwelling about 1840, (hence the present window form on the front), ‘modernised’ in the 1870s and again to accommodate bathrooms etc. in the mid-20th century.

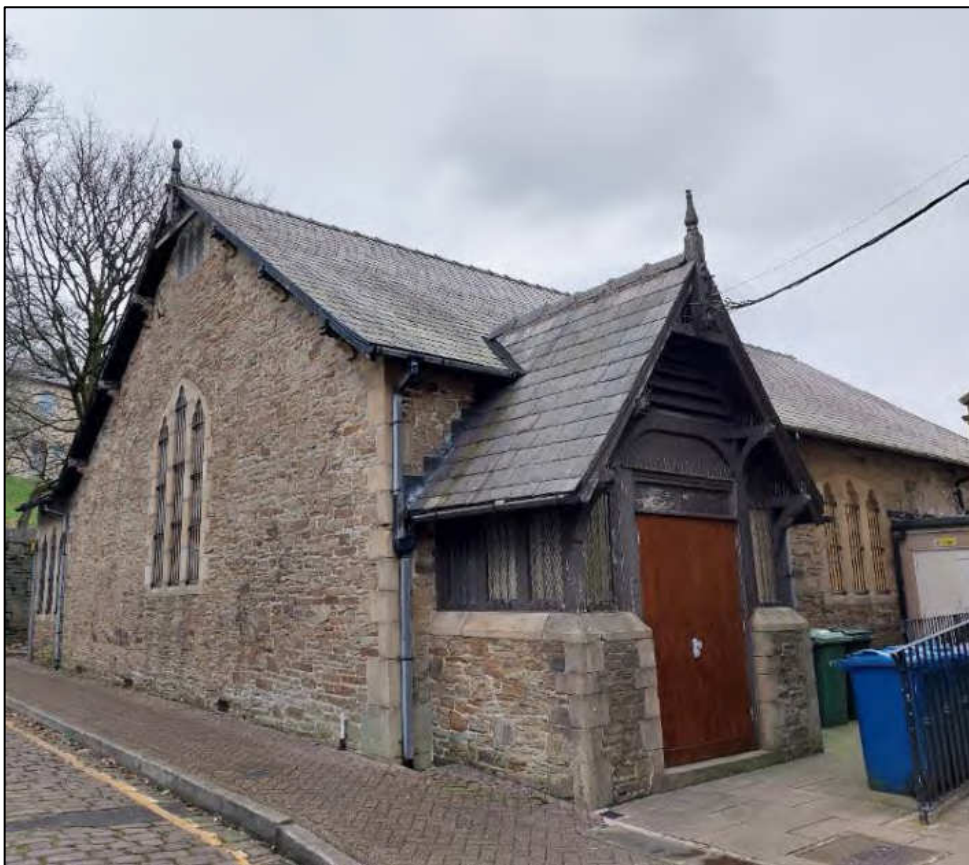
This is a former Baptist chapel, now used as the church hall and meeting rooms, to the rear (northeast) of Kay Street Baptist Chapel, which it predates. The cornerstone for the chapel was laid on the 15th of July 1876.

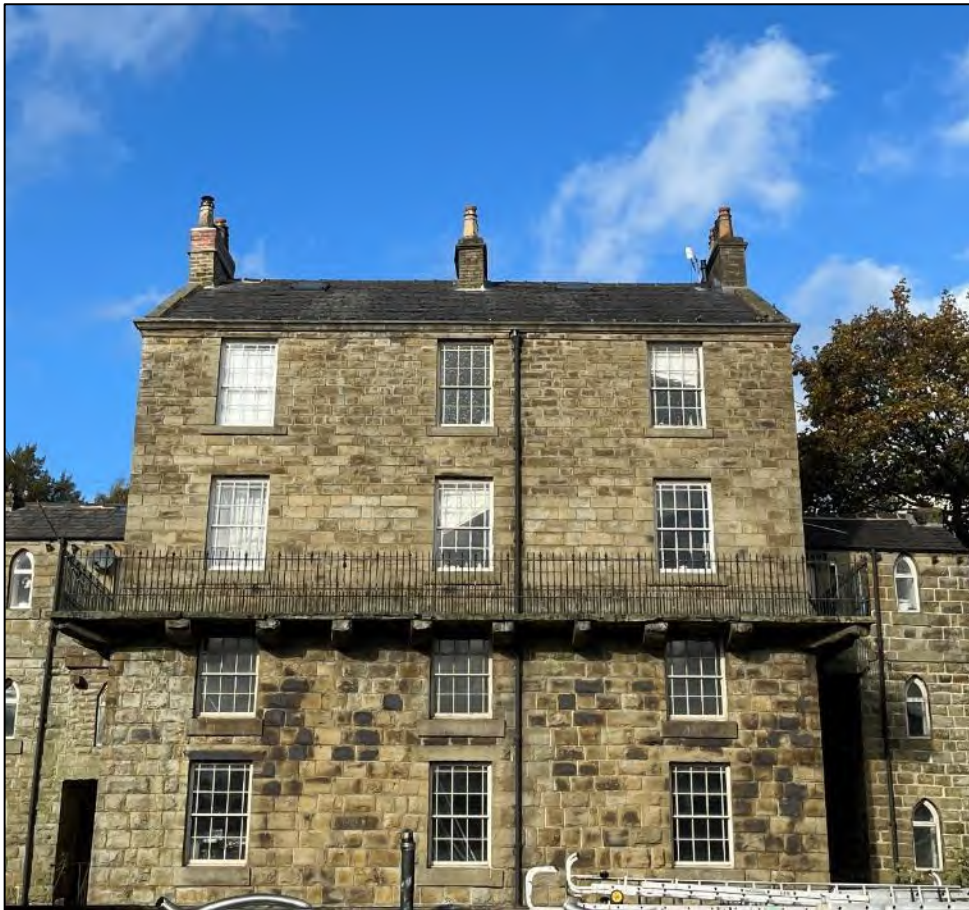
Built as a Georgian gentleman's residence with a three storey workshop supporting the back on the steep edge of the river bank, and fashionable 'pavilions' disguising further workshops on each side. Flights of stone stairs, both in and around the building. It was possibly intended for production of worsteds, as the separate side wings contain sink and fireplace facilities (worsted needed heated combs).

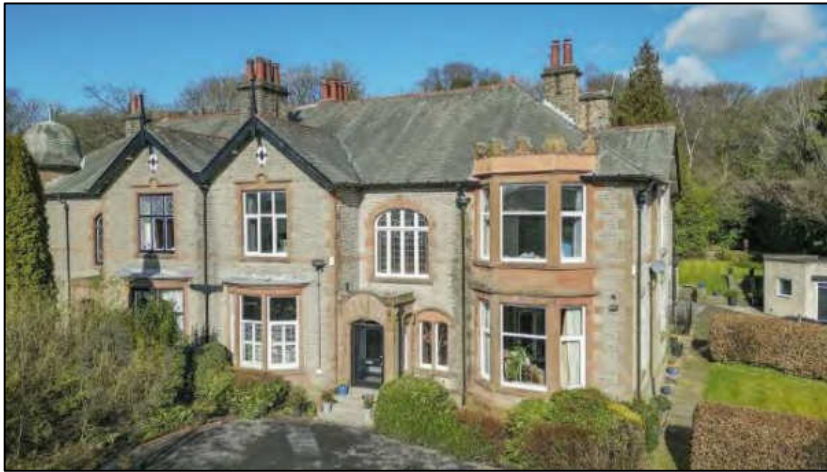
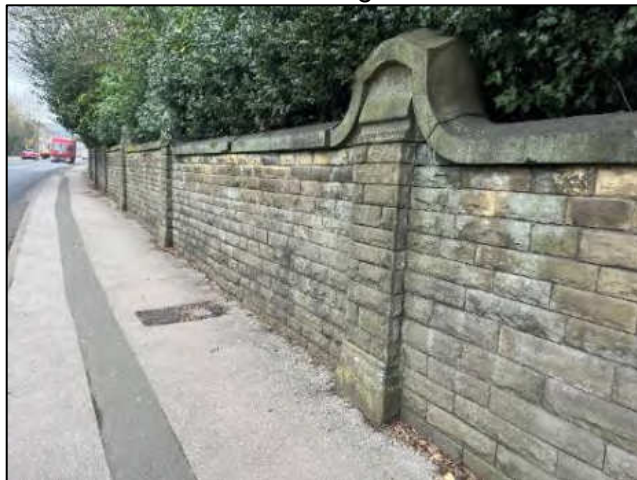
A pair, not identical, of large elaborate houses in a mixture of local and red Cheshire sandstone. Turrets and domes are features.

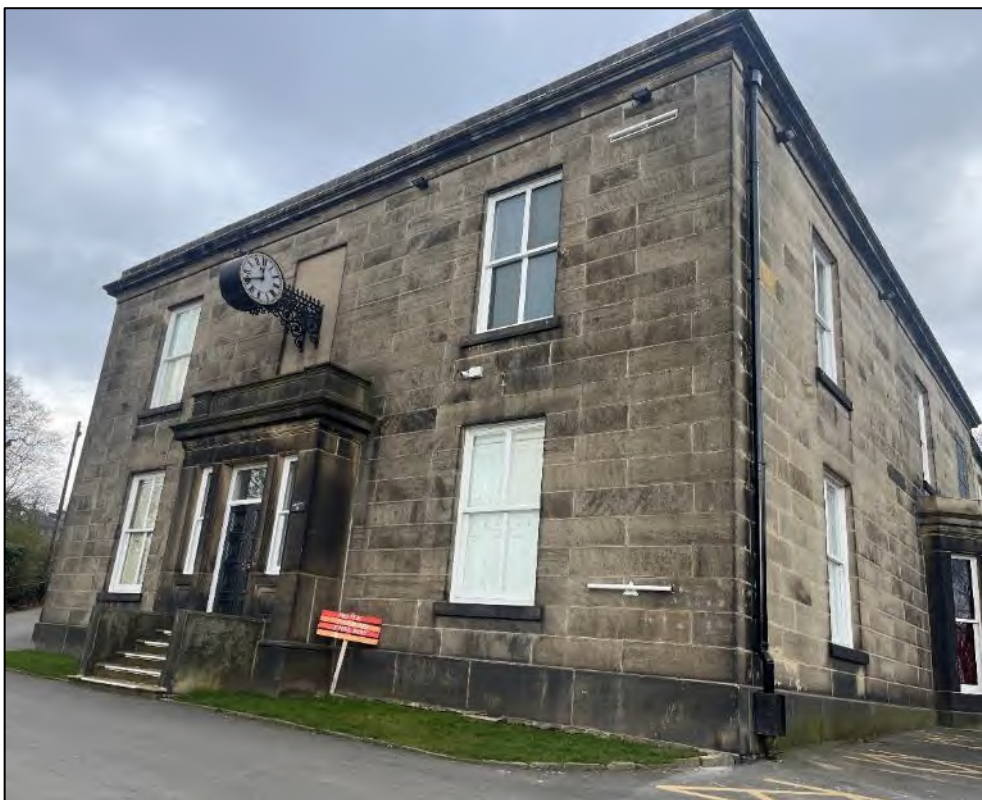
Plain, cubic house in large ashlar blocks built 1840. Interior 'modernised' c.1880. Much survives unaltered and recent restoration project has uncovered many original details in addition to excellent plasterwork, fireplaces and even wallpaper. New extension to rear has provided disabled access, with the former stair window used as an entrance from the landing to the new first floor meeting room. The house is set in a notable landscaped garden with a good collection of trees, evergreen and deciduous, some of which were planted when the public park was created.

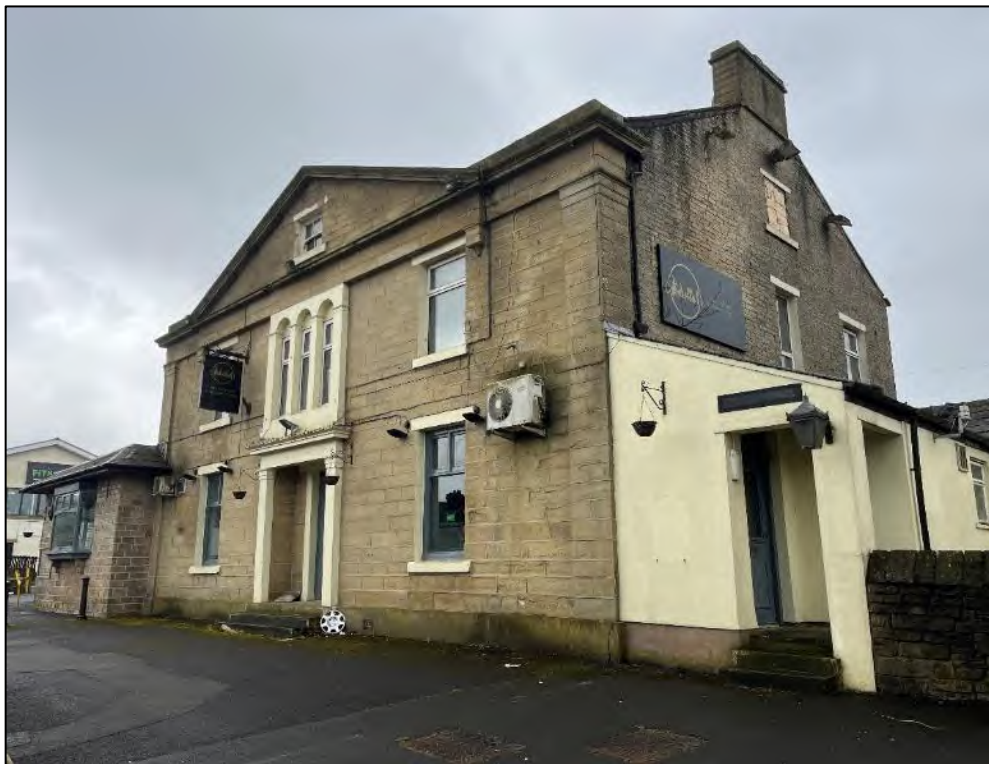
Early 19th Century former coaching inn and public house. Of the same design as the Rostron Arms in Edenfield, possibly built by same brewery or architect.
