Draft Rosendale Local List of Non-Designated Heritage Assets

December 2024

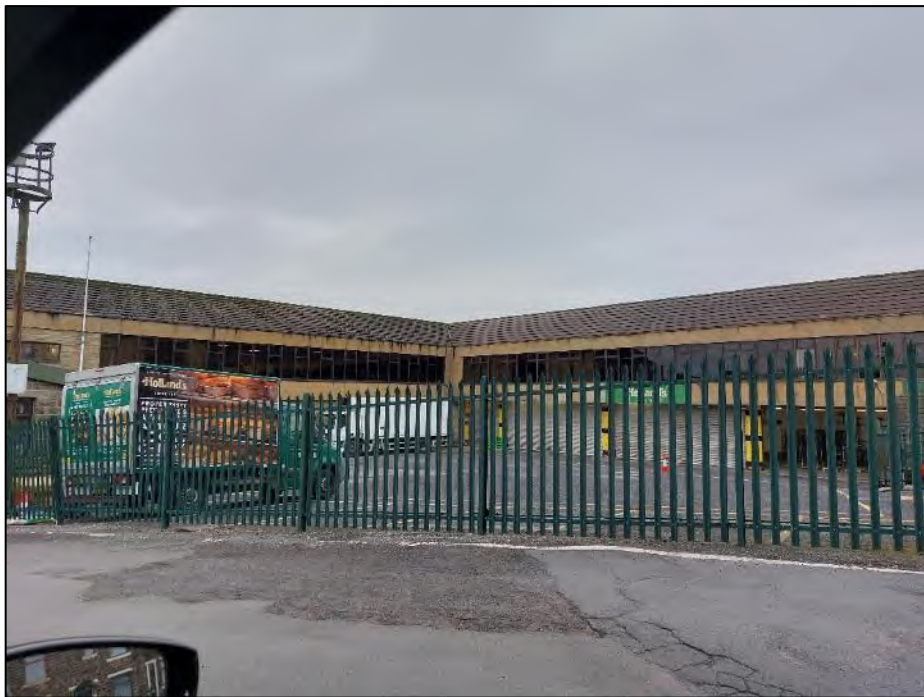
Image

Hope or Industrial Mill, with the exception of the chimney, is intact, although there are also later additions by Hollands. The original weaving shed is in the north-west portion of the site. The random stone walls of the shed date from the 1860s, but the northern light roof is a twentieth century replacement of the original. A two storey preparation department, with slate roof, extends along the southern perimeter. The boiler and original engine houses were at the south-eastern end of the first weaving shed, on either side of the recently removed chimney. Two shed extensions are attached, and both retain their northern light roofs (Rothwell, 2009).

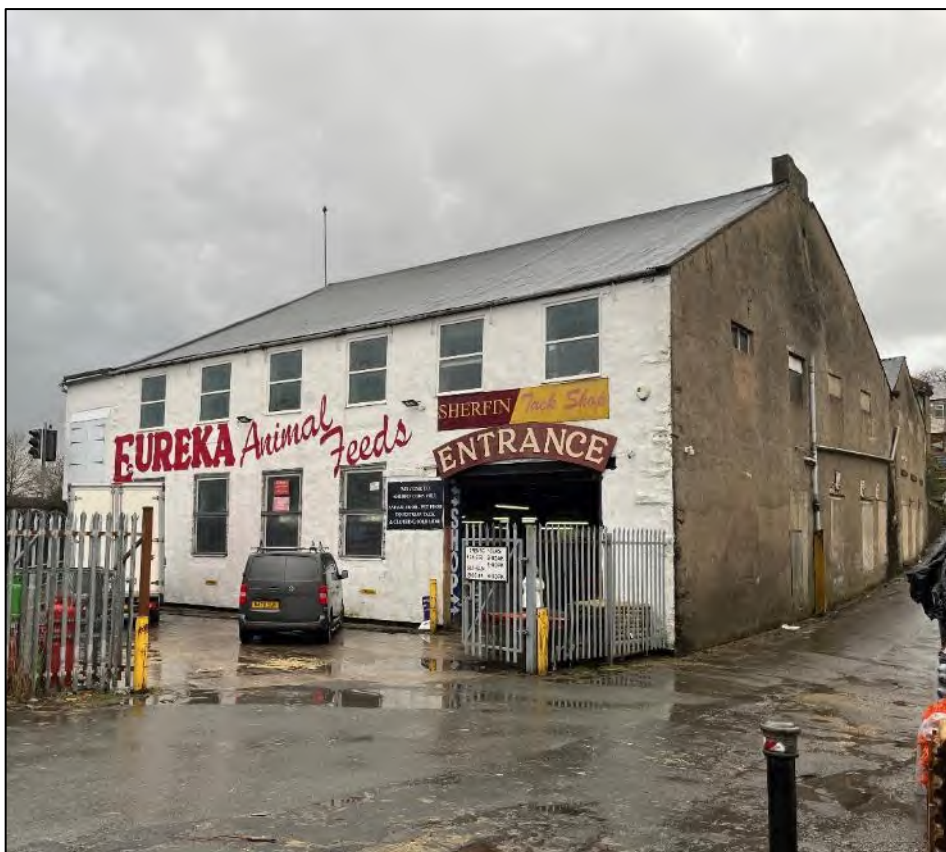
Lancashire Textile Mills Gazetteer: Rising Bridge Mill comprise a two storey block, with a single span roof to the south-west of the site. The non-fireproof building, used for spinning and weaving, is six bays long and four bays wide. A reduced square chimney is built against the western gable end. The end of a narrower, two storey building, possibly used for scutching, can be seen on Back Lane. Later parts of the mill face the main road. The single-storey range with loading slots and a cellar was a warehouse. Attached is a two-storey office, constructed with par-point masonry (Rothwell, 2009).

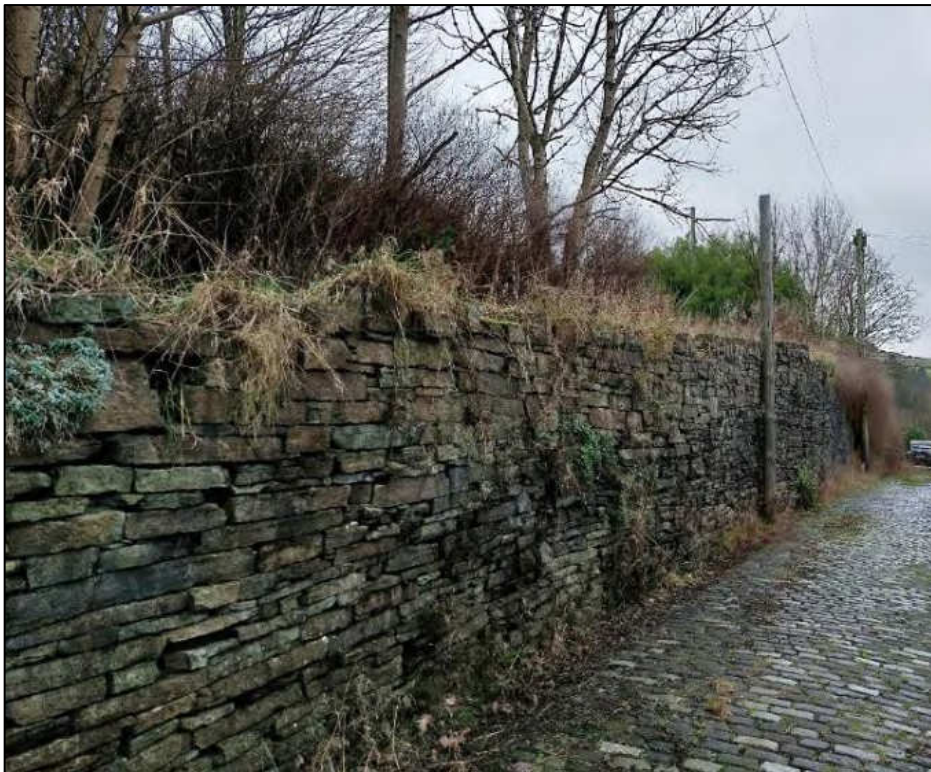
The whole length of The Back Road, including the original stone gutters and stone flag footpaths on Taylor Street, are of historic significance as these original features are part of the historic planned Victorian village of Acre. This village was planned and created as part of a vision of a Cooperative village. The associated Victorian well is believed to be the original water supply for village and is situated along this extensive stone set road.

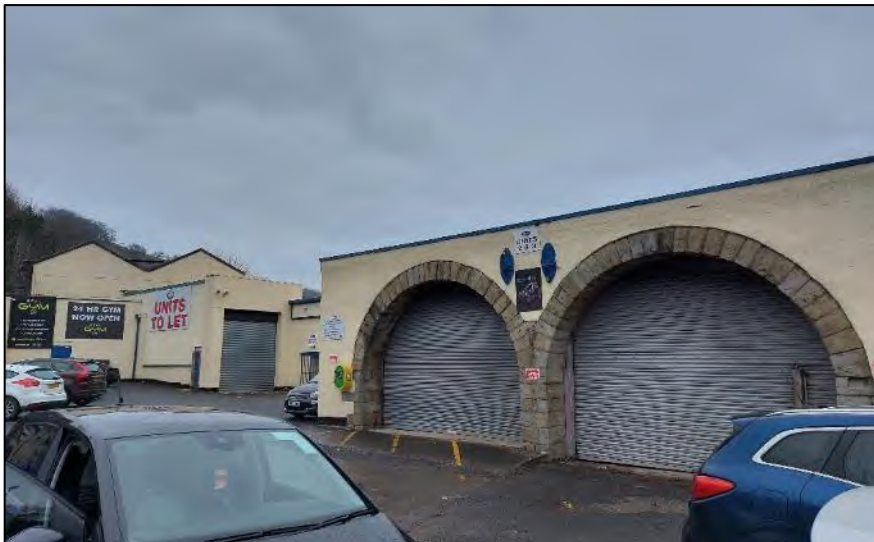
The 1891 OS map shows the former Edge Holme Mill labelled as 'Dale Mills' and Old Shoddy Mill is labelled as 'Edgeside Mill (Disused)'. The 1930 published OS map shows that the main part of the complex along Burnley Road had been enlarged to fill in all the gaps that were there. The smaller of the two blocks that were on the Old Shoddy site has also been greatly enlarged. All the site is now labelled as 'Dale Mills (cotton)'.

On the OS map surveyed in 1939 little seems to have changed with the general layout of the complex, however, the larger eastern building on the former Old Shoddy Mill site seems to have become linked to Whitewell Works across the brook, which is now labelled 'Glove Mill', indicating that building had perhaps become separate to the rest of the complex.

The 1891 OS map shows the former Edge Holme Mill labelled as 'Dale Mills' and Old Shoddy Mill is labelled as 'Edgeside Mill (Disused)'. The 1930 published OS map shows that the main part of the complex along Burnley Road had been enlarged to fill in all the gaps that were there. The smaller of the two blocks that were on the Old Shoddy site has also been greatly enlarged. All the site is now labelled as 'Dale Mills (cotton)'.

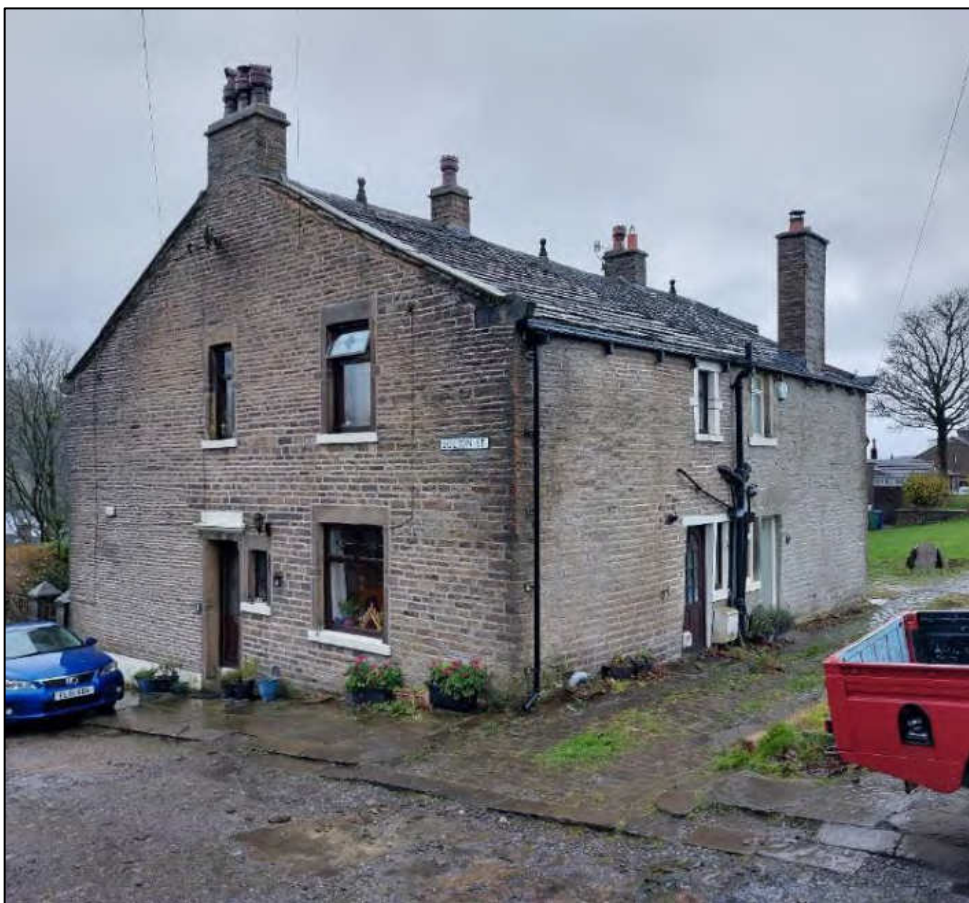
Complex of three houses in L shape, dating from c.1780s but with 1759 date inside no.3, Mills Fold. No.5, Bolton St. is Listed, but Mills Fold which adjoins (and has date on fireplace) is not.

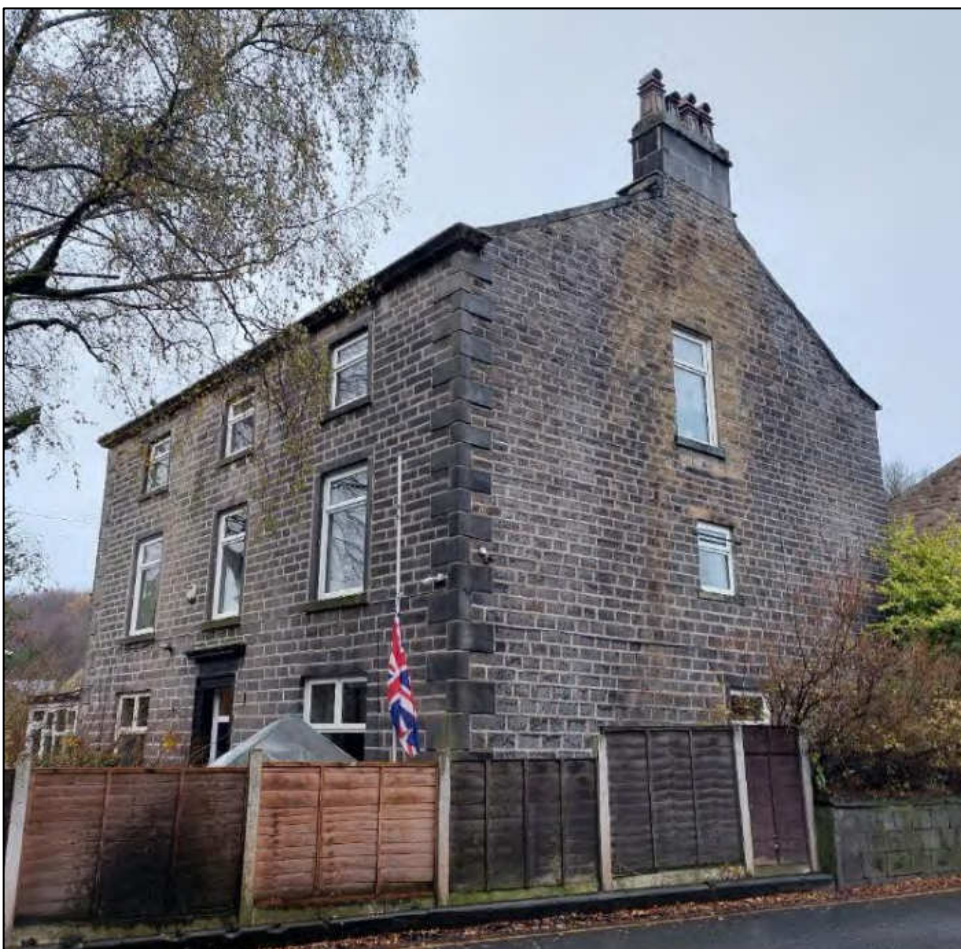
Three storey symmetrical fronted house set at oblique angle to Burnley Road East and important in town centre setting. Dates from c.1800-1830, possibly mill owner's house - Baltic Mill was adjacent.

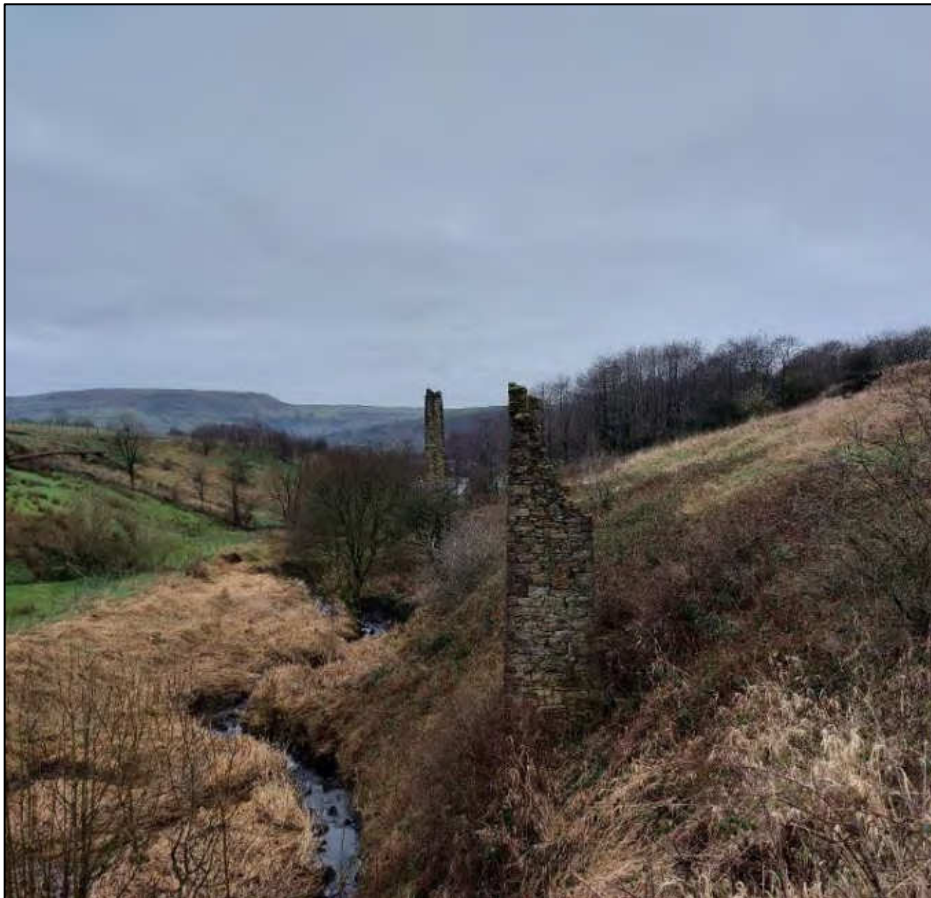
Mill ruins in side valley full of character with possibly the two oldest mill chimneys in Rossendale. One chimney appears to have been demolished. The remaining chimney has a square cemented cornerstones but give the appearance of drystone building. Impressive ruins of large waterwheel pit. Filled in lodges higher up valley.

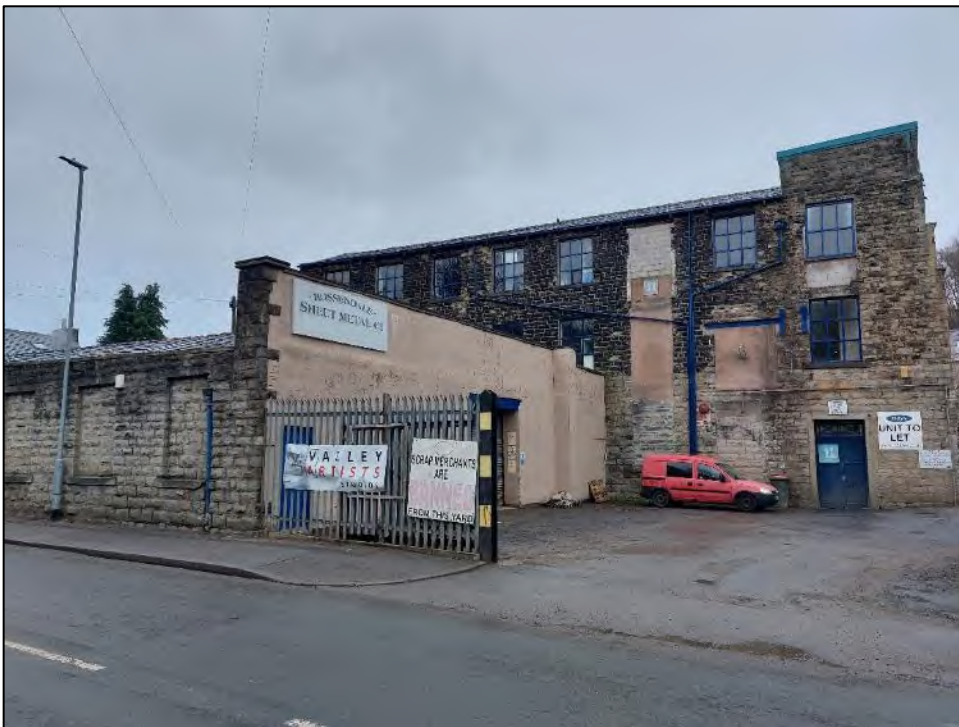
Image

Clarke Holme Mill is a former cotton mill constructed from coursed stone, the Burnley Road East elevation is single storey and it has a larger, three storey range to the rear. The larger, rear building has a regular fenestration pattern of nine-light windows and a triple gable front facing onto Clarke Holme Street.

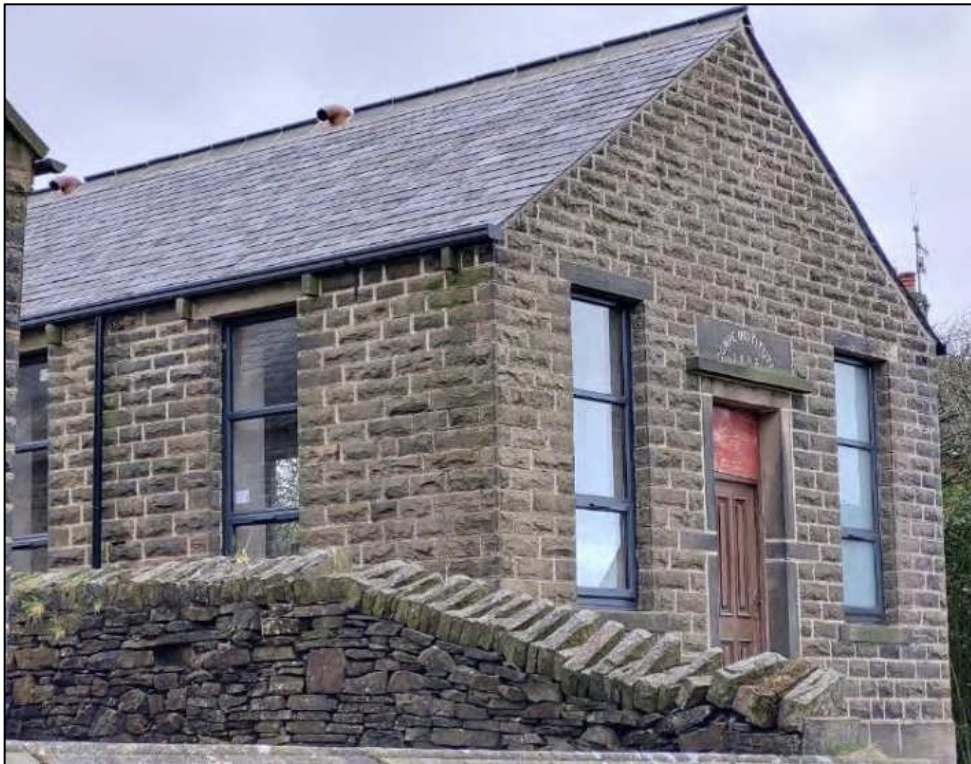
A stone building with a slate roof, possibly used as an ancillary building to the Cowpe Sunday School adjacent. A date stone above the front door reads "Cowpe Institute 1903". The building was renovated in 2024 following receipt of grant funding and assistance from the local community.

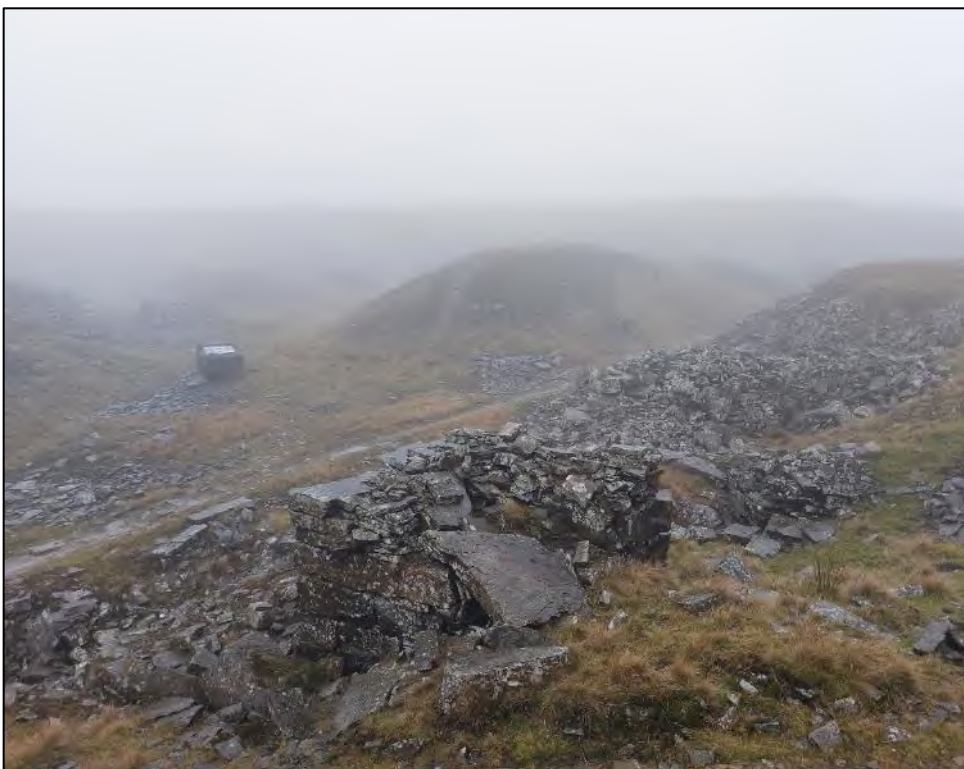
Image

A stretch of a former tramway routes which cross the Rossendale moorlands. Excellent examples of double causeyed stone waggon routes, running parallel to a curved sweeping embankment of the mineral tramway.

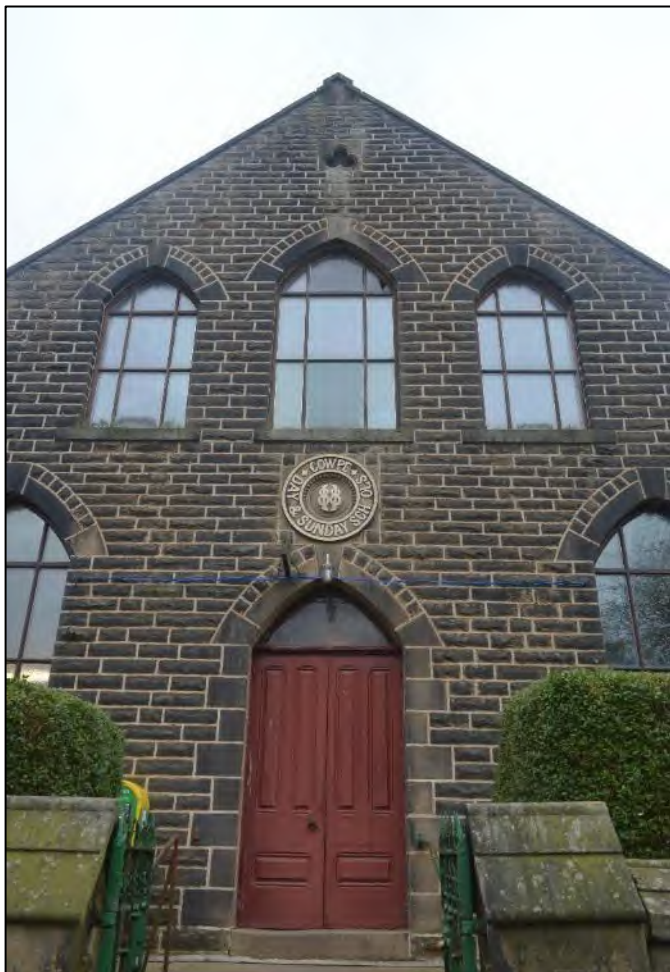
Dated 1881, a typical village hall building of the period, set close to, but higher than the road and therefore looks more impressive than size would otherwise allow. Very much a part of a separate, semi-rural community and therefore important in context, if not for itself.

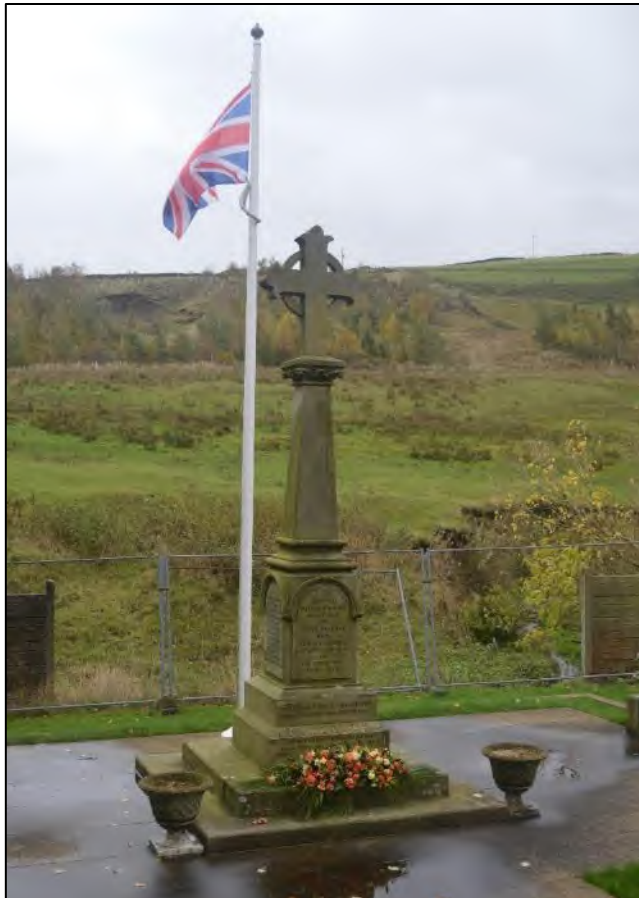
Cowpe war memorial is located in a small gated memorial garden. The memorial is accessed via a set of steps from a metal gate which is hung from two stone pillars each with a wreath, in relief, engraved on the front face. Above the gate is an ornate metal arch. The memorial is made up of a rectangular stone block, with panels on three faces, supporting a square column topped by an unadorned wheel cross. The assemblage is mounted on a two step plinth which in turn is mounted on a two step base.

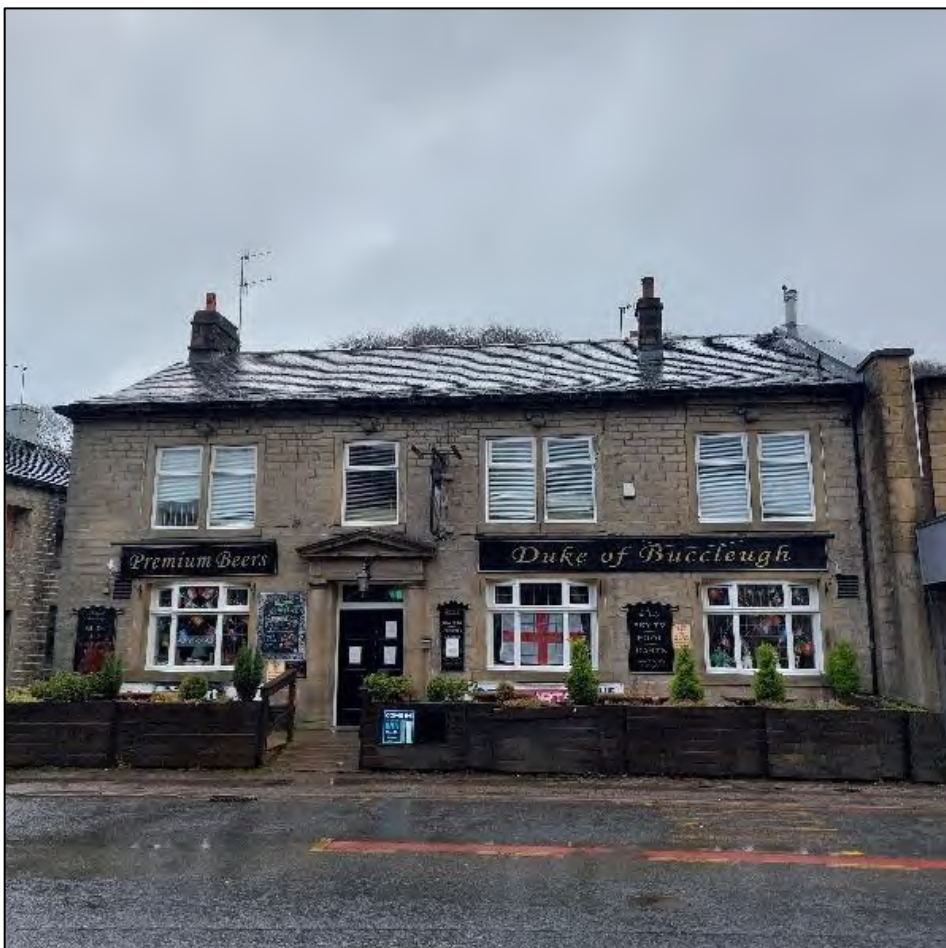
c.1900 with earlier origins. Imposing frontage with pillared entrance and 'set-back' bay windows. Very good stonework. East gable has long row of mullioned windows betraying origins as weaver's workshop. Dignified contribution to the centre of Waterfoot.

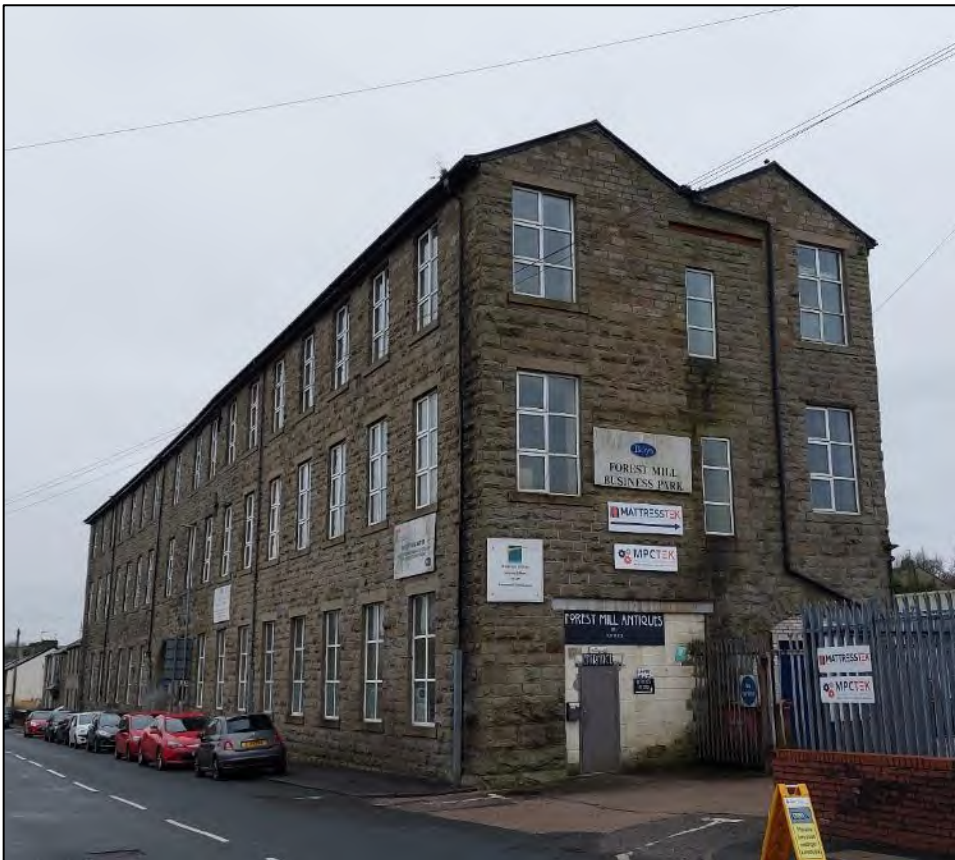
Image

Forest Mill fronts Burnley Road East and has a large 17-bay front elevation. The mill is three storey and constructed from coursed stone with a hipped roof, the site extends to the rear with a section of northern lights. The Burnley Road East elevation has an arched entry way with a large fanlight and 'Forest Mill erected AD 1861' written in relief above the door.

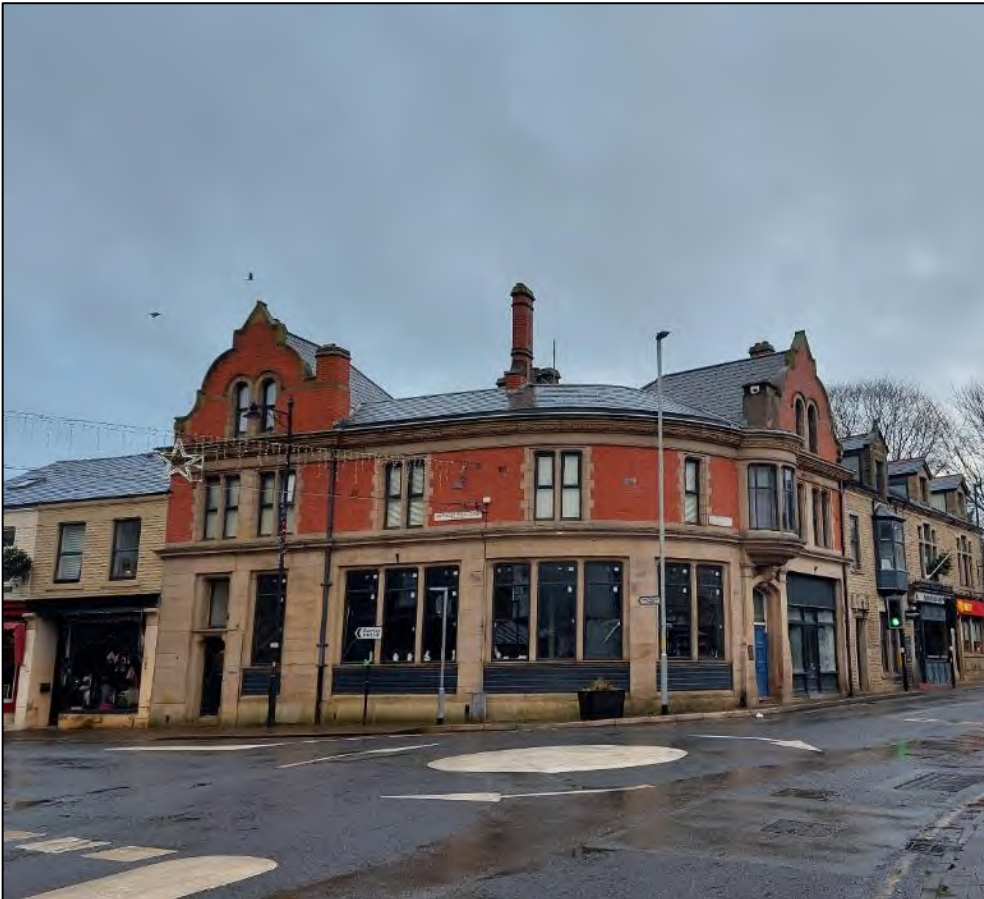
c.1907. Rich mixture of styles in stone and brick, the stonework being beautifully detailed, especially the large oriel window over the entrance. Has shaped gables with arched windows, tall chimney and carved stonework.

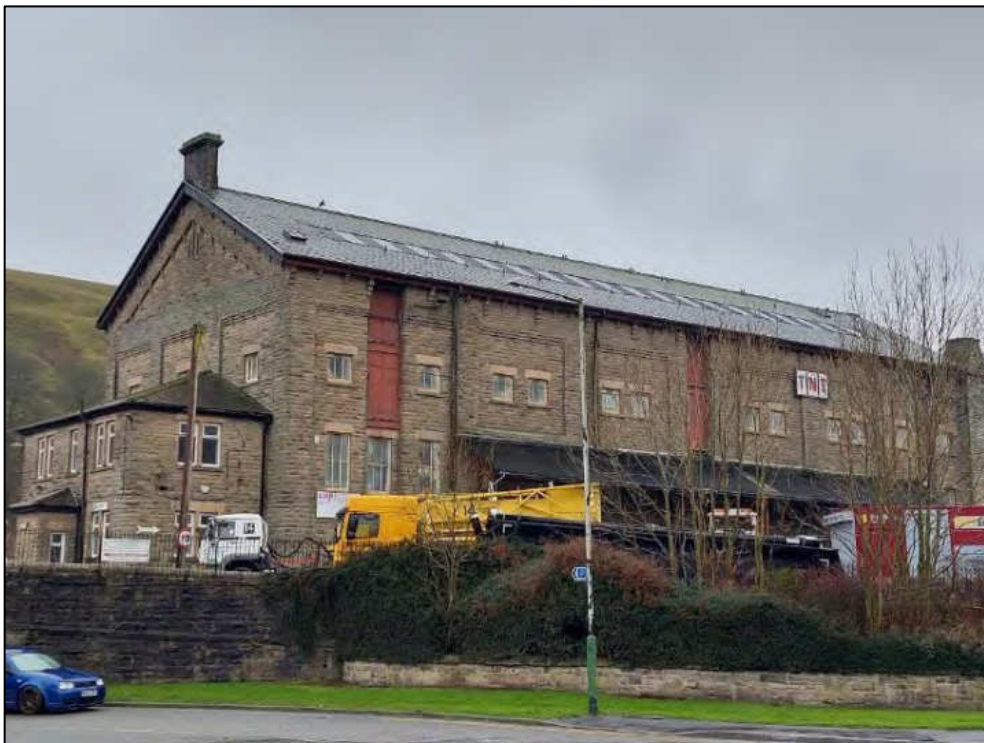
Much more elaborate than Rawtenstall's goods shed showing growing importance of railway. Good stonework, some interesting details, e.g. corner set chimneys.

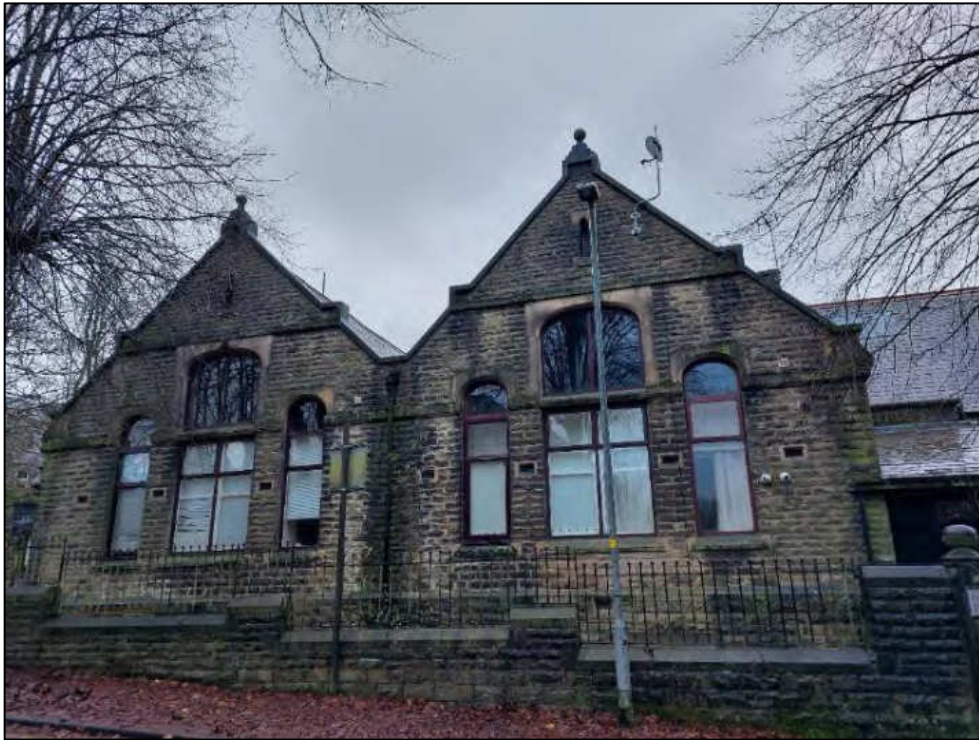
Stone built turn-of-the-century former school with much more architectural style than usual. Victorian in detail. Single storey to road, two storey to playground. Attractive setting to rear. Integral part of this elegant and above average quality street.

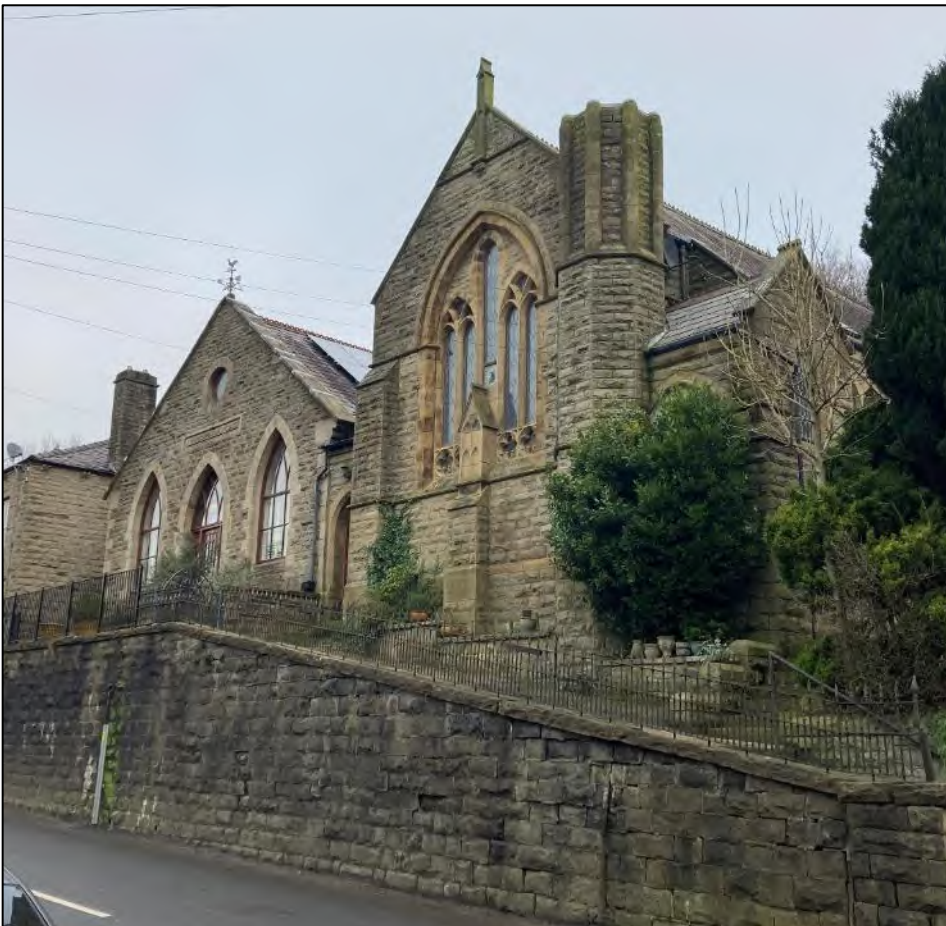
This could be an early example of non-conformist use of the gothic style and therefore could be important. Its setting high above the road adds to the character of the area. A striking building.

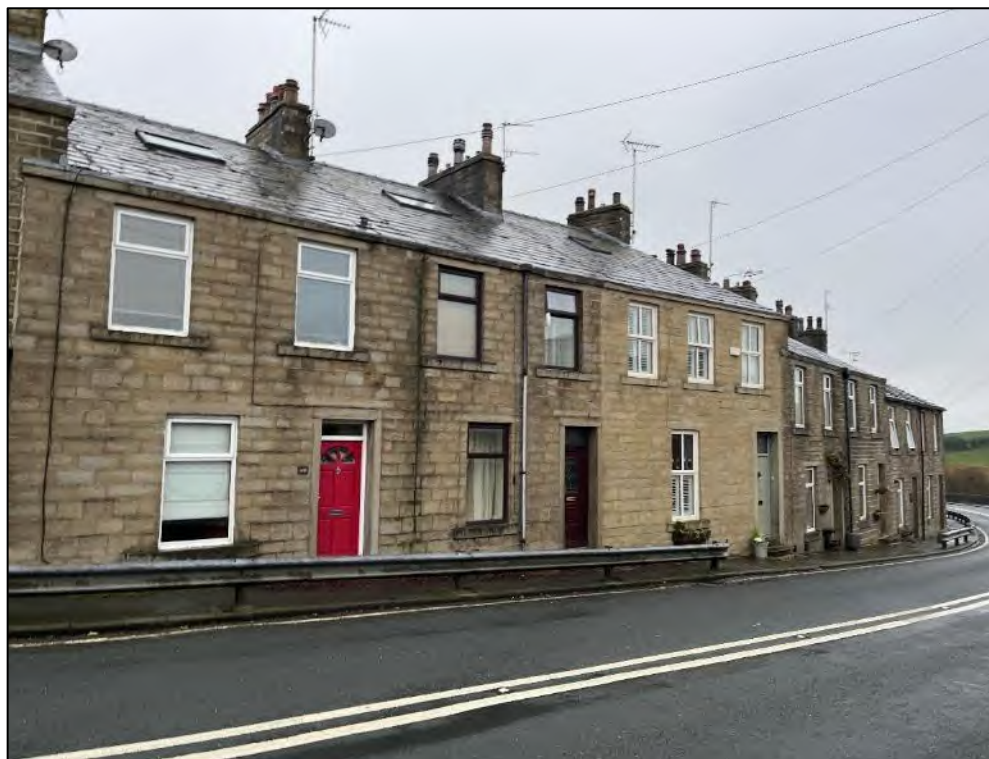
Terrace of millowner-built houses for employees with manager's house as elaborate one in centre, c.1840. Two storey front, three storey back with flagstone balcony. Interiors much tidied but not at all spoiled; intricate stairways and passages abound. Communal garden with stream and bridge at rear.

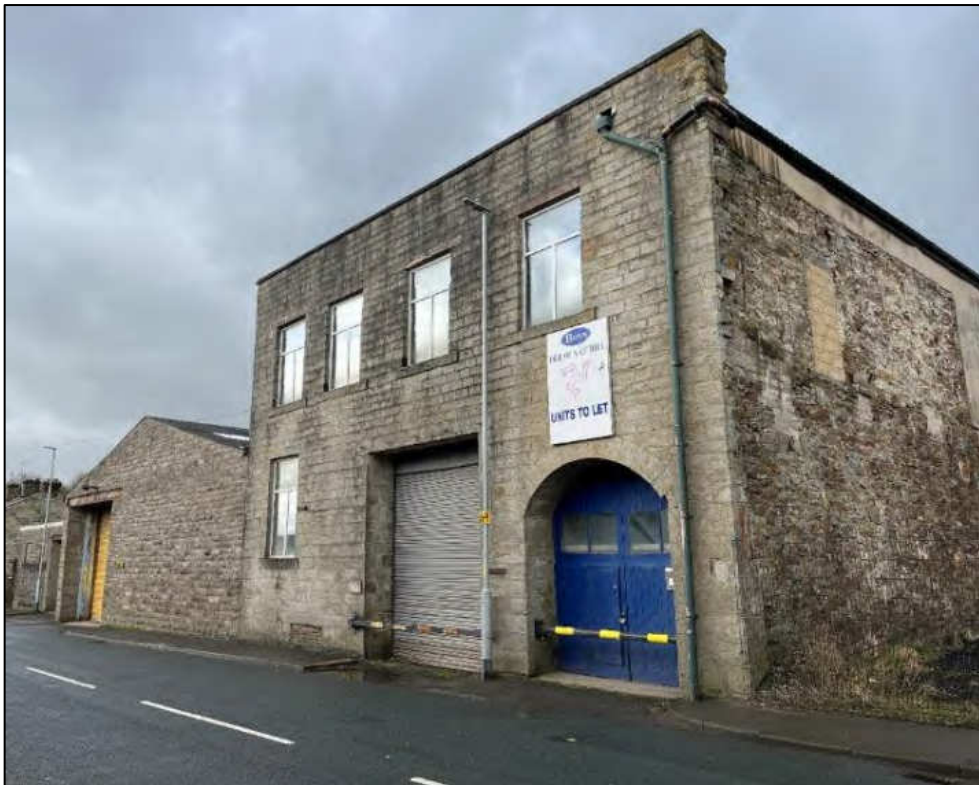
Image

Lancashire Textile Sites: Buildings at Risk Assessment Survey Report (September 2018): Isle of Man Mill (along with Forest Mill, situated further to the north along Burnley Road East) makes an important contribution to the historic townscape of Waterfoot. In particular, Isle of Man Mill retained one of the few full-height chimneys to survive in the valley, however this has now been demolished, along with a large amount of the mill itself.

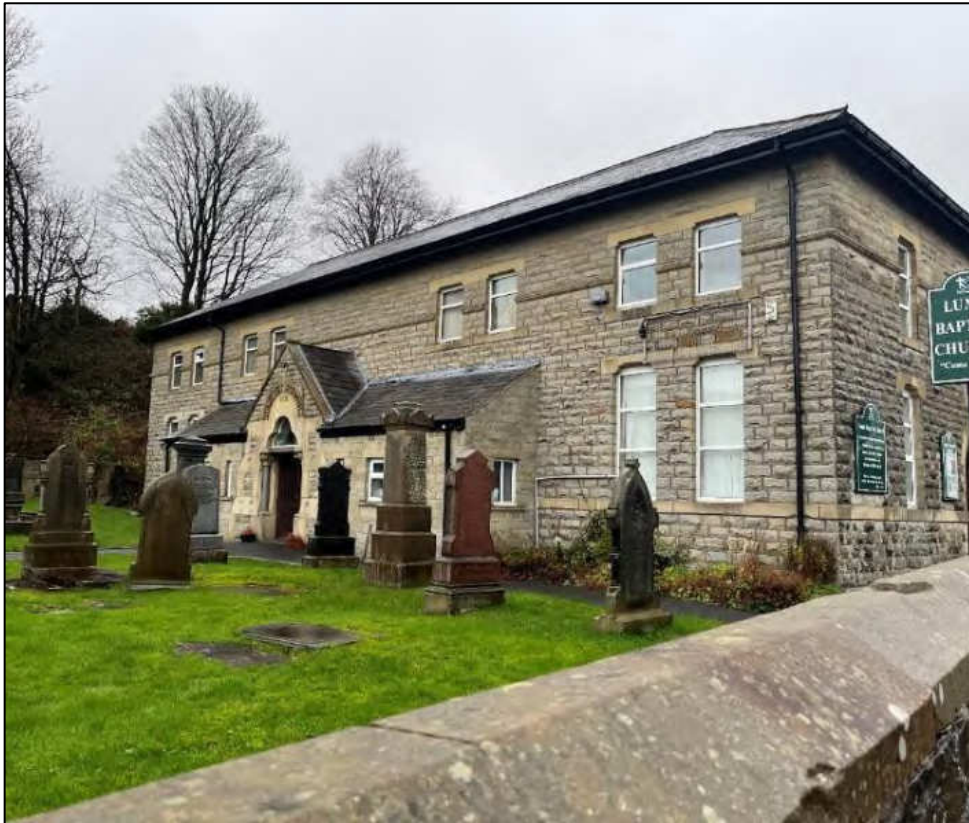
Chapel (originally 1828) with later additions and alterations, but still a prominent part of the narrow valley. Size and simplicity give it a character of its own.

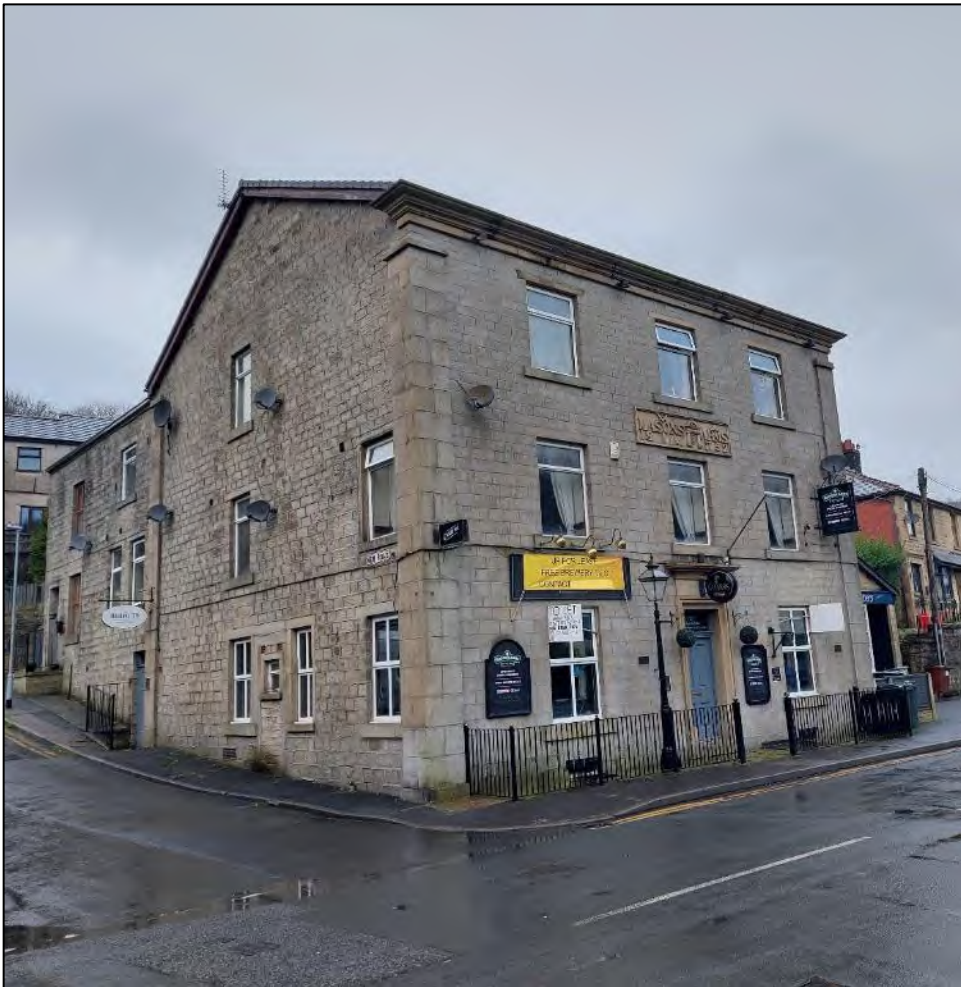
Image

Large three-storey building with strong stonework, corner pilasters and elaborate 1852 datestone with various masonic signs and symbols. Restored 1989-1992.

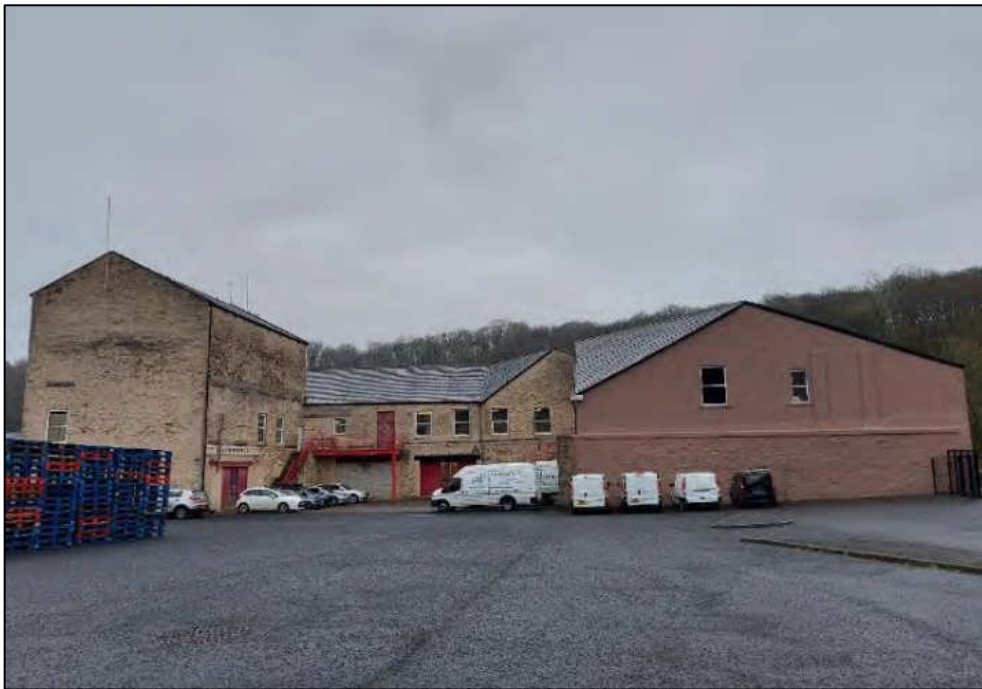
Image

Very large two / four storey stone built mill complex, still in industrial use. Solidly built, stone mill consisting of two blocks, a two storey block next to the road and a four storey block behind. Both are of regular fenestration. Mentioned only very briefly in the All District report as first noted on the OS map of 1894.

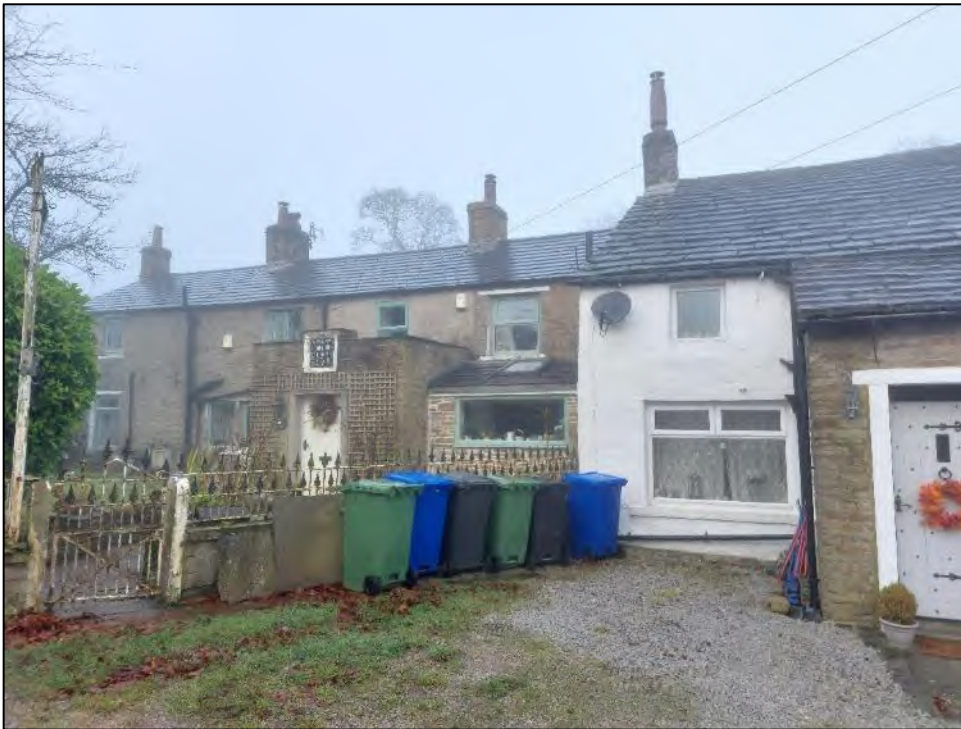
Image

Group of cottages to west of Rough Lee House, one of which claims to be Rough Lee Manor House, dated 1768. Interesting different porches. Altered, but still a very attractive group in rural setting. The buildings are constructed from stone with some rendered sections.

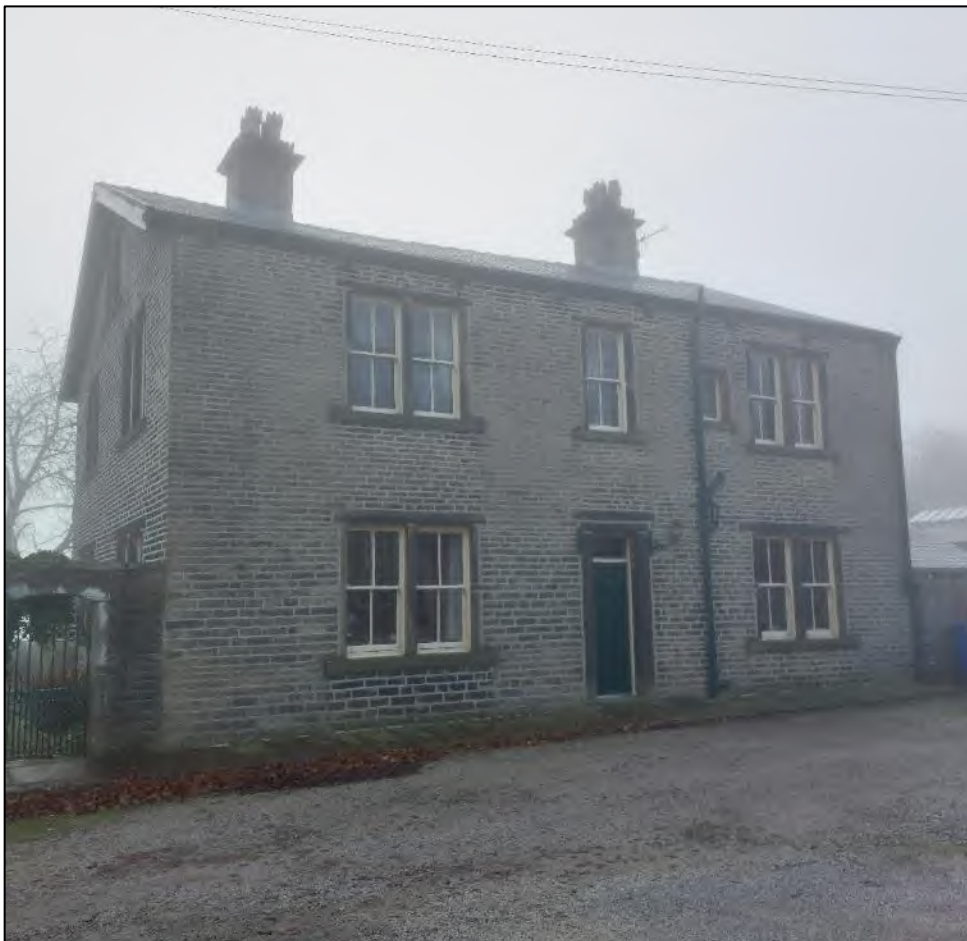
Image

Simple symmetrically designed early-19th century house of quality stone build. Porch has large single flagstone floor. Gates to former drive through garden are marked 'Coalbrookdale', an excellent example of the products of that famous manufacturing place.

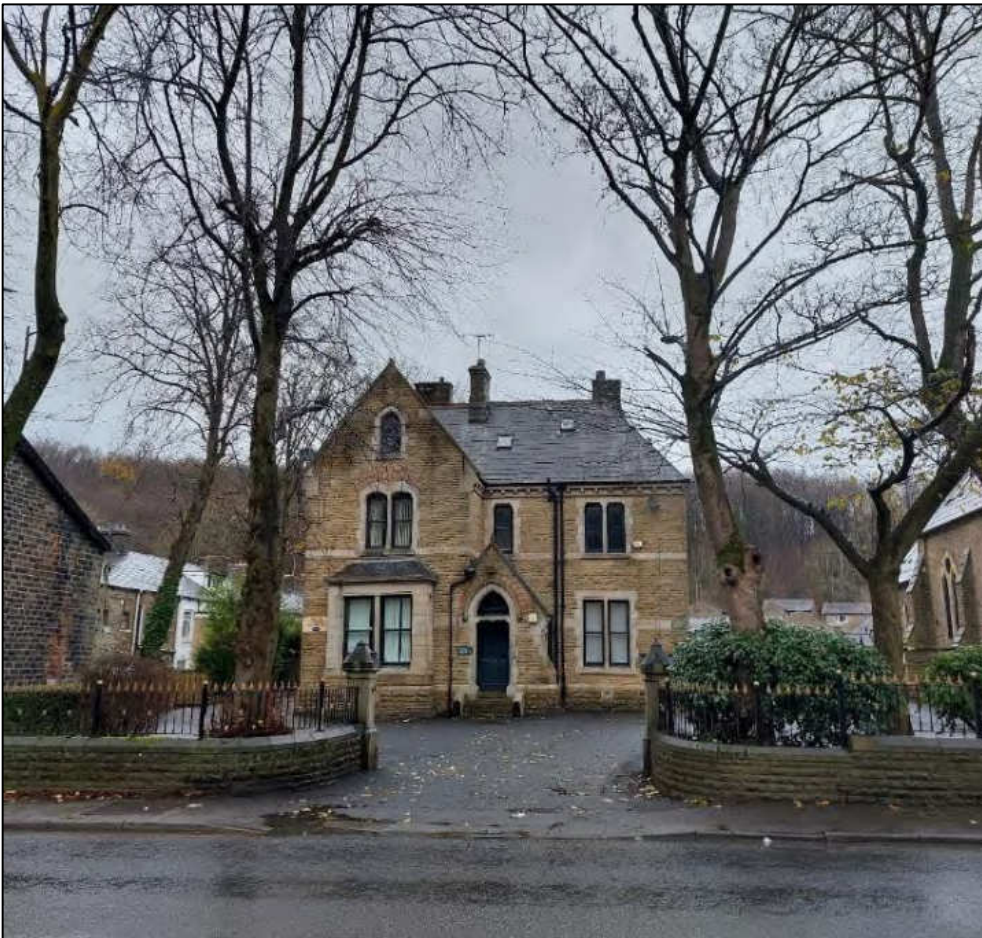
Image

Attractive Victorian villa with banded decorative stonework, pointed arch drip moulds, pointed arch windows, square bay and pointed arch entrance door.
