Draft Rosendale Local List of Non-Designated Heritage Assets

December 2024

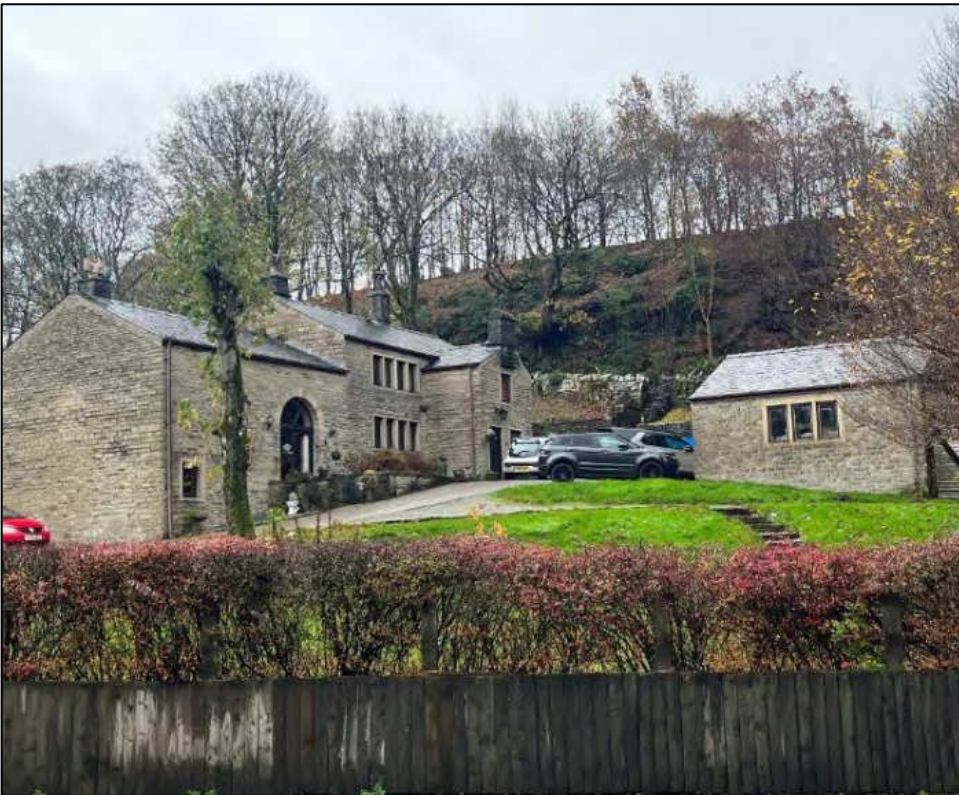
Image

From a distance still retains much of its original character and is important to setting on angle of road. Appears to have been sympathetically restored somewhat recently. Has a dove cote. Two-storey and constructed from stone with a slate roof, it has a partially gabled front elevation and four-light stone mullioned windows and an arched entry.

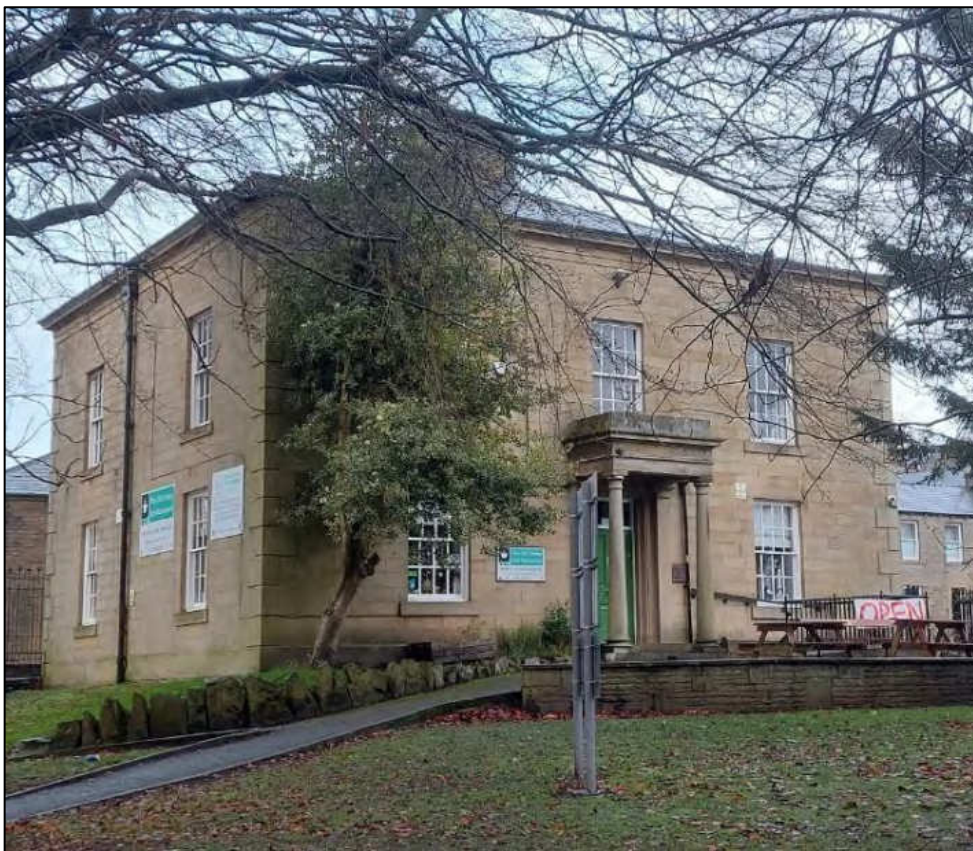
Image

Former Bridge End House, a stone gentleman's residence built c.1840. Set back from road with a smooth Ashlar front of 3 large bays, in a classical style with Doric Portico. Outside original and well presented. Important town centre building.

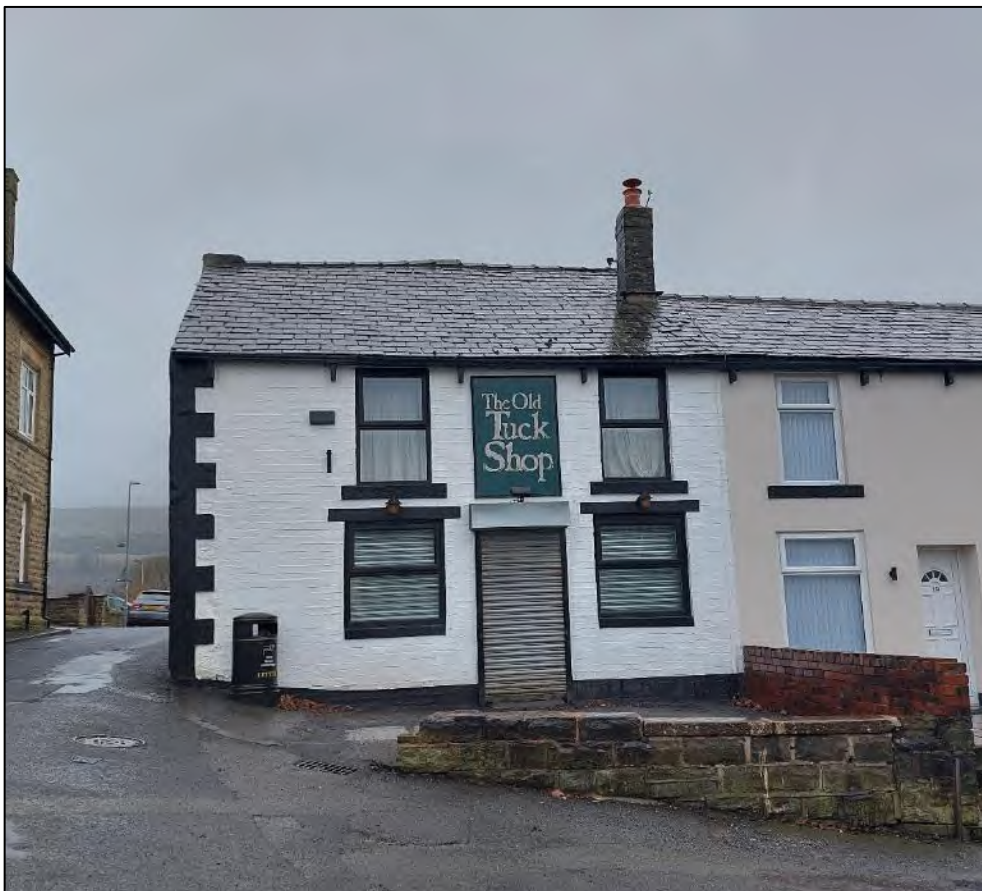
Image

Origins in late 1600s. Unremarkable from outside, much altered. Interior has evidence of 'bressummer beam' and possible fire hood feature on east gable.

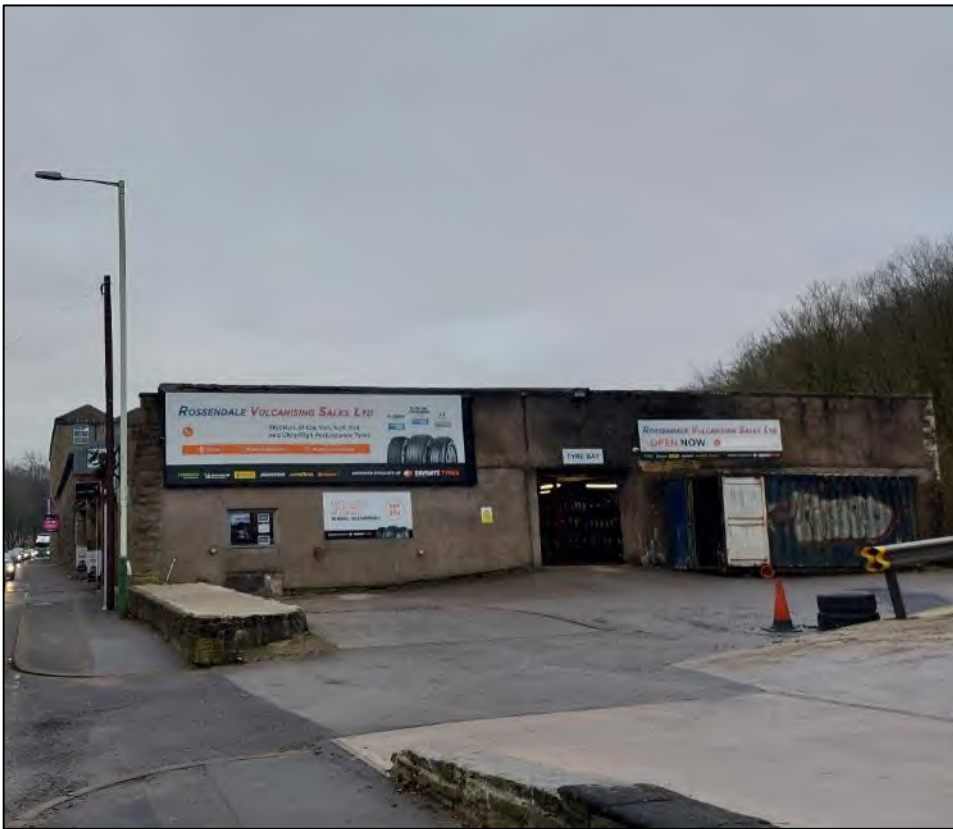
Image

A large, stone built mill still in industrial use by a variety of businesses. Regular fenestration, four storey, four pile, 14 bay block on Bacup Road, the building as stone lintels and cills and features six-light windows.

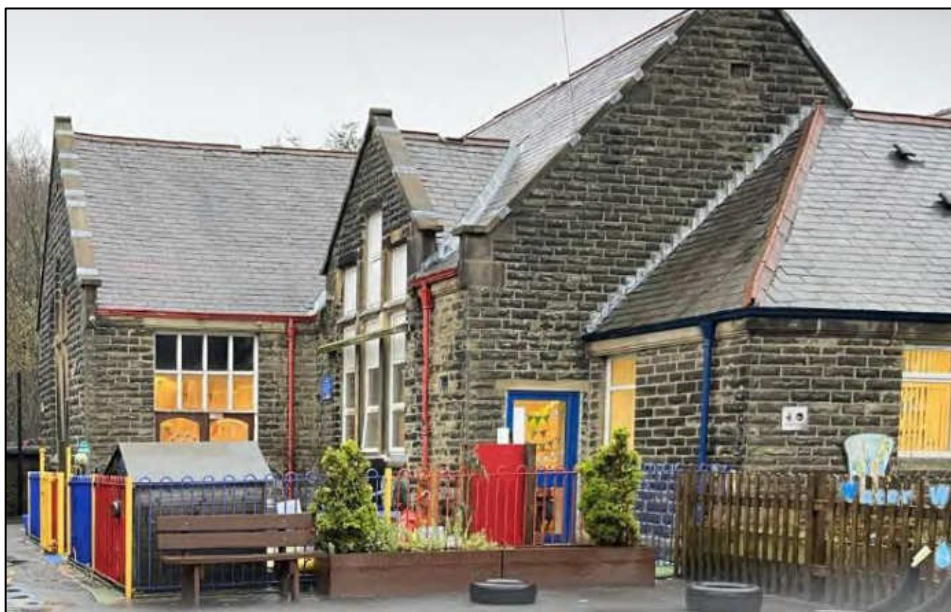
Image

Good example of turn-of-the-century local Board school, dated 1895. Large gables and good window area. It is largely single storey and constructed from stone with a slate roof and large mullioned windows.

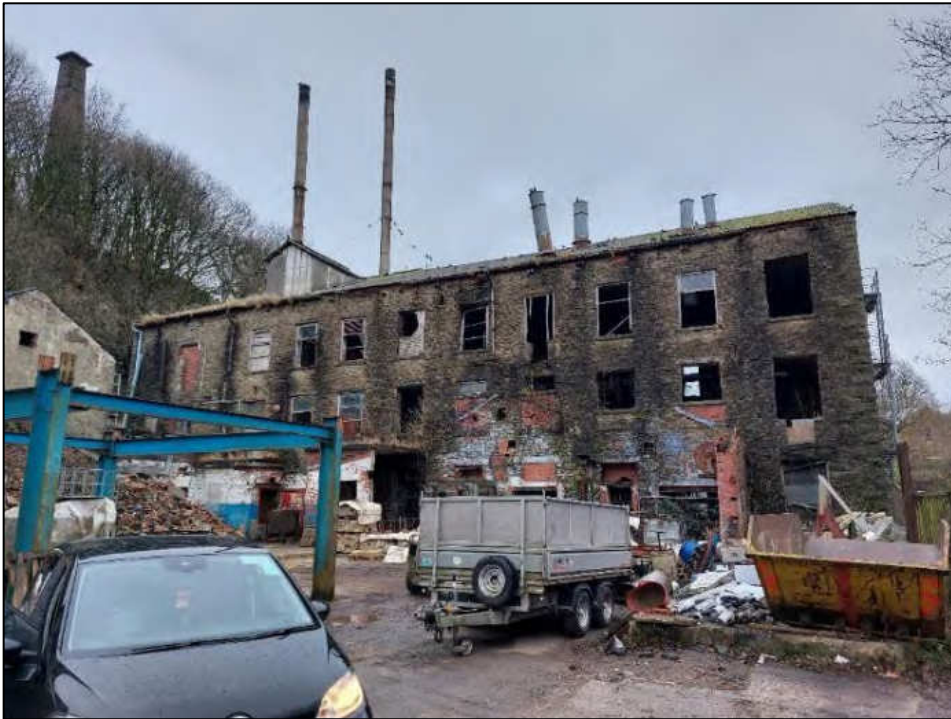
Image

Wood Mill is a former cotton mill constructed from coursed stone and has a corrugated sheet roof with numerous chimneys. The building is three-storey and has a gabled front elevation which faces towards Whitewell Brook.

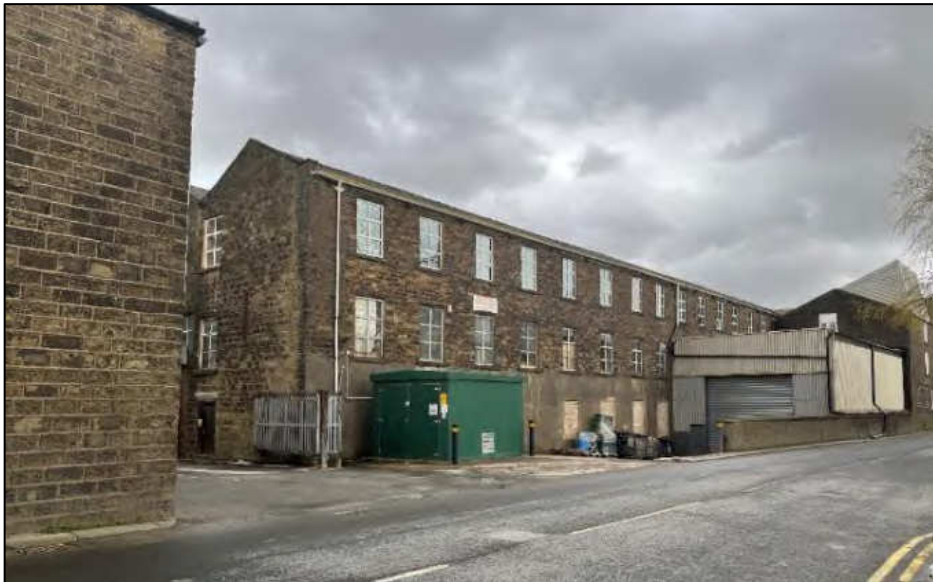
Image

Number Two Mill: the three-storey spinning mill factory is similar in size to its eastern neighbour, and is 15 bays long by four wide, with a double pitched roof. An integral engine house was situated at the eastern end of the mill, in the void now used as a loading bay. A two-storey yarn preparation and warehouse block runs at a right angle from the spinning mill to Tong Lane where it has a hipped roof. Originally a covered entrance in this building gave access to a passage separating weaving and spinning departments, but this has been roofed to form an enclosed lobby. A second, two storey block, reroofed and reduced in height runs along Tong Lane. The 'L' shaped weaving shed, which retains a northern light roof, extends along the lane and into John Street. Watershot coursing is the main building material of the mill. (Rothwell, 2008).

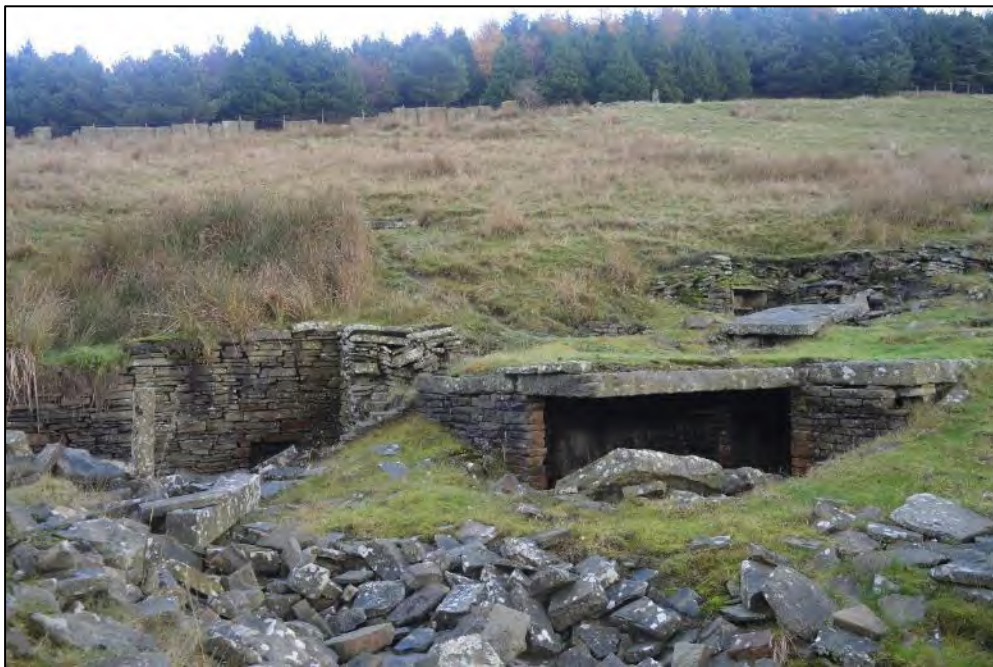
Image

This is an early water-powered stone rubbing / scrubbing mill that was in operation from 1844 until 1910. In the early 1990s, the remains of the mill include a waterwheel pit, vaulted cellar, lodge and two bevelled millstones. The site has an important landscape as the whole of Cwm valley is crisscrossed by flagstone walling which is possibly made from the waste products of this unusual industry (Valley of Stone).

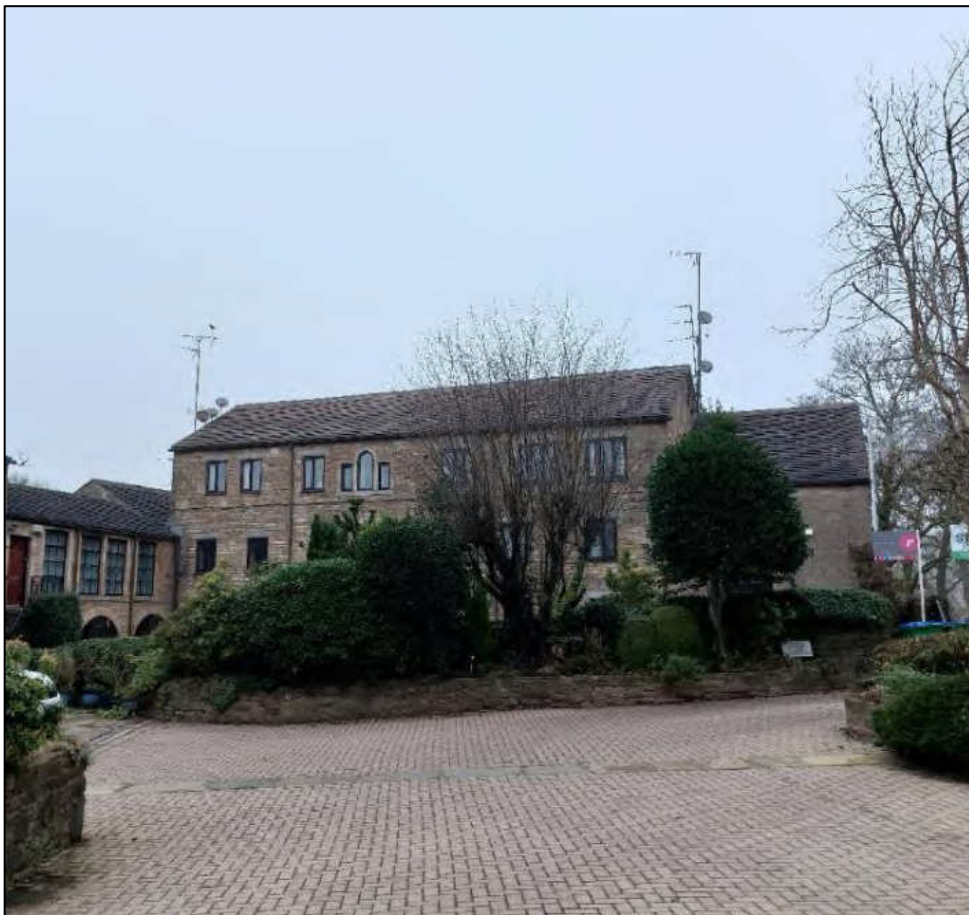
Image

This is a two / three-storey building in the northwest corner of the courtyard to the north of Grade II listed Healey Hall. The building is of rough-coursed stone with sandstone dressings and a slate roof. The windows are mainly casement windows with one arched mullion window on the second floor. The lower floor has three arched entrances (now glazed) above which are 12-pane large casement windows. There is an external flight of steps to the door in the upper storey on the left-hand side of the building.

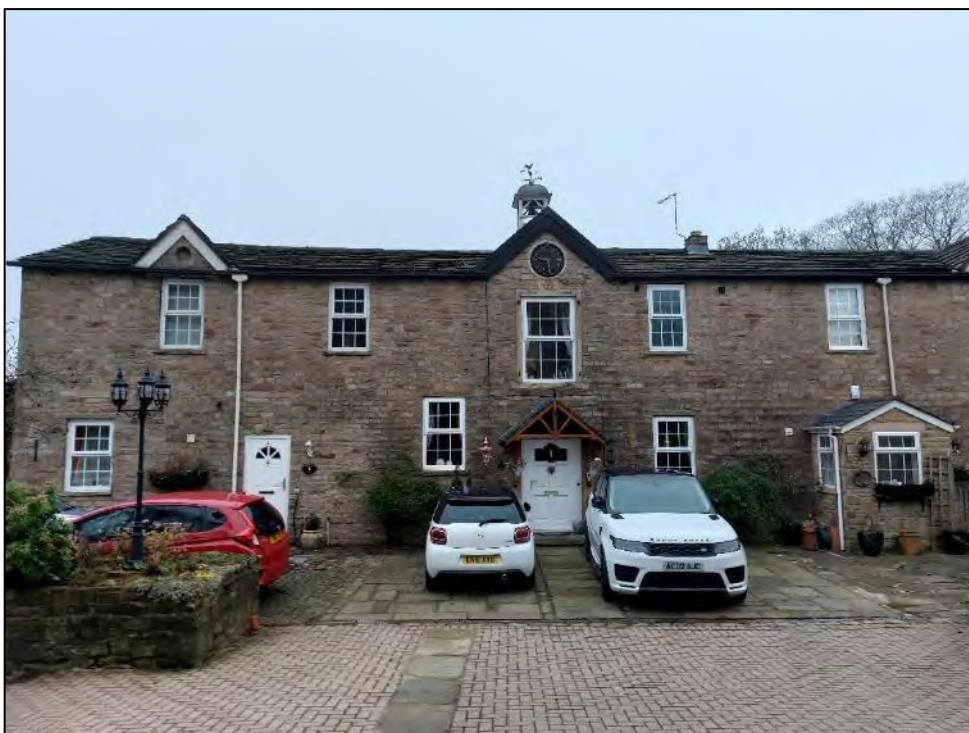
Image

The building is two storey and constructed from coursed stone with a slate roof, with a clock positioned centrally, and a weathervane on the ridgeline. It has a somewhat irregular fenestration pattern with modern windows.

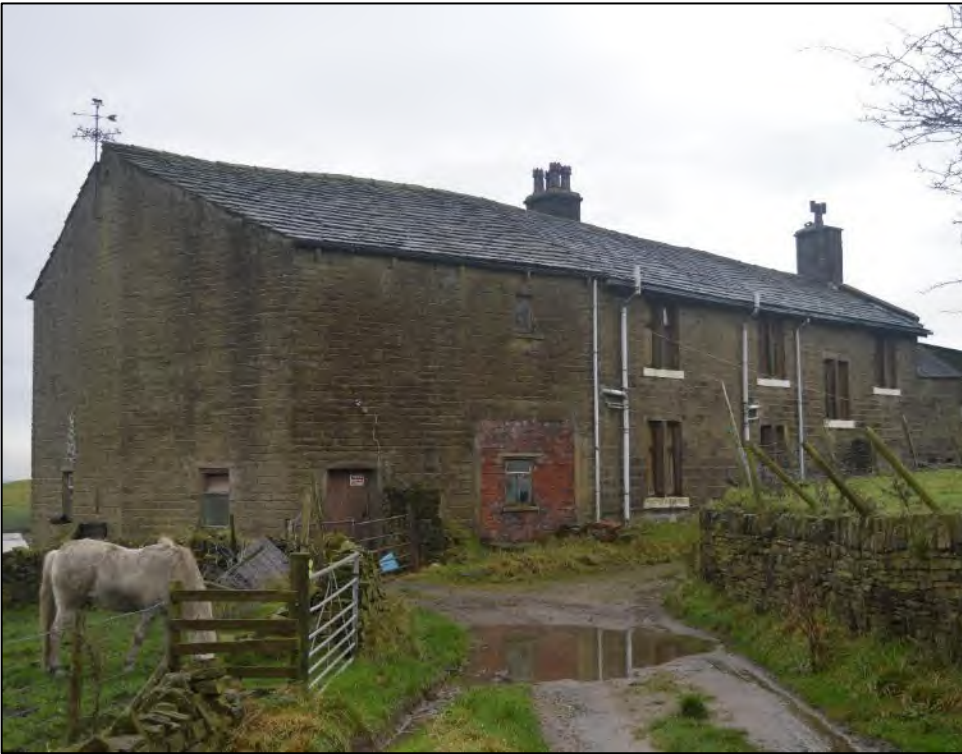
Image

Long rectangular two-storey building constructed from coursed stone with a slate roof with two chimneys. A section of the building appears to be a barn / farm building. The building has pairs of two-light stone mullioned windows with stone cills and headers.

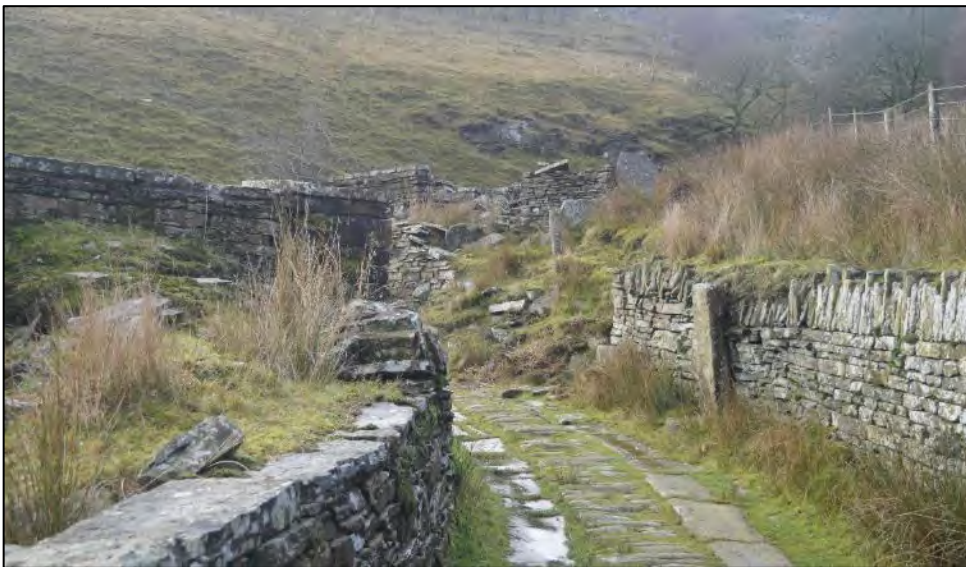
Image

Today, visible remains consist of rough coursed stone walls, or dry walls, which have upright slabs (this may have been used as internal partitions to create areas for storage or for farm animals). Architectural details such as quoins and a canted corner of a building on Cowclough Lane in Far Cowclough are noteworthy. The grooves on the lane itself attest to the heavy loads and use of the road (Abandoned Communities).

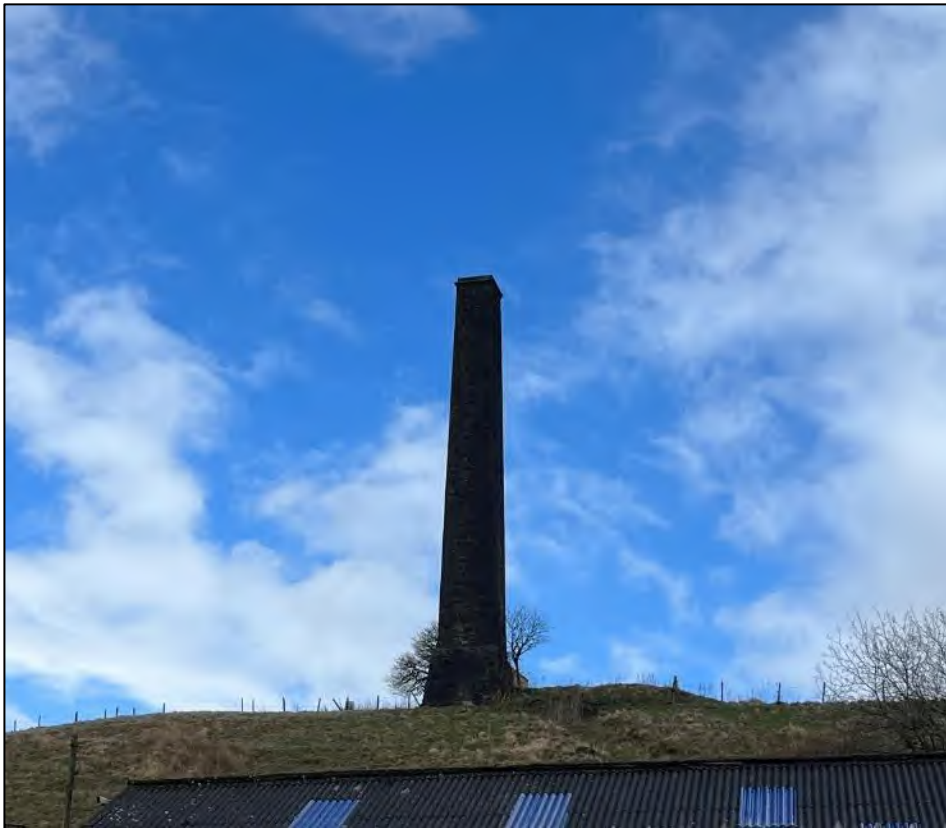
Image

This is the detached tall chimney of Peel Mill, which was totally destroyed by fire in 7th November 1956. The mill possibly dates to the late 19th century. The chimney, which being on a hill further away from the mill buildings on Market Street, may have saved it. The chimney is of stone and is square-sectioned in plan, tapering towards the top, sitting on a tapered plinth. It is a good example of a detached mill chimney, fitting well into its location on the hillside (Fire Flash).

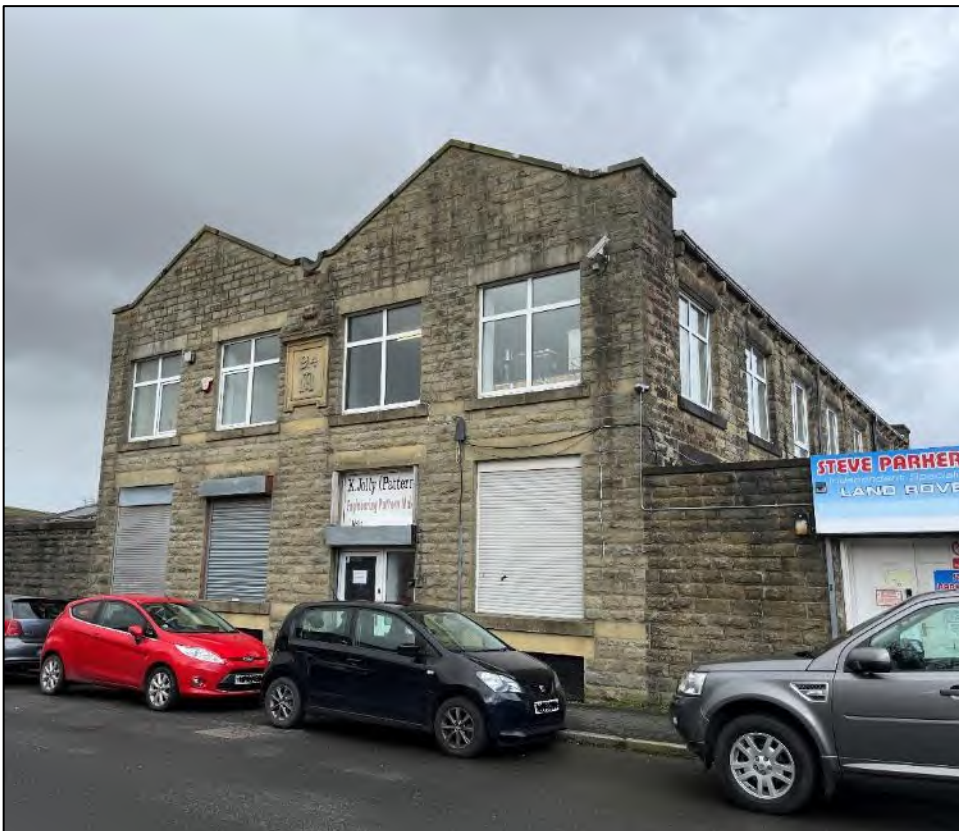
Image

A weaving shed, designed by G & S Keighley of Burnley, and erected on Lloyd Street in 1914 by Hartley Thomas Normanton. Surviving buildings comprise a two-storey, double gabled preparation building fronting onto Lloyd Street. The weaving shed has been re-roofed (GAZETEER OF ALL MILLS - Lancashire Textile Mills, 2010).

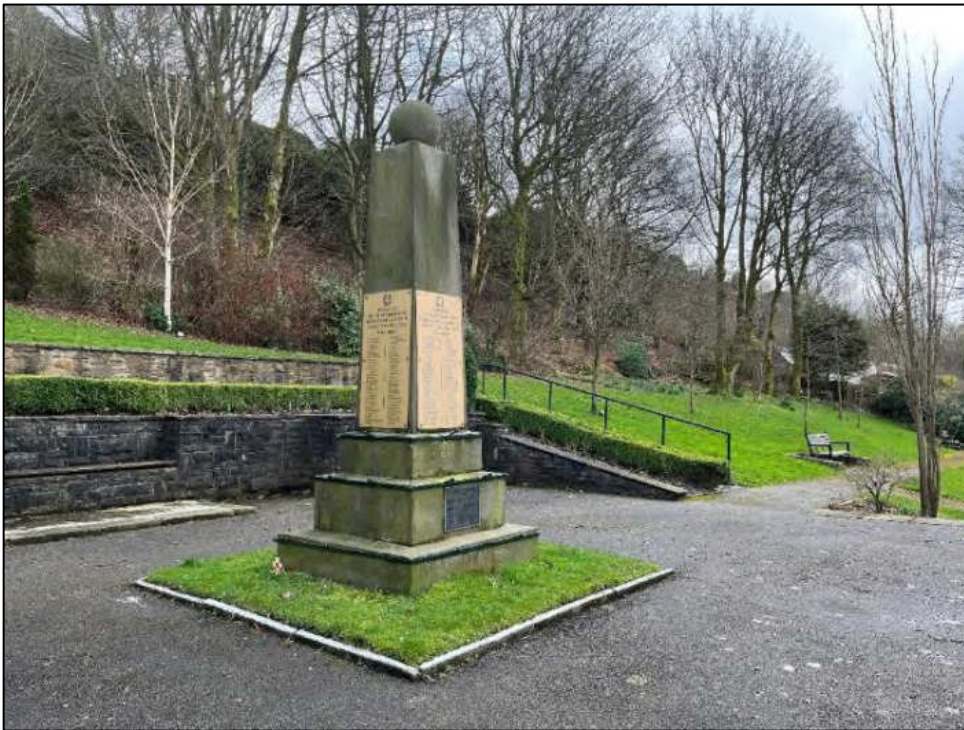
Image

Whitworth war memorial is located within Whitworth memorial garden. The memorial is an obelisk surmounted by a ball on a three stepped base with plaques on three sides and lettering in black. The words "PRO PATRIA" surrounded by a wreath sit at the top of each plaque. The memorial is dedicated to those who fought in the First World War (1914-1918) and the Second World War (1939-1945). The memorial garden was refurbished in 2011. In 2013, volunteers from Veterans in the Community restored the drystone wall around the space and upgraded some of the landscaping.

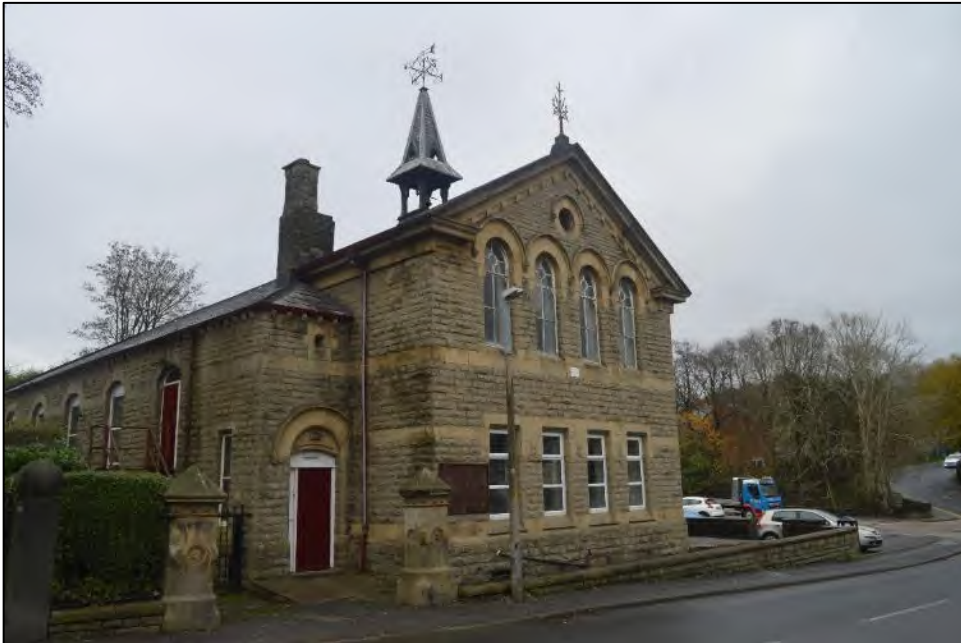
Image

The building used to be the congregational day school associated with the chapel that used to be immediately opposite but has subsequently been demolished (the area is currently being used as a car park). It is a two-storey Italianate building constructed of rock-faced stone. The street elevation has an impressive open-bed/broken pediment with dentils above which is an intricately shaped finial. The ground floor facing the street has stone lintel windows while the upper floor has arched windows and a circular window (the latter two have hood moulds with floral stops). On the roof, there is a square bellcote / bell tower standing on four pillars and covered with a pyramidal roof, on top of which is a weathervane. The stone chimney stack rises to the west of the bellcote. The roof is adorned with small stone corbels.

The building has a rectangular plan with two extensions on either side of the street elevation. The original gate posts to the left of the street elevation, along with the perimeter wall, are intact though without the railings (Pevsner & Genuki).
