BACUP TOWN CENTRE CONSERVATION AREA

CHARACTER APPRAISAL AND MANAGEMENT PROPOSALS PLAN

ADOPTED FOR DEVELOPMENT CONTROL PURPOSES FROM 2nd DECEMBER 2011

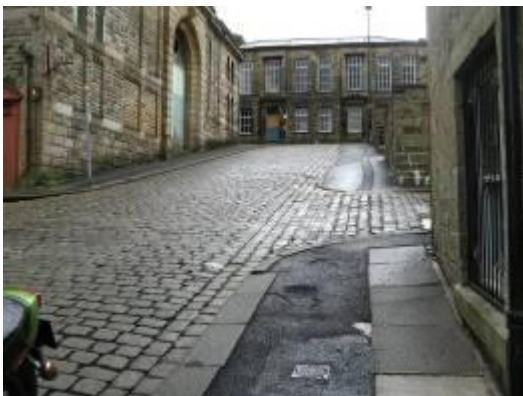
Traditional paving in Bank Street although the stone pavements have been replaced

Whilst modern tarmacadam is used for many of the pavements and street surfaces in the Conservation Area, Bacup is fortunate in retaining some substantial remains of the original (probably 19th century) sandstone setted or flagged paving which must once have been ubiquitous. These stone flags came from the Haslingden Flag beds. Examples can be mainly seen in the middle west of the Conservation Area, between Market Street and Fern Street, although a few narrow setted streets remain off Union Street. The setted streets next to the old Market Building and former Police Station are of special significance in that they provide an appropriate setting for these important historic buildings. A path next to Bankside Cottage retains some particularly fine examples of sandstone flags and huge pieces of sandstone which have been used to create steps. All of the traditional paving or street surfacing is marked on the Townscape Appraisal Map, although smaller sections also remain which have not been specifically recorded. Some cast iron coal or drain covers remain, such as the one in Bank Street entitled *R Hardman & Bro. Bacup*. Examples remain, though in a limited number, of a gully sometimes referred to as a 'Bacup gully'. This is a glazed purple-brown claypipe in the shape of a narrow trough about one meter long with a knockout in the sides at the upper end to accept sink wastes, and a spitter to the trap at the other. These carry a full length cast iron grate of diagonal trellis work.

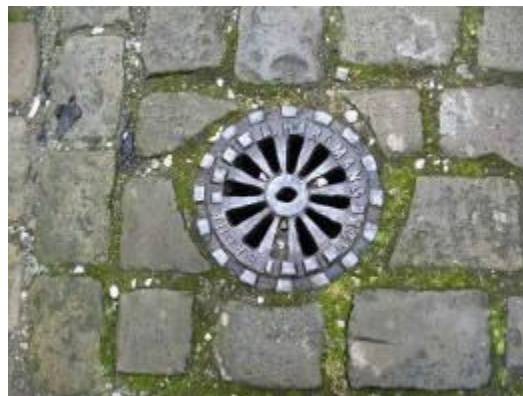
Drain cover in Bank Street

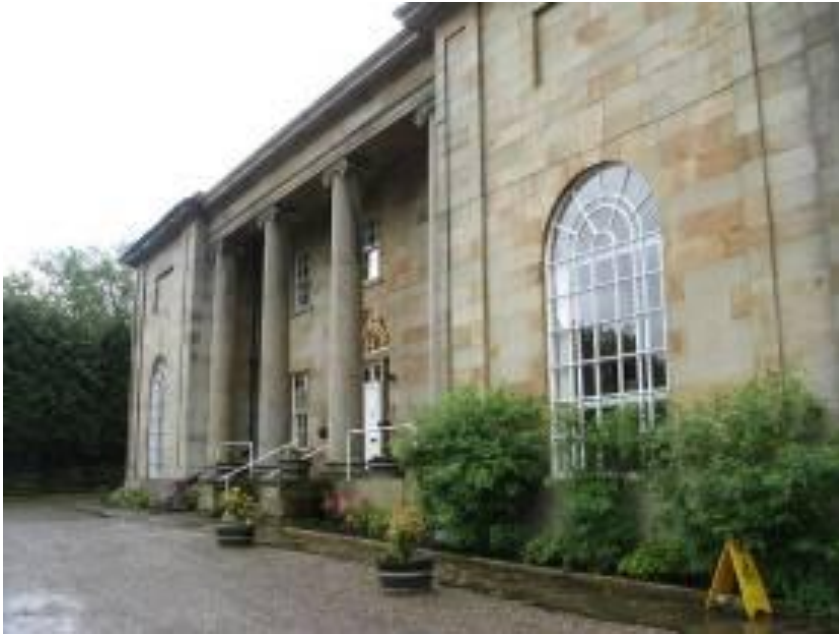
Forest House, now The Laurels, Bankside Lane

This large house was probably designed by John Foster of Liverpool in around 1828. It is built in a neo-classical style using ashlar, with a hipped tiled roof which is largely hidden by moulded parapets. Its most notable feature is provided by the symmetrical front elevation which contains a row of four two storey Ionic columns which mark a recessed bay. On each side are two end bays which stand slightly forward and are decorated by a large round-headed window with multiple panes of glass. Once derelict, the house is now a home for the elderly.

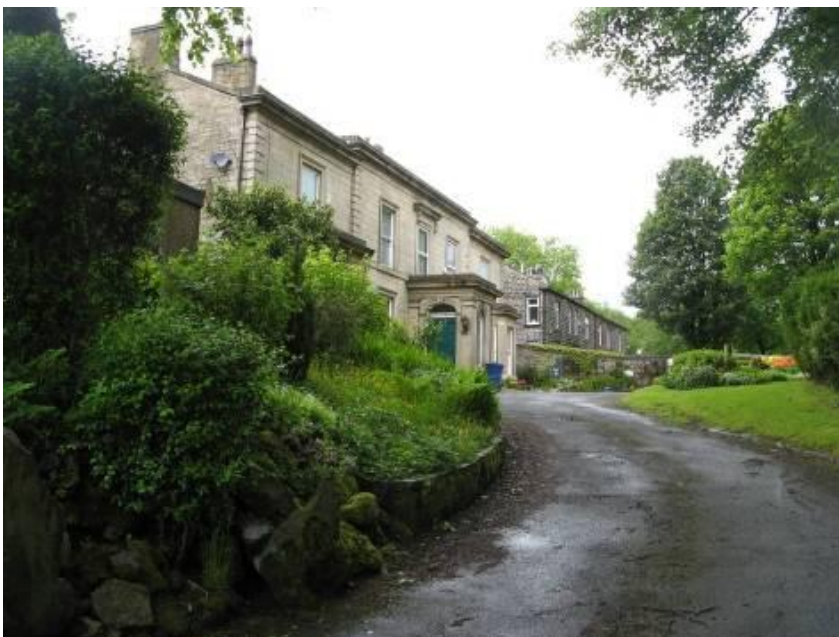
Bankside Hall (on left), Bankside Lane

Bankside Hall has now been divided into three properties – Bankside Hall, Bankside House and Bankside Cottage. It dates to the mid 19th century and is built in the Italianate style with coursed dressed sandstone walls with a hipped slate roof concealed by a moulded parapet. The one over one sash windows appear original.

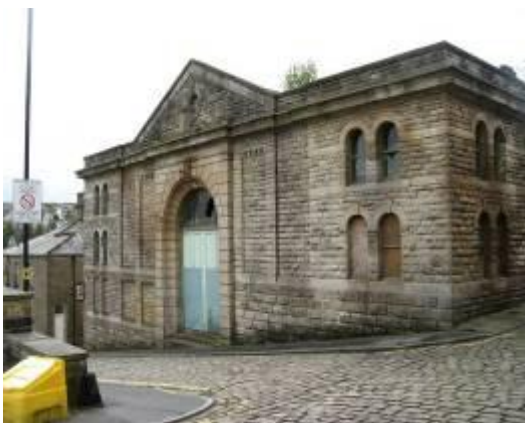
Old Market Hall, Bank Street

The Old Market Hall dates to 1867 with a later addition to the west side. It is built on a slope with three bays one side and eight bays the other in a simple rectangular shape. The walls are rock-faced sandstone with sandstone ashlar bands and dressings, in a vaguely Italianate style. A large portico adds definition to the Bank Street elevation. On the lower ground floor there are eight shops, with some original shopfronts, now in a very poor state of repair. The building has been empty for some time and is at risk.

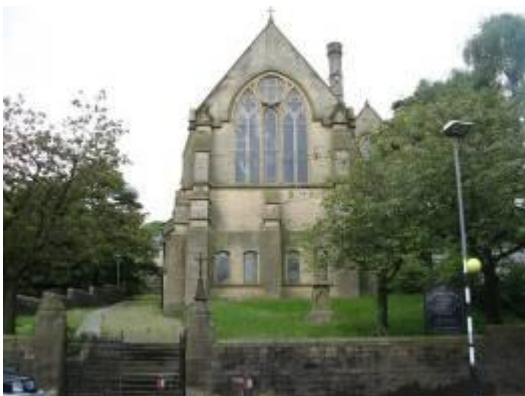
St John's Church, Burnley Road

The church was built on the site of the late 18th century church in 1882 to the designs of Medland Taylor. It is constructed using coursed sandstone with a blue slate roof with patterned bands of green slate. The style is simplified Gothic with traceried windows.

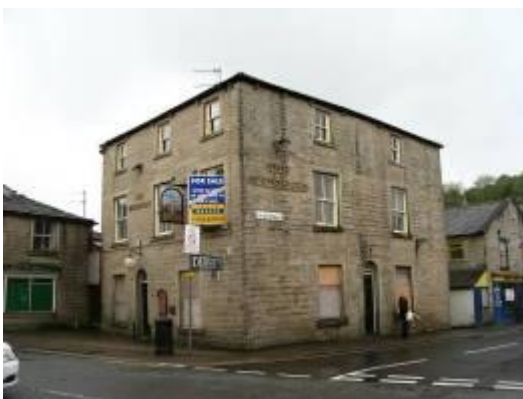
The Waterloo Hotel, No.1 Rochdale Road

This dates to c1840 and is three storeys high with a pyramid-shaped slate roof. Built from coursed sandstone, it has symmetrical elevations to two sites and sits on a prominent corner site at the junction of Union Street and Rochdale Road. It is currently (2011) vacant.

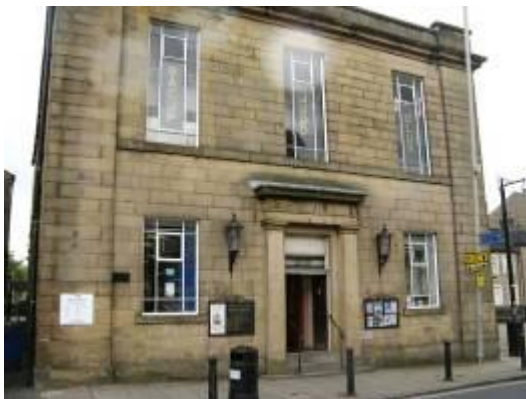
Bacup Library (former Mechanics Institute)

This building was built in 1846 using sandstone ashlar with a hipped slate roof. The simple rectangular plan is two storeys high with a central front door with a simple Tuscan doorcase. The mechanics Institute was founded in 1839 and this building was erected by some of the principal manufacturers of the town at a cost of £1,300 and was presented to the members in July 1846.

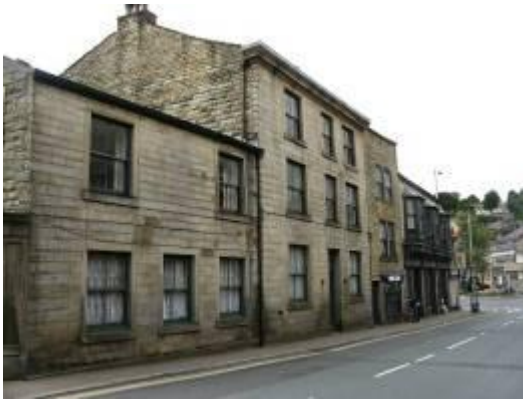
No.17 Yorkshire Street (in centre)

This three storey building retains an almost symmetrical but very plain front face, three windows wide with a central front door. The stone slate roof is partially hidden by the heavily moulded parapet. It dates to the early 19th century and is now used as offices.

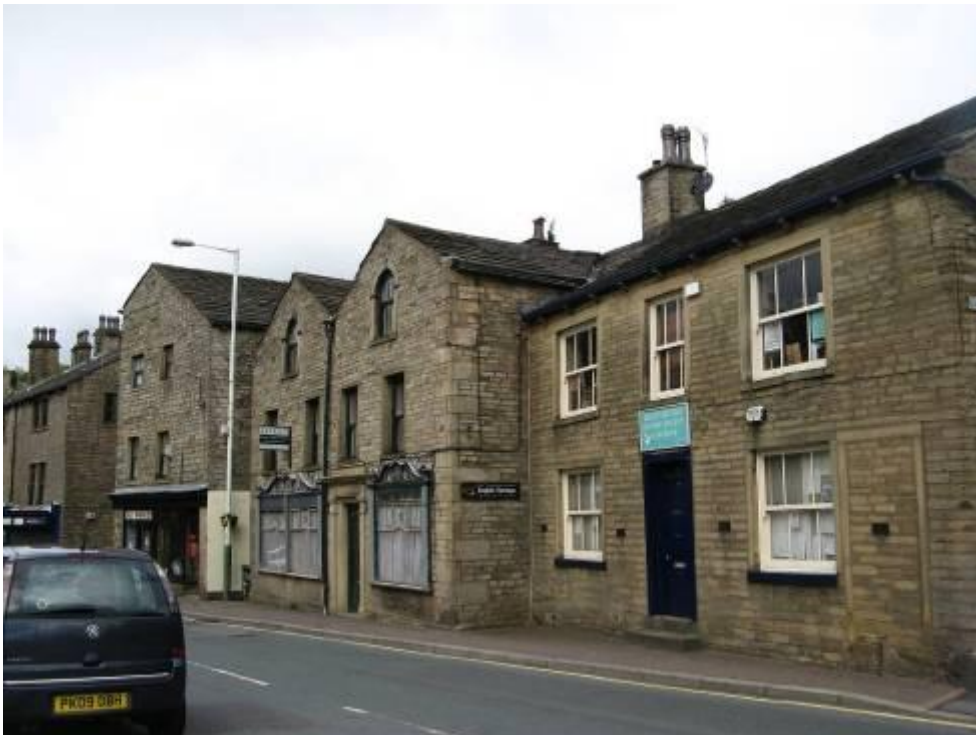
Nos. 20 and 22 Yorkshire Street

These gabled three storey houses are dated 1770 and may have been built as a taking-in warehouse for woollen cloth, later becoming a public house and then a shop with residential accommodation above. They are faced in watershot coursed sandstone with quoins, and retain their stone slate roofs and shopfronts which may date to 1907 (date plaque).

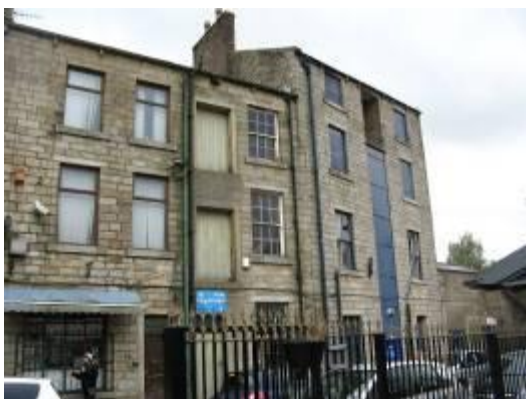
Varied window types at the back of St James Square facing Temple Court Place

Mullioned windows were traditional in vernacular construction from the earliest stone buildings up to about 1830 or 1840. It was usual for the lintel over the centre light to be bedded on top of those to either side, giving the typical stepped, mullioned window. These can be seen throughout the Conservation Area including Nos. 15-19 Union Street, where stepped windows survive to the rear elevations, the front windows being replaced by sashes in the Victorian period. Sash windows survive in very few places, with examples of early multi-paned Georgian windows being very rare although on the rear elevation of No. 5 Bankside Lane (which overlooks Elgin Street) can be seen a broken Georgian multi-paned window which is presumably original. Altered or replaced sash
