Draft Rosendale Local List of Non-Designated Heritage Assets

December 2024

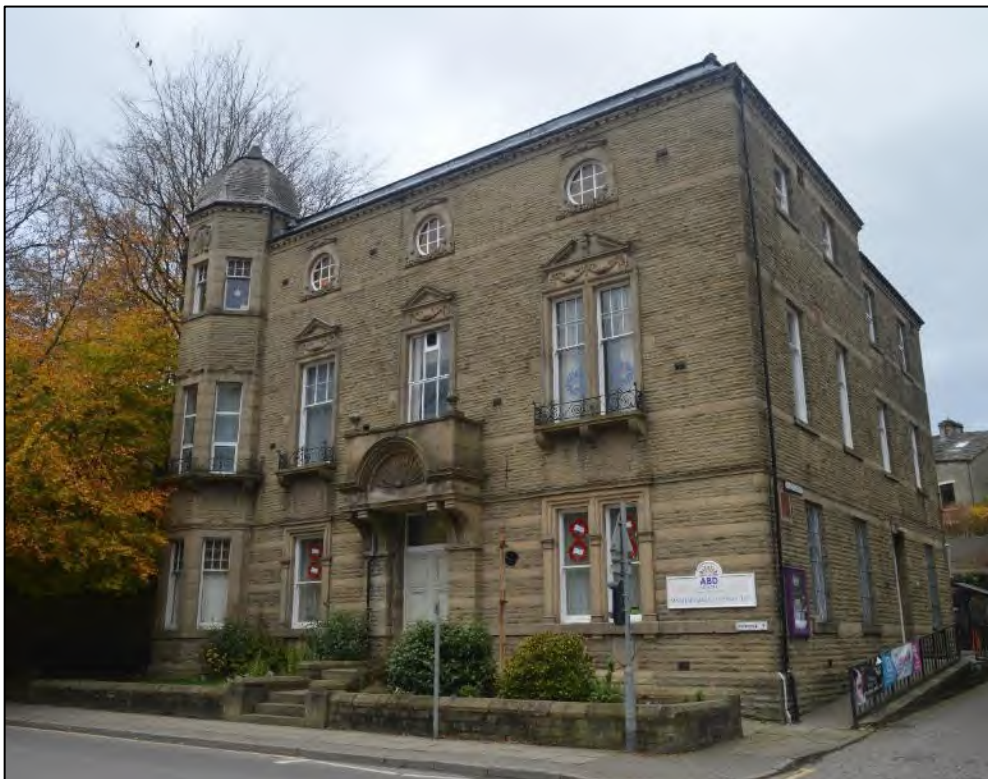
Image

A much larger and more convenient building that replaced an existing club, which had been in use since 1875. The club is three-storeys and built of rock-faced stone, with Ashlar stripes in an Idiosyncratic Baroque style (Pevsner). The design shows the principal entrance in the centre of the front elevation. Large octagonal corner tower with a dome, doorway with a shell tympanum and balcony over, windows with Adamish details and a row of bullseye windows along the top (Pevsner).

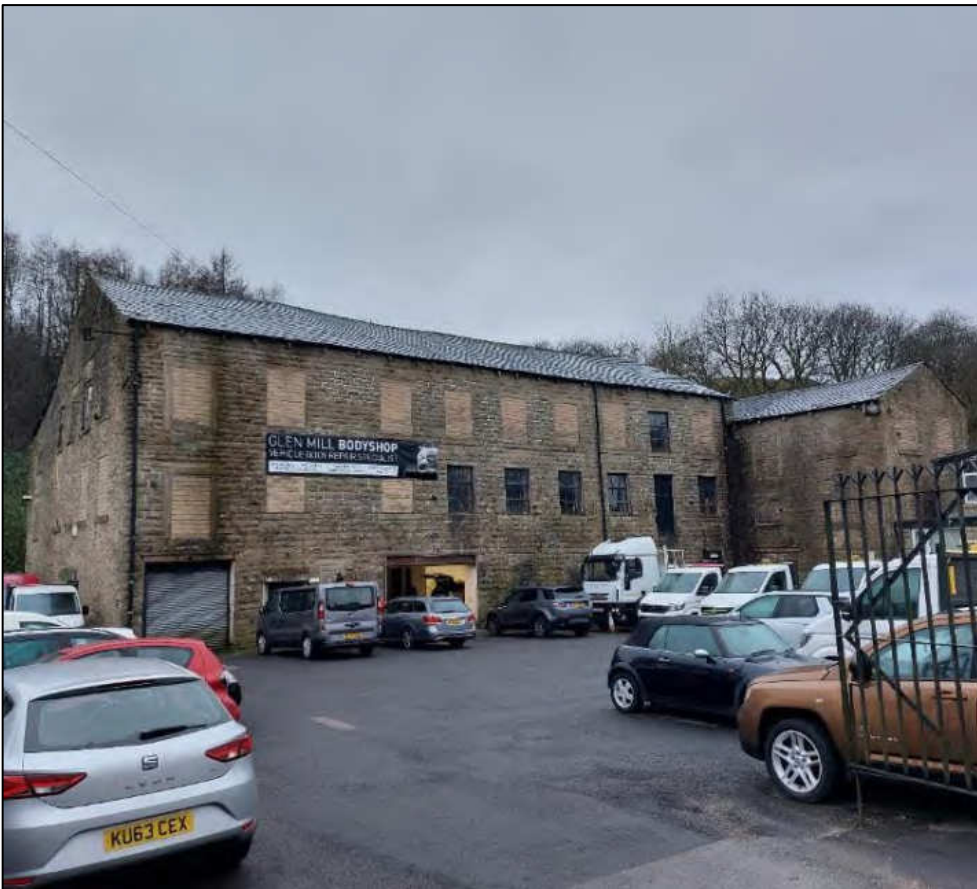
Image

Built in 1854. Three storey, stone built, original slate roof, some windows filled in modern times. Built for cotton spinning and manufacture by Henry Duckworth (Mannex, 1854). Later used for slipper manufacture. Currently still in industrial use as a auto body repair shop.

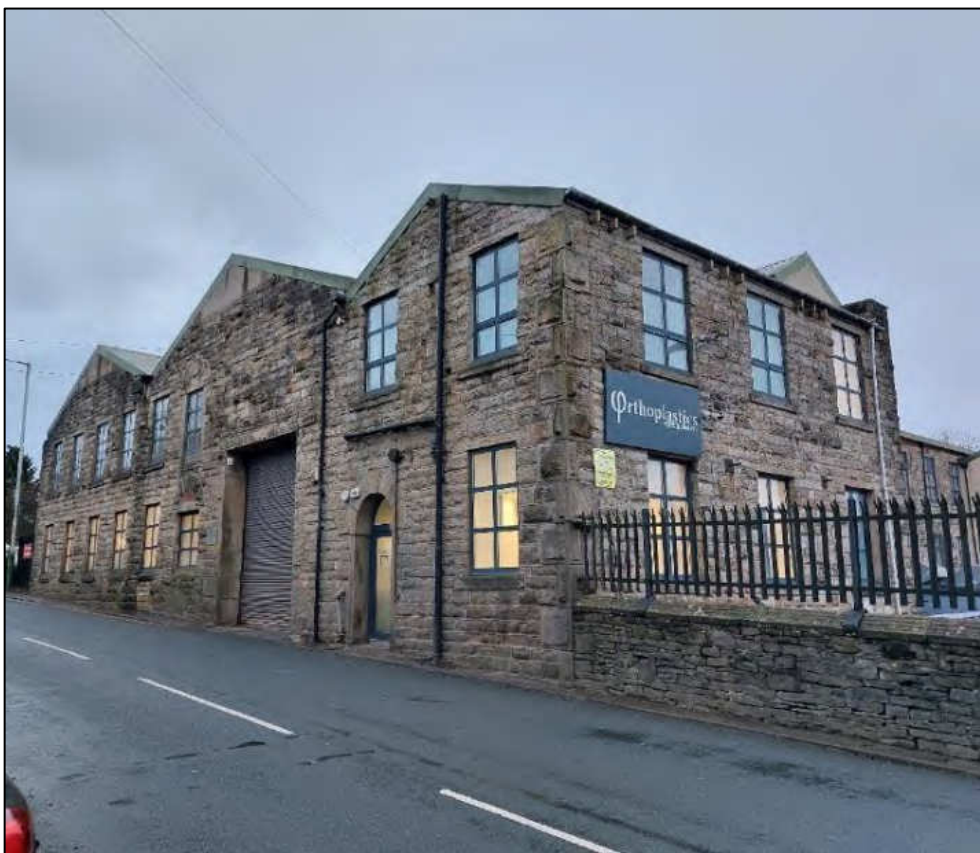
Image

Although the original roof has been replaced and a modern stairwell/lift shaft added, much of the original material remains including an arched doorway.

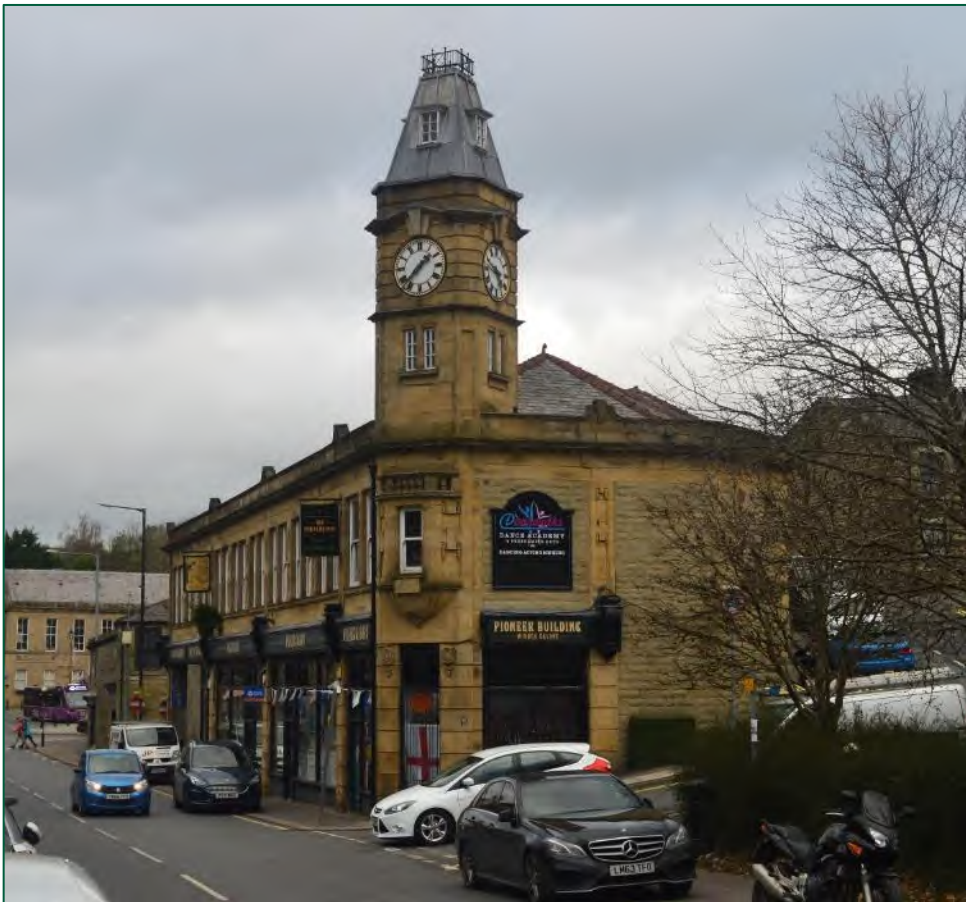
Image

Purpose-built department store of 1914. Pioneer Buildings is a large purpose-built shop, built by the Bacup Co-operative Society with a corner tower and clock which forms an important focal point. Previously the building was stripped of original features replaced by a large acrylic fascia and had clashing shop signs. The original features have now been restored by Bacup THI.

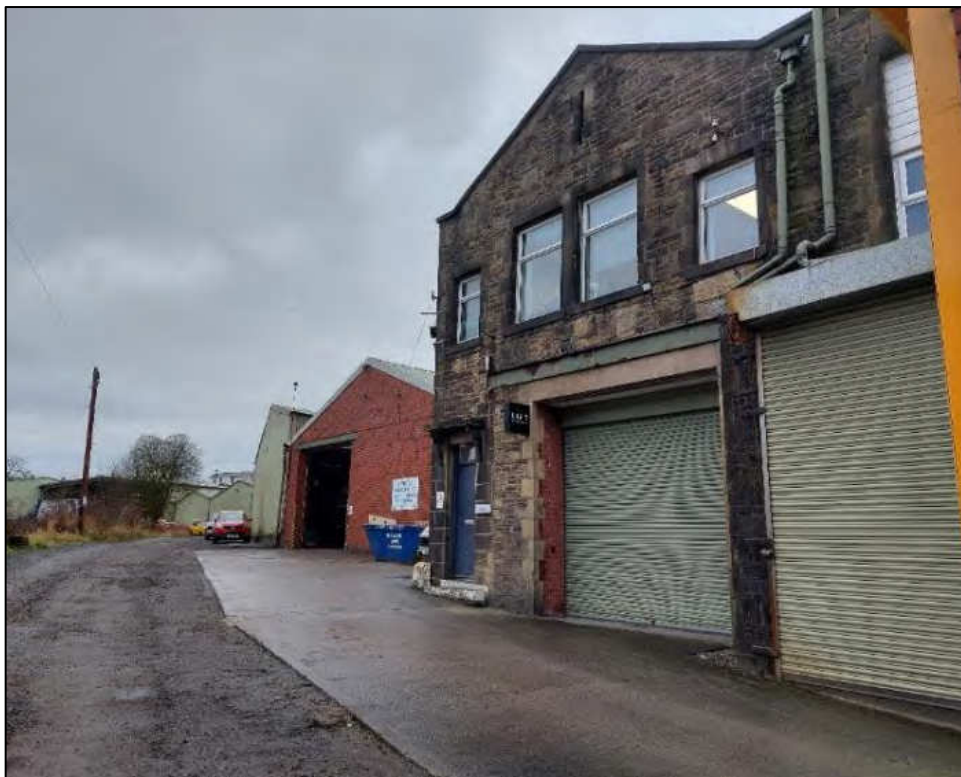
Image

The mill, along with a dye house and mill ponds is shown on the Ordnance Survey first edition map of 1849. On the Ordnance Survey map for 1894 it is noted as being a cotton mill. The 1930 Ordnance Survey map shows it as having been enlarged (or replaced) and renamed 'Kippax Mill (Cotton Waste)'.

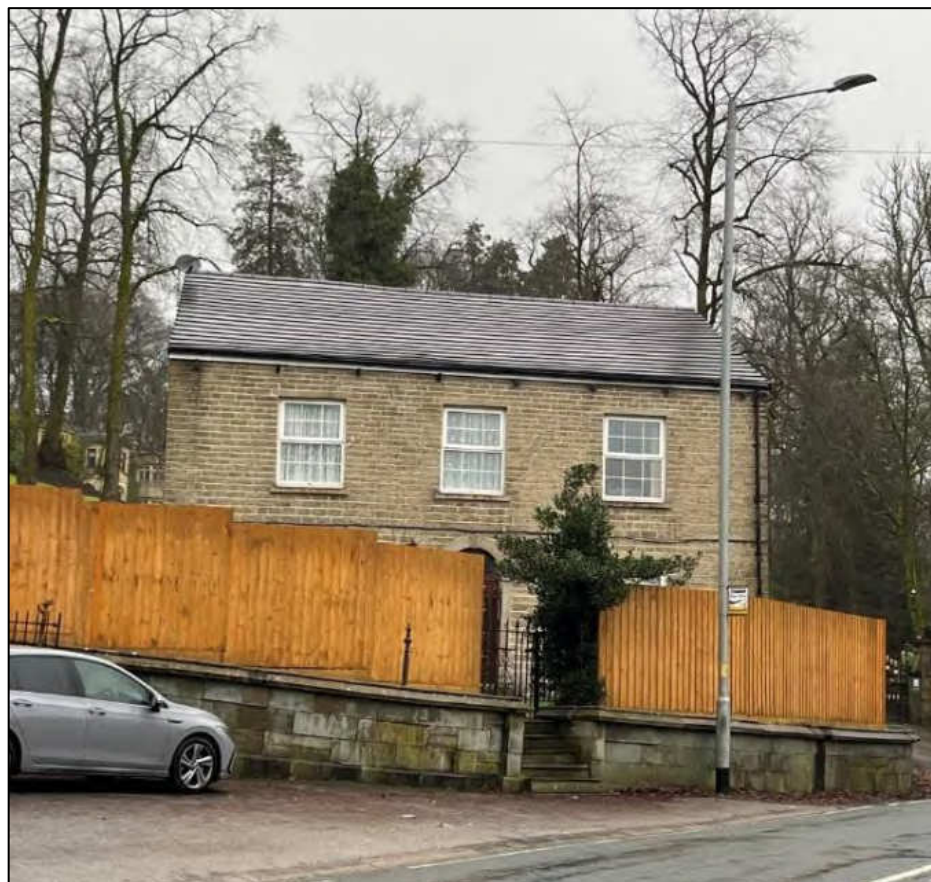
Image

Stone built house with symmetrical frontage and arched door dating from c.1830-1850. Former house of estate agent to Brooks family of Crawshaw Hall. Façade faces directly down Burnley Road and forms an important feature at entrance to Crawshawbooth village. The asset forms an important feature at entrance to Crawshawbooth village.

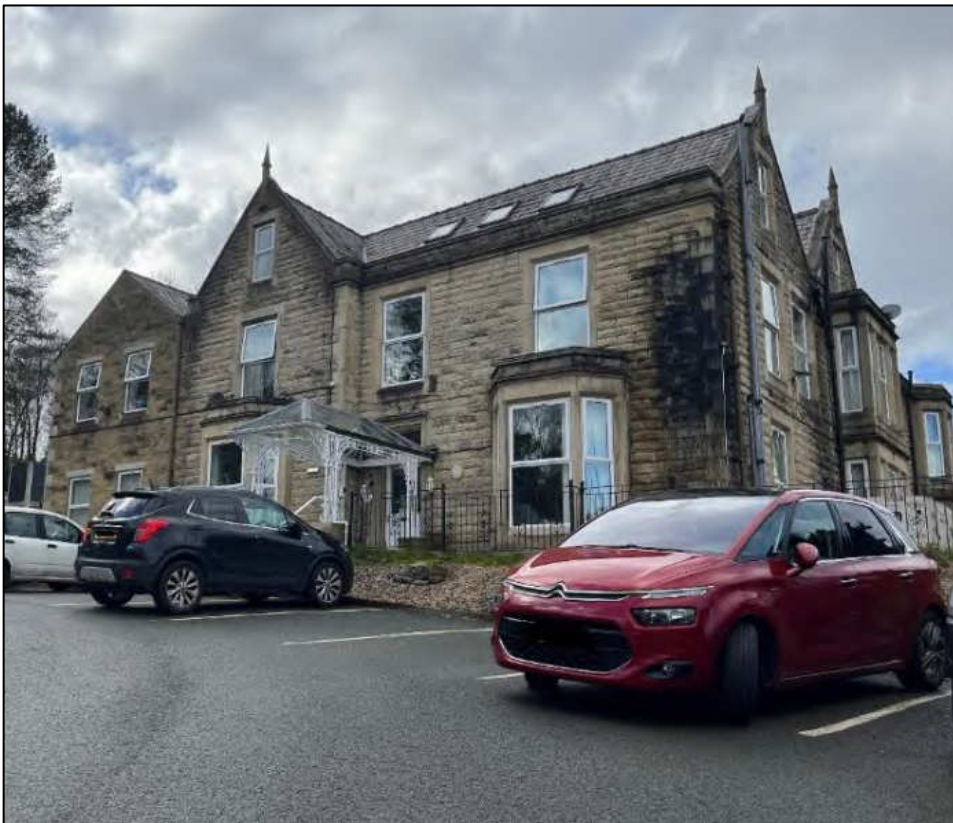
Image

The Cliffe is two storey and constructed from coursed stone, the front elevation is partially gabled and there appears to be an extension to the left of the property, this mimics the gable to the right which is part of the original building. The original part of the building has a central entry door which is accessed via a set of steps, either side sit two bay windows. The first floor has three windows and another window can be found in the gable. Both gables are decorated with spires. The extension to the left has two windows at ground floor level and two at first floor level. None of the original joinery appears to remain on the front elevation. The asset was built in the 1850s with considerable additions in 1892, it has been altered again more recently.

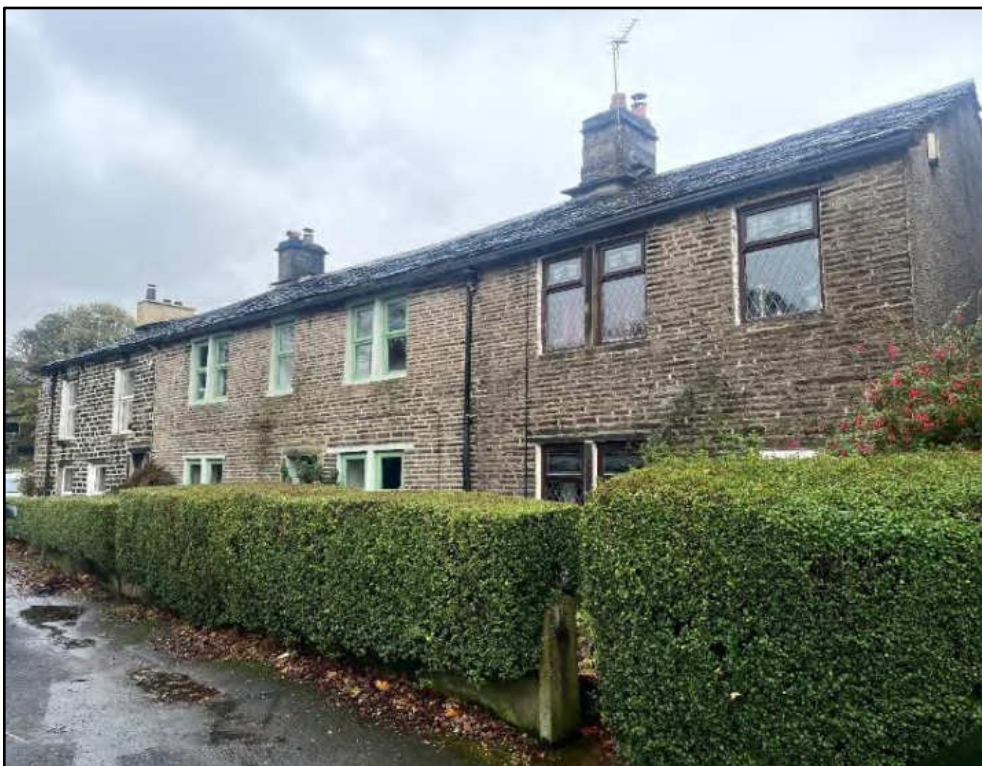
Image

A row of small independently designed 2 storey stone houses joined together into a terrace which gives it great character. Many historic features remain, particularly possible Victorian era stained glass and some window frames. Possibly dating to the 18th century although No. 445 is possibly later as the stonework is different. The shallow pitched stone slated roofs are subdivided by chunky axial stacks.

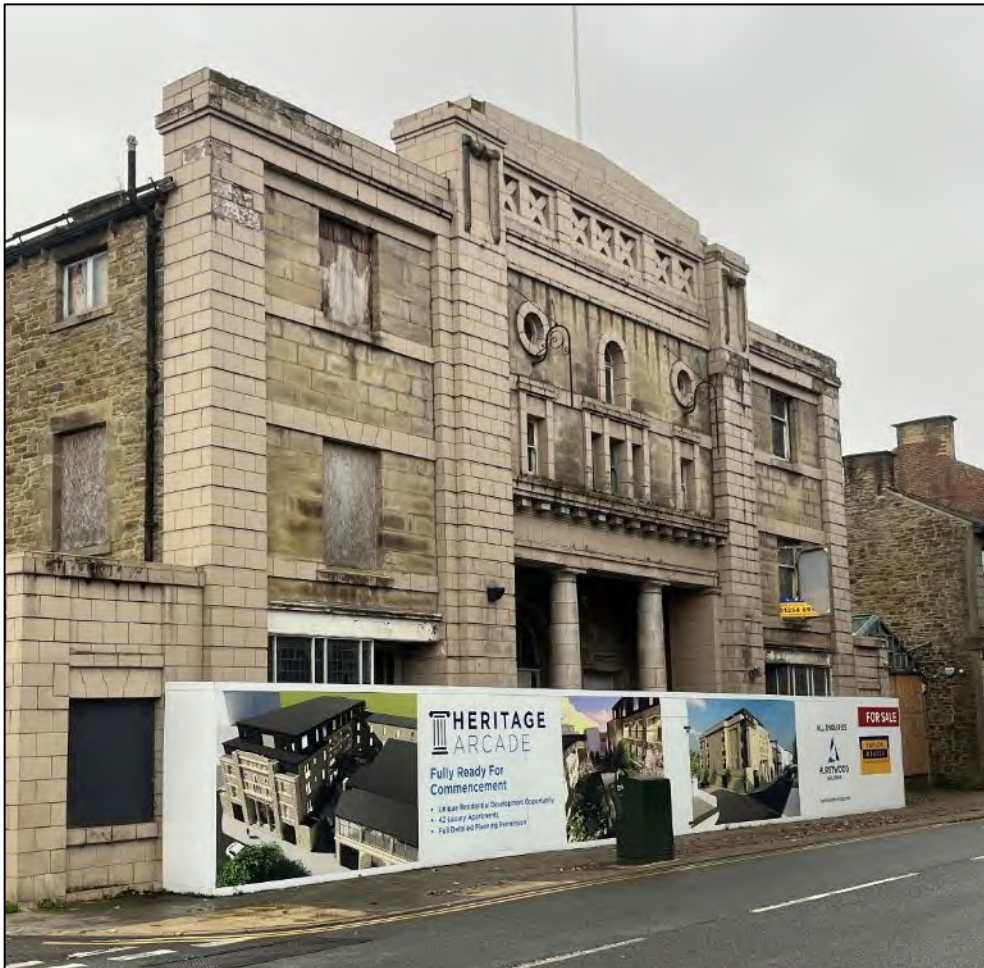
Image

Built 1920 in typical 'Picture Palace' style. Pillared entrance with set back doorways has defied modernisation. Some original stained glass windows remain.

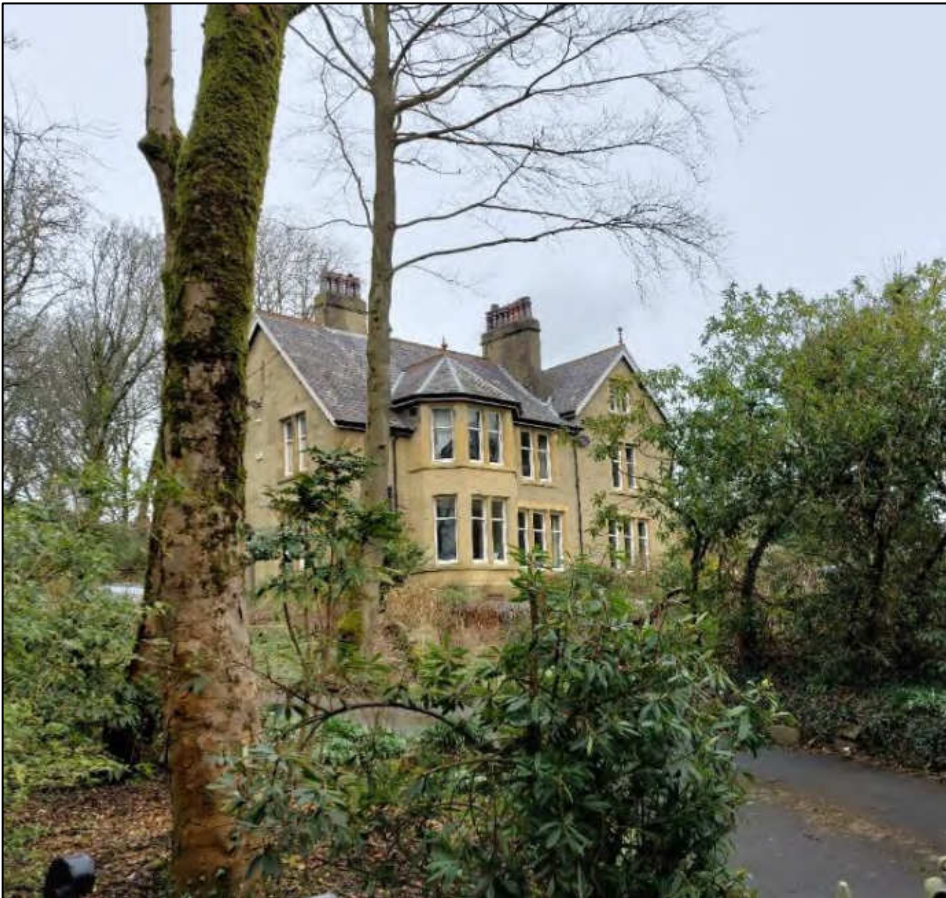
Image

Purpose built 1886 as vicarage to St. Mary's church and as such contains a wealth of church furniture type fittings e.g. woodwork and stained glass leaded lights. Still very original and excellent example of late Victorian style.

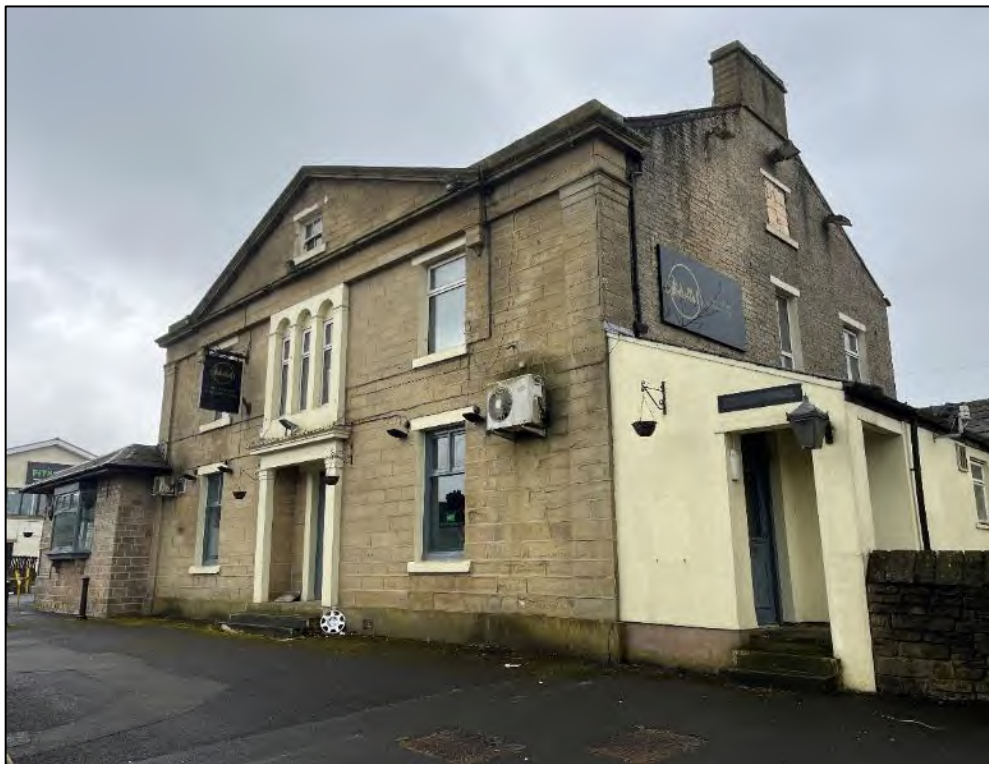
Image

Early 19th Century former coaching inn and public house. Of the same design as the Rostron Arms in Edenfield, possibly built by same brewery or architect.

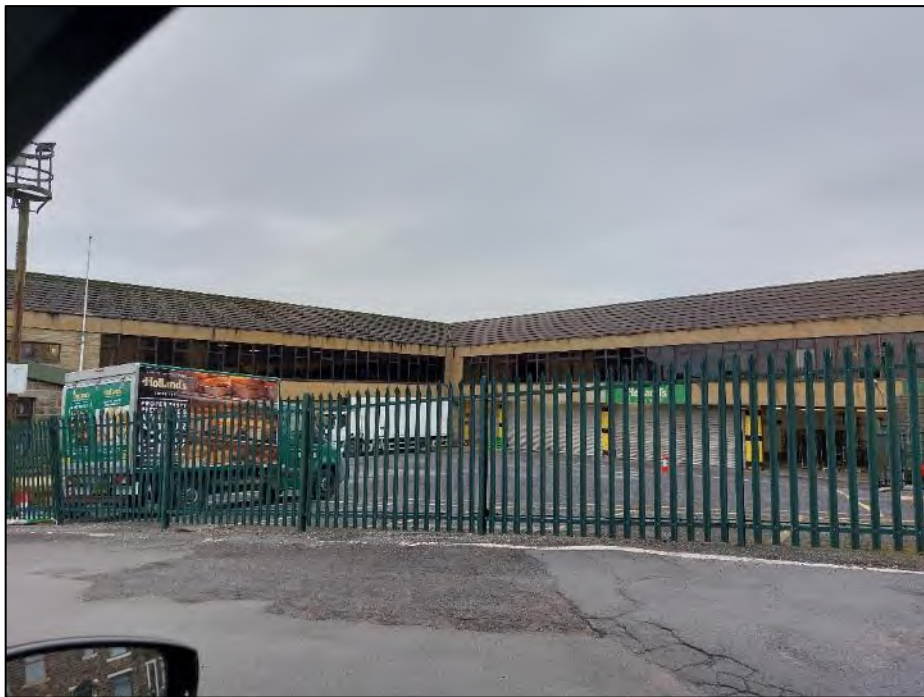
Image

Hope or Industrial Mill, with the exception of the chimney, is intact, although there are also later additions by Hollands. The original weaving shed is in the north-west portion of the site. The random stone walls of the shed date from the 1860s, but the northern light roof is a twentieth century replacement of the original. A two storey preparation department, with slate roof, extends along the southern perimeter. The boiler and original engine houses were at the south-eastern end of the first weaving shed, on either side of the recently removed chimney. Two shed extensions are attached, and both retain their northern light roofs (Rothwell, 2009).

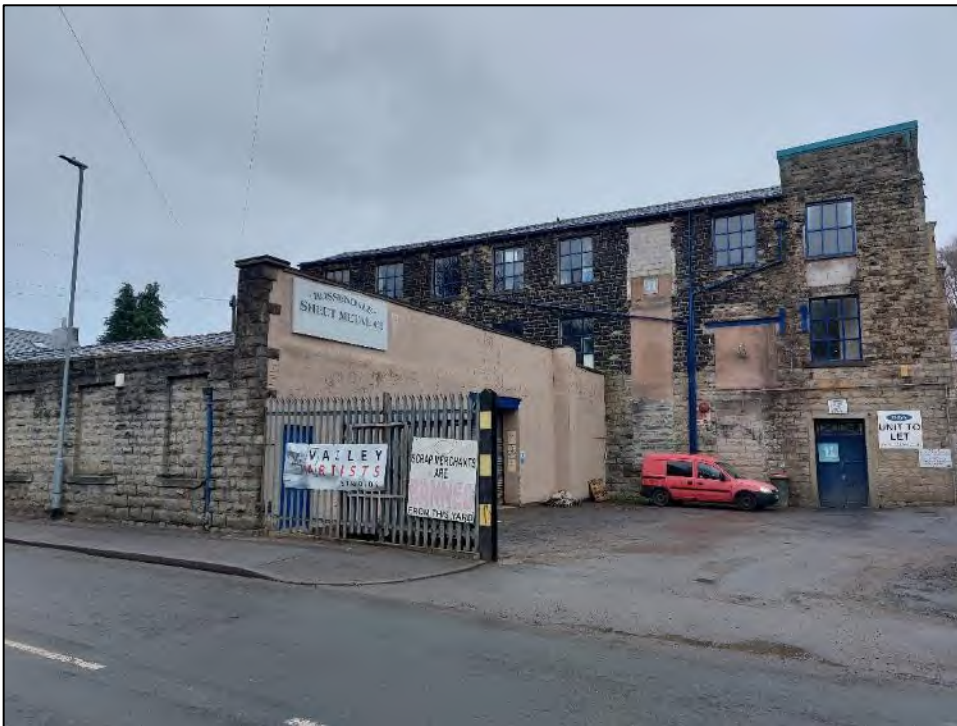
Image

Clarke Holme Mill is a former cotton mill constructed from coursed stone, the Burnley Road East elevation is single storey and it has a larger, three storey range to the rear. The larger, rear building has a regular fenestration pattern of nine-light windows and a triple gable front facing onto Clarke Holme Street.

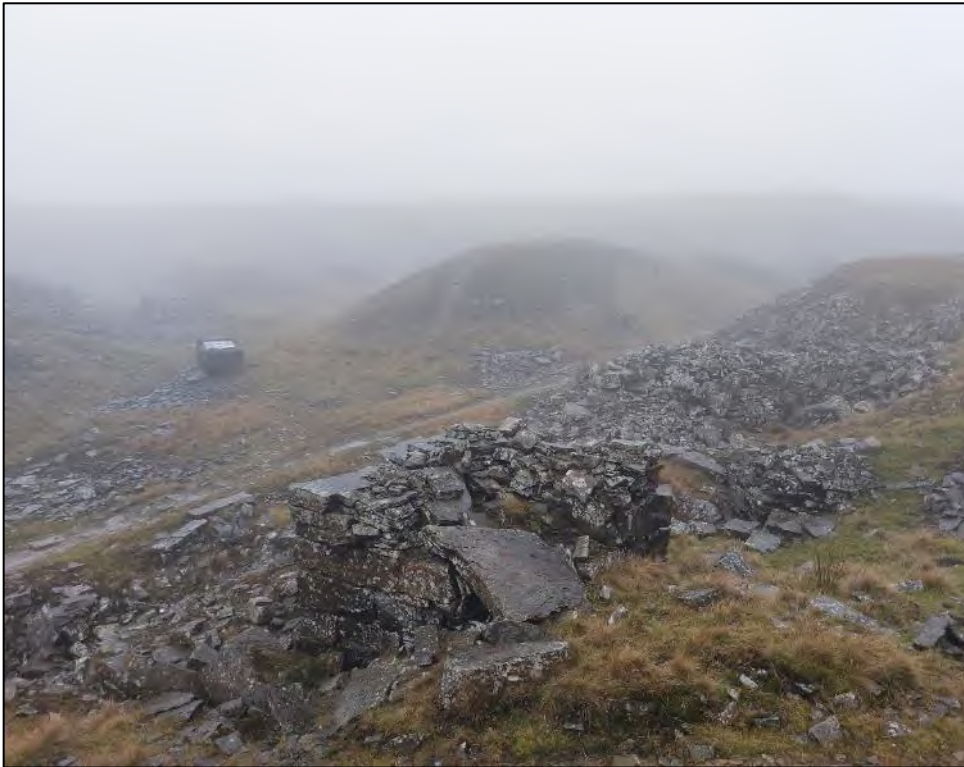
Image

A stretch of a former tramway routes which cross the Rossendale moorlands. Excellent examples of double causeyed stone waggon routes, running parallel to a curved sweeping embankment of the mineral tramway.

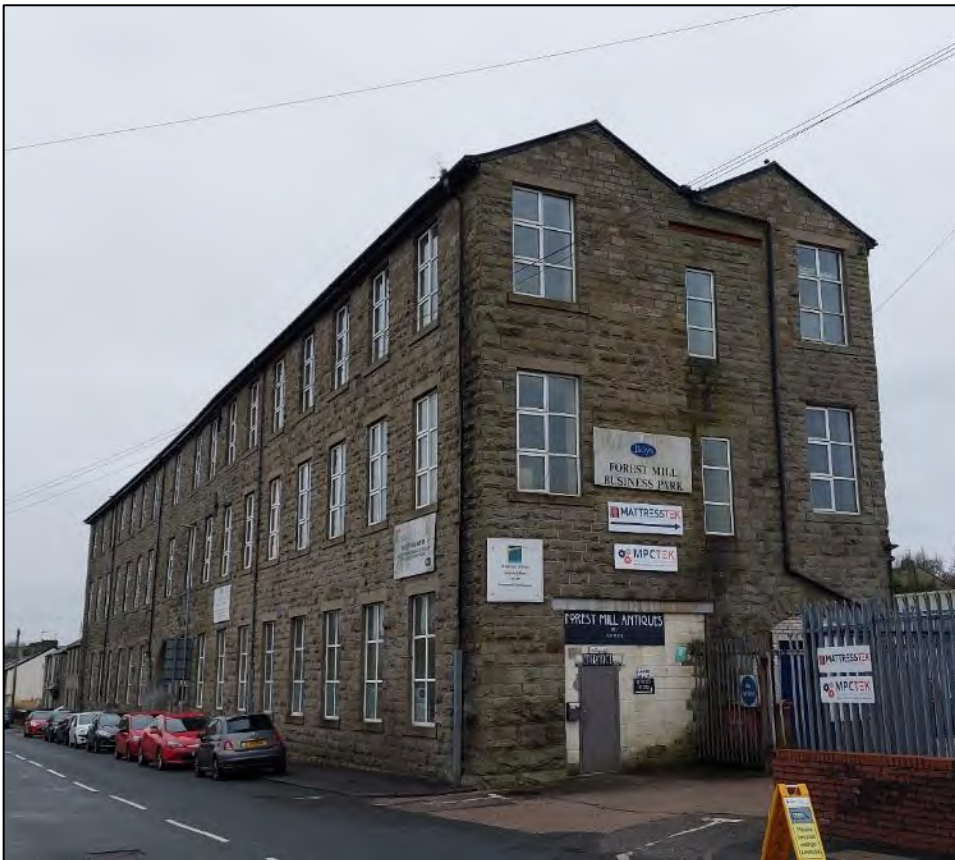
Image

Forest Mill fronts Burnley Road East and has a large 17-bay front elevation. The mill is three storey and constructed from coursed stone with a hipped roof, the site extends to the rear with a section of northern lights. The Burnley Road East elevation has an arched entry way with a large fanlight and 'Forest Mill erected AD 1861' written in relief above the door.

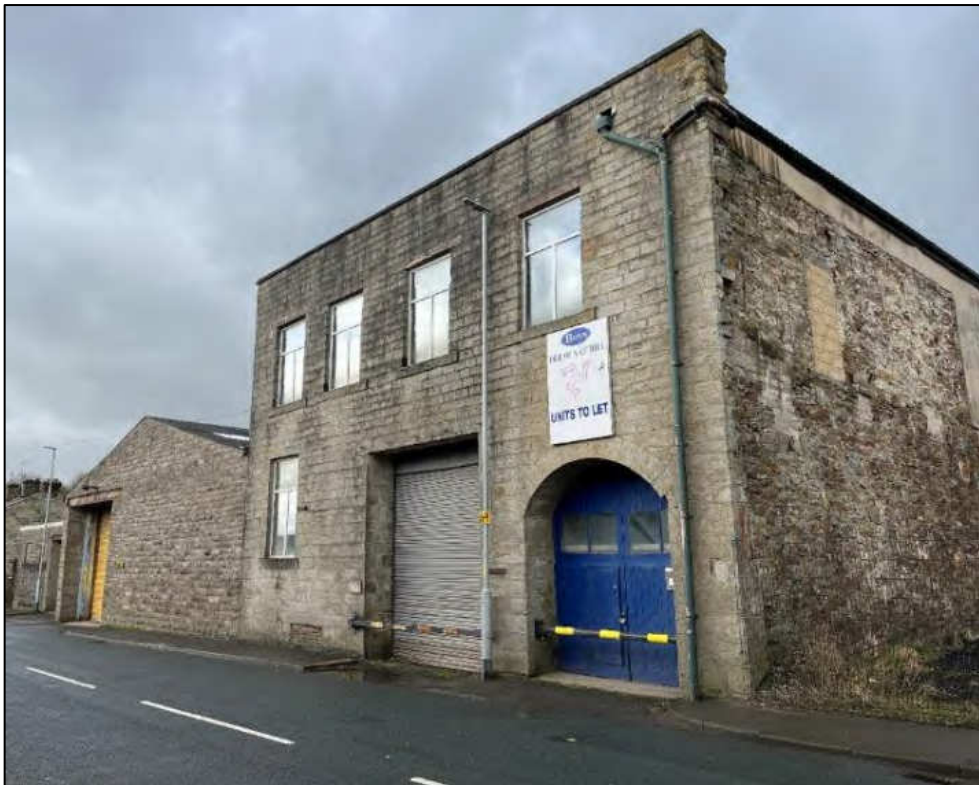
Image

Lancashire Textile Sites: Buildings at Risk Assessment Survey Report (September 2018): Isle of Man Mill (along with Forest Mill, situated further to the north along Burnley Road East) makes an important contribution to the historic townscape of Waterfoot. In particular, Isle of Man Mill retained one of the few full-height chimneys to survive in the valley, however this has now been demolished, along with a large amount of the mill itself.

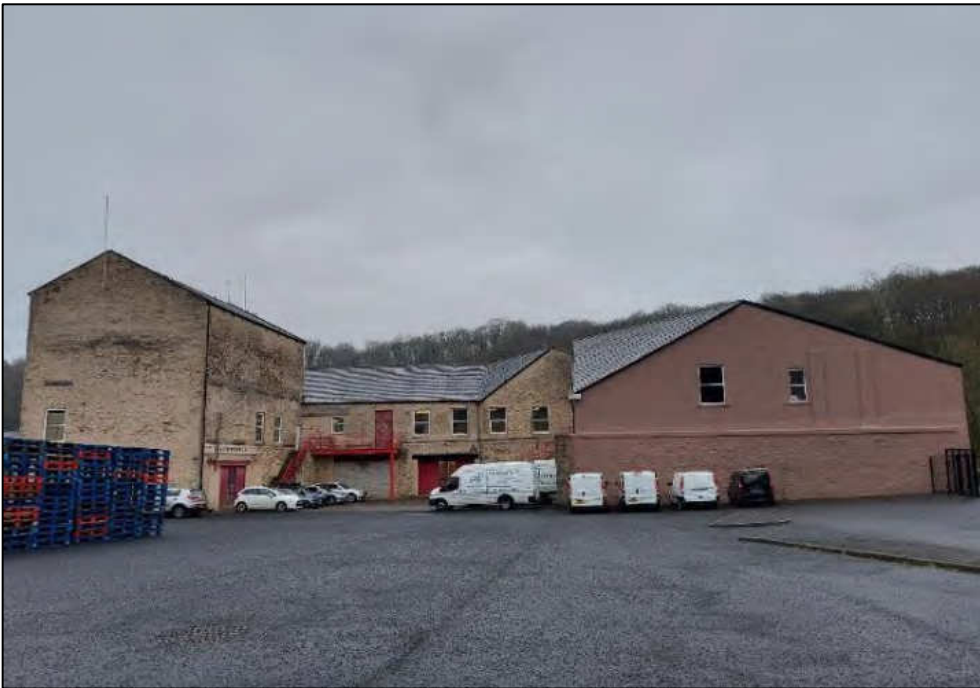
Image

Very large two / four storey stone built mill complex, still in industrial use. Solidly built, stone mill consisting of two blocks, a two storey block next to the road and a four storey block behind. Both are of regular fenestration. Mentioned only very briefly in the All District report as first noted on the OS map of 1894.

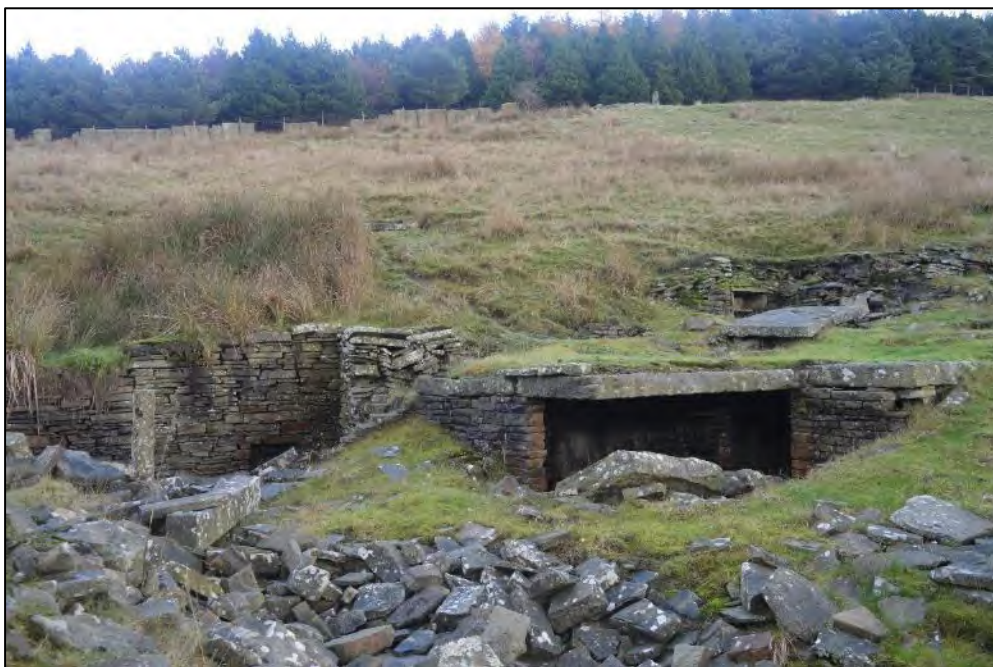
Image

This is an early water-powered stone rubbing / scrubbing mill that was in operation from 1844 until 1910. In the early 1990s, the remains of the mill include a waterwheel pit, vaulted cellar, lodge and two bevelled millstones. The site has an important landscape as the whole of Cwm valley is crisscrossed by flagstone walling which is possibly made from the waste products of this unusual industry (Valley of Stone).
